Lakeside Park

Location: Mississauga
Constructed: 2012

Public Lands

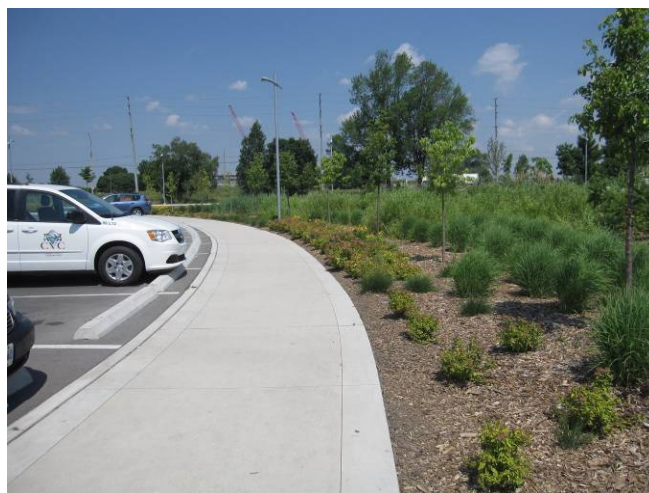
Parking lot is graded to allow water to flow over the sidewalk and into the bioswale. This creates icing issues in winter months.

- The design incorporated several LID features, which offered both water quality functions as well as aesthetic appeal.
- CVC notified the City of Mississauga that the bioretention soil media did not meet specifications. It was immediately replaced. CVC and City staff inspected the soil media prior to placement.
- To expand the objectives for a green sustainable landscape, City of Mississauga partnered with Holcim Canada to construct the permeable concrete parking lot.
- CVC and City of Mississauga routinely monitors the bioswale for invasive species and removes them as part of regular maintenance.
- City of Mississauga regularly checks areas where ice build up occurs during winter months and applies de-icing salt when necessary.

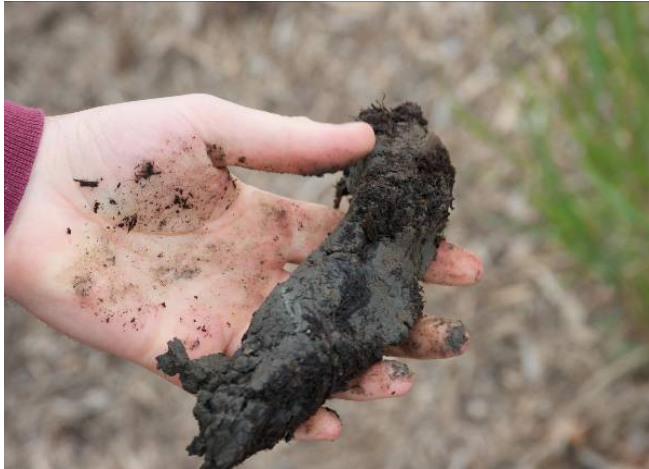
As previously discussed in the design section, soils were specified based on the draft 2010 CVC/TRCA Low Impact Development Stormwater Management Planning and Design Guide. CVC staff visited the park after construction was complete to verify the LID features met the design specifications. CVC staff found that the bioretention soil media did not fully meet specifications. Site instructions were issued to the contractor to correct the problems. The contractor immediately replaced the soil media under their warranty obligations.

A simple ribbon test was conducted on site as a visual tool to gauge clay content. If the soil clumps into the length of a ribbon rather than crumbling, there is high clay content.

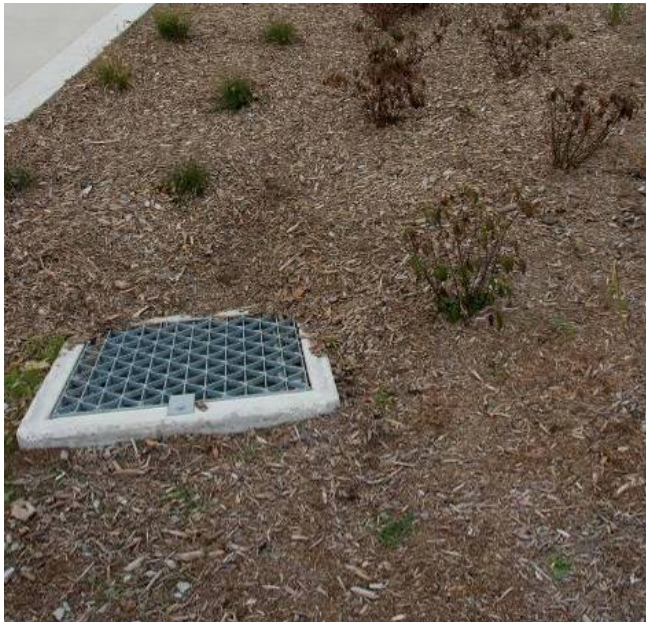
The mulch was predominantly shredded as specified, but a portion of the mulch consisted of large unshredded pieces, longer than the maximum recommended length of 100 mm. These larger pieces of mulch can dislodge and float during heavy downpours. This resulted in the minor problem of channeling and deposition of mulch near the overflow during heavy downpours.

Channeling of unshredded mulch towards overflow catch basin

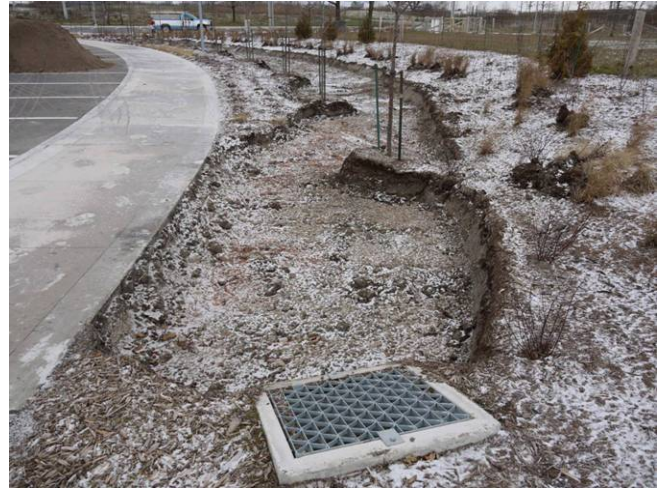
Bioretention soil media has been scrapped out of the cell after discovering it didn't meet specifications.

- Original soil in bioretention swale did not meet specifications in the design, in accordance with CVC/TRCA Low Impact Development Stormwater Management Planning and Design Guide.

- It is important to stress to the contractor the importance of testing and approval of bioretention soil media prior to delivery on site.

- Bioretention soil media should be tested and approved by an engineer prior to delivery at a construction site.

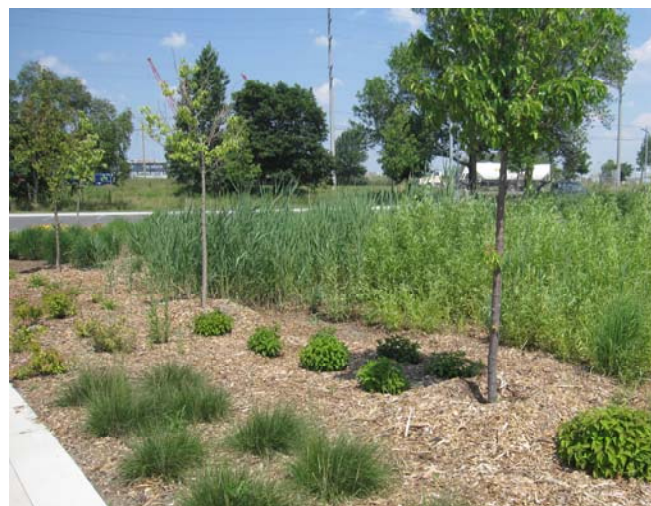
One issue that has been noted at Lakeside Park is the presence of two invasive species, European Reed Grass and Canada Thistle, within the bioswale. They are likely blowing in from the adjoining industrial sites. These invasive species pose a great risk to the establishment of native vegetation in the swale. CVC has assisted the City of Mississauga in identifying and removing these invasive species and replanting native species. Once the native plants in the bioswale are established, they should outcompete invasive species. Until then, CVC and the City of Mississauga must routinely monitor the bioswale for invasive species.

Invasive species European Reed Grass and willow colonizing the bioswale

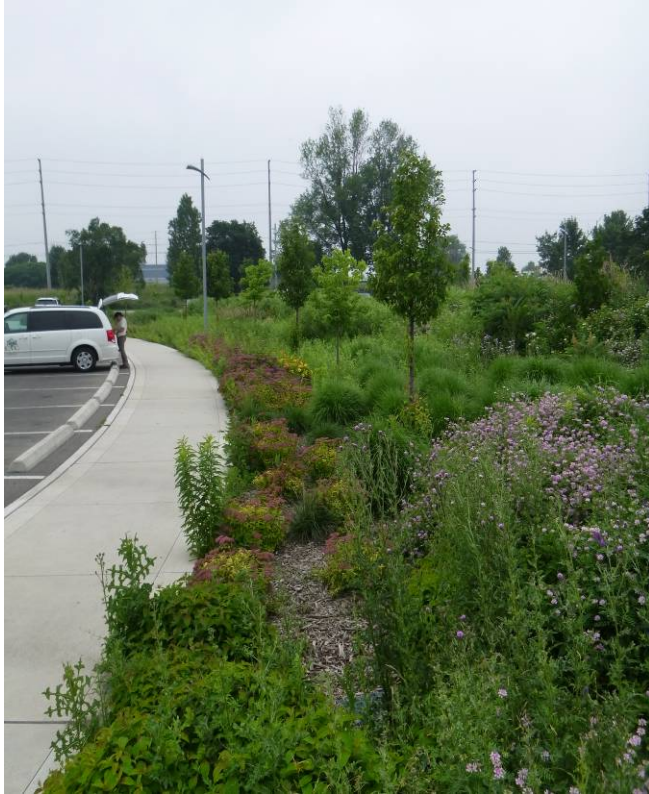
This photo was taken as one of the LID Checklist Inspection photos for the photo log in order to track site progress and maintenance needs over time. Plants are established and doing well but a bit of weeding is required at this time as a part of the routine maintenance plan

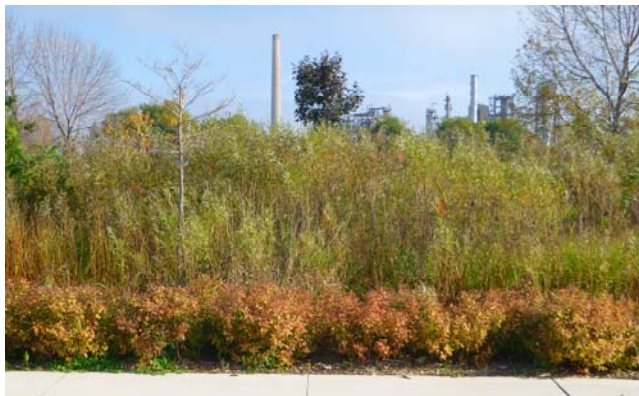
The landscaping assessments were conducted in September 2013 and overall, the site **passes** the vegetation survey protocol. The plants are thriving and are meeting the aesthetic goals as shown in the picture below

Bioswale showing good fall colour
