# Appendix C

Case Studies

# Elm Drive

## Road Right-of-Way Retrofit

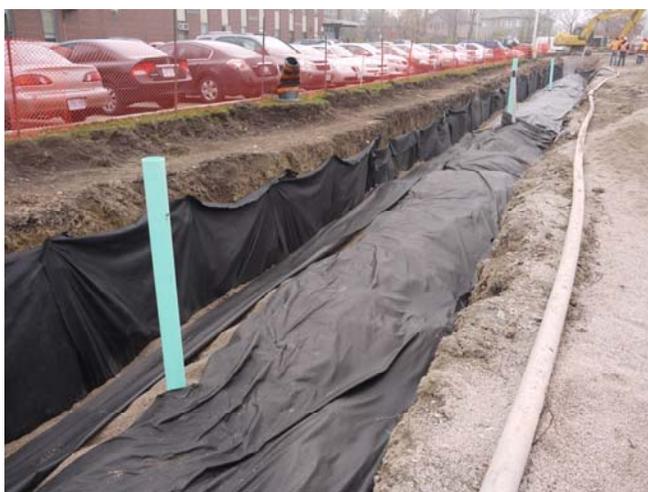
Temporary geotextile placed to prevent contamination

When preparing the tender documents, it is very important to provide sediment and erosion control guidelines with emphasis on protecting the infiltration areas. In addition, a site inspector who understands the need for proper ESC in LID construction should be hired.

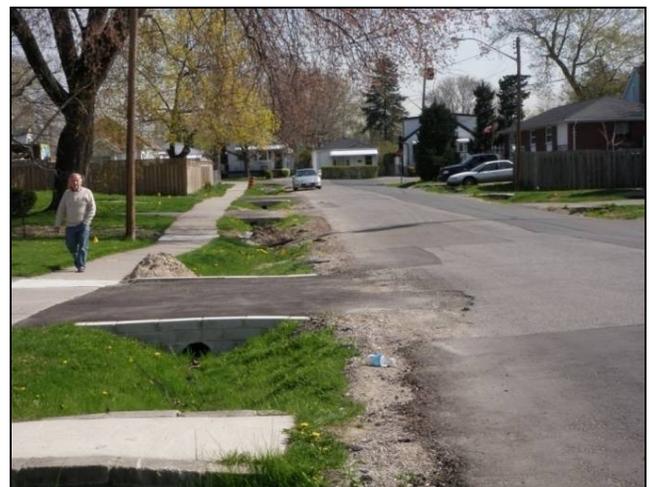
Many residents in the Lakeview community were concerned about the severe degradation of the road surface and issues related to poor drainage. Following wet weather events, standing water was sustained within roadside ditches for prolonged periods. Saturated subsoils and asphalt base layers influenced by poorly draining subsoils are assumed to have assisted the degradation of the asphalt surface.

Figure 3 - Third Street pre-retrofit conditions

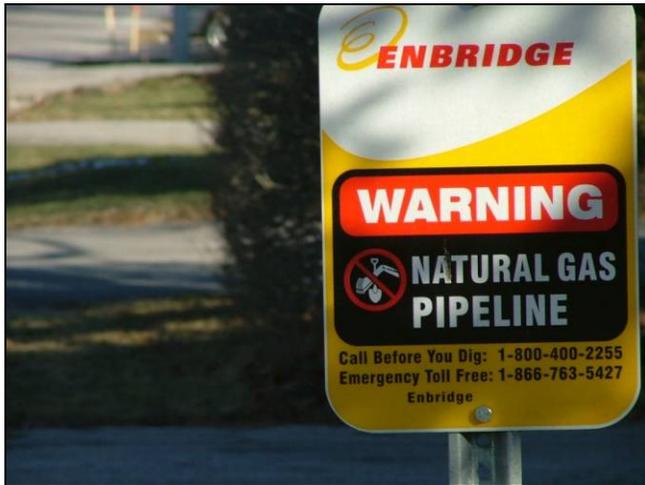
Utilities both overhead and underground were located throughout the proposed locations for the LID practices. Locate information was surveyed during the completion of pre-design tasks and added to existing mapping to ensure as much utility information was available during the design phase.

Figure 9: Many buried utilities were located along First Street and Third Street, posing a challenge for construction

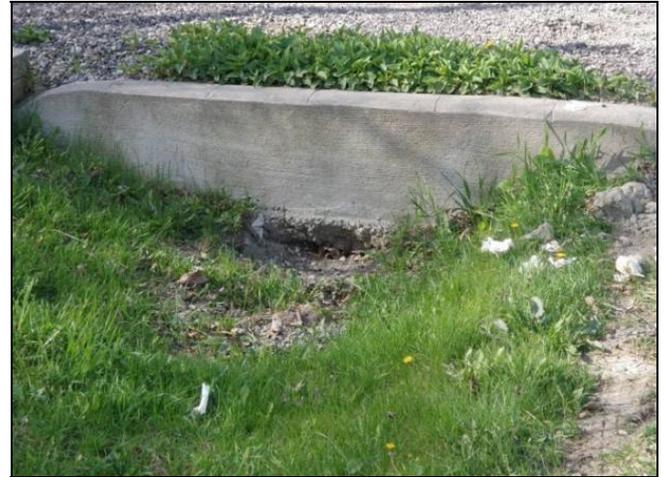
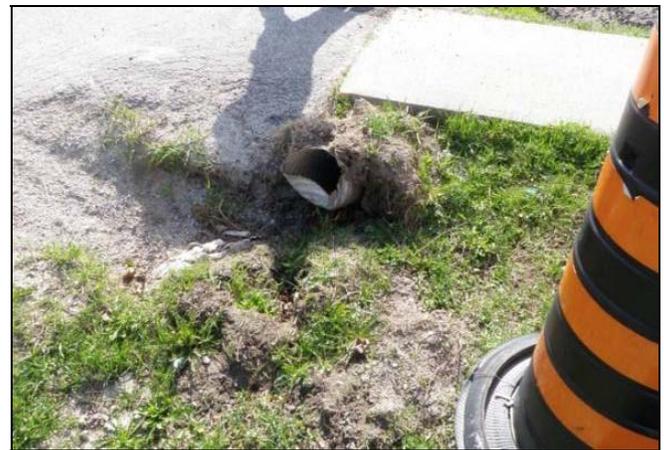
Several residents voiced concerns about degraded stormwater and road infrastructure in the Lakeview neighbourhood. Following wet weather events, standing water was sustained within the roadside ditches for prolonged periods. In addition, the age of the area led to many encroachment issues and alterations made to existing lots and drainage system.

Figure 10 and 11: Obstructed and damaged culverts in need of repair.

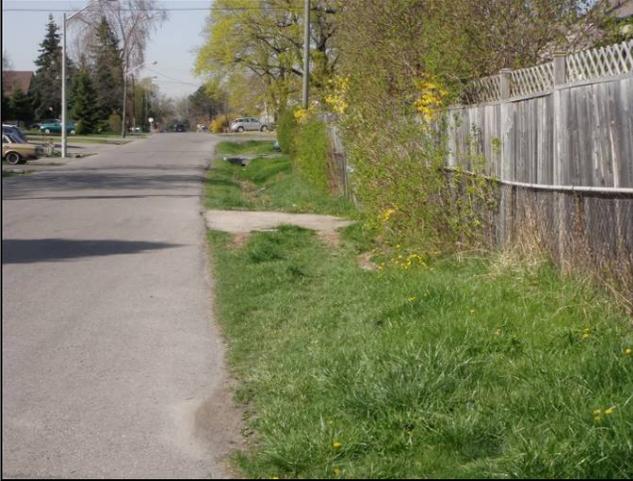
Figure 12: Ditches filled in for parking purposes

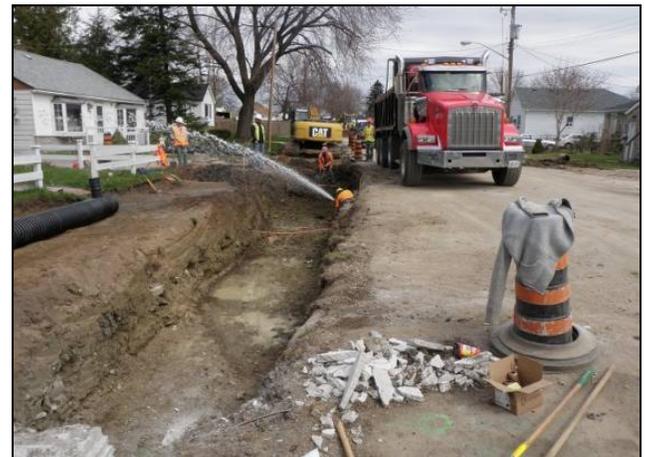
Although all reasonable actions were taken to avoid damaging utilities, on several occasions utilities were damaged and had to be repaired. Repair costs were incurred by the contractor.

Figure 37 - Damaged water service line

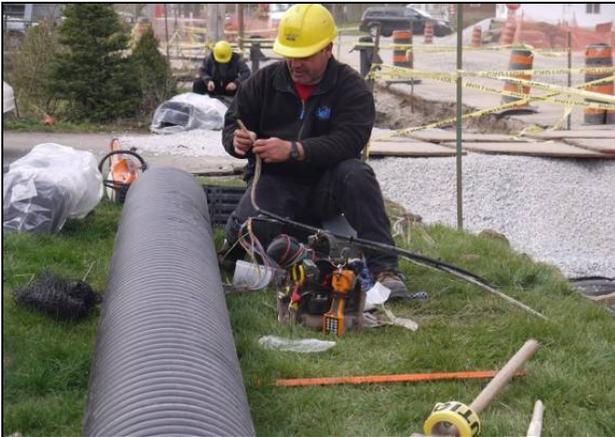
Figure 39 - Repair of a damaged telephone communication line

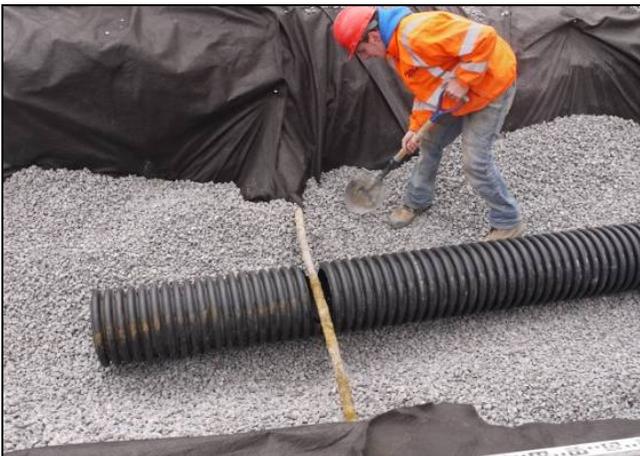
Figure 40 - Existing gas line being avoided by notching the perforated underdrain

In situations where utilities interfered with the proposed design, design elements were revised to either avoid or accommodate the utility of concern.

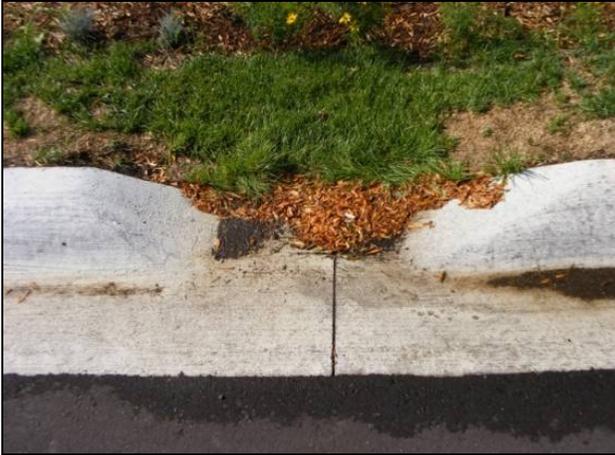
During the installation of the sod material, the contractor and designer expected much more settling and compaction of the bioretention soil media to occur. In effect, the sod acted as a barrier to runoff flowing through the curb cut inlets. During larger rainfall events a certain portion of runoff would bypass the inlets as a result. To rectify the deficiency, sod sections near the inlets were removed, soil heights adjusted and the sod reinstalled.

**Figure 46 –the sod at the curb cut inlets was too high following construction, creating a barrier for stormwater to enter the bioretention units.**

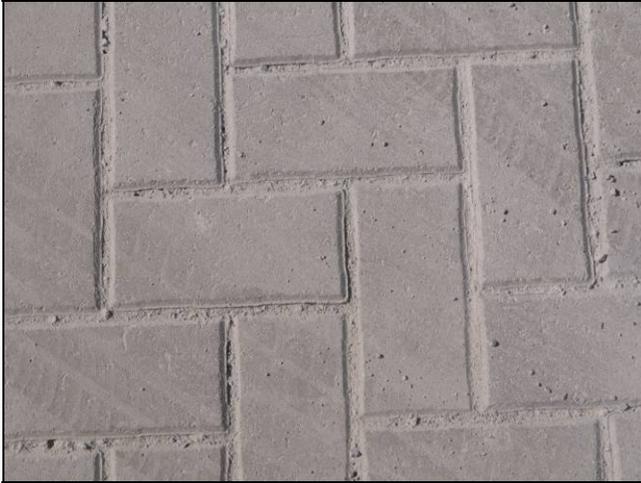
**Figure 54 – Gaps of permeable pavement filled with fines from tamping activities**

To address this issue, the fine material was removed via a vacuum truck and disposed of. The gaps were subsequently filled with chip stone to ensure free drainage was provided.

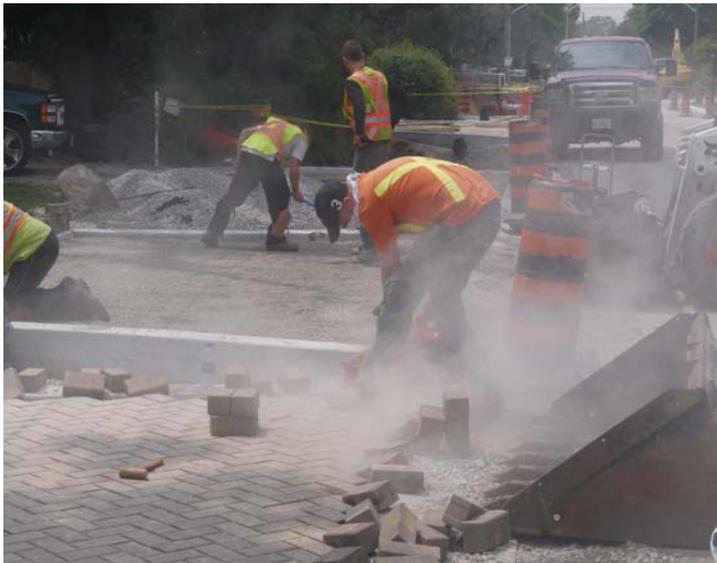
During placement of the permeable pavers, a significant amount of fine dust was created by the cutting process when the contractor was creating the soldier course. It was then requested that the contractor cut pavers away from the infiltration area or use a sacrificial piece of geotextile laid on the permeable pavers during cutting.

**Figure 55 – Fine dust during cutting of permeable pavers**

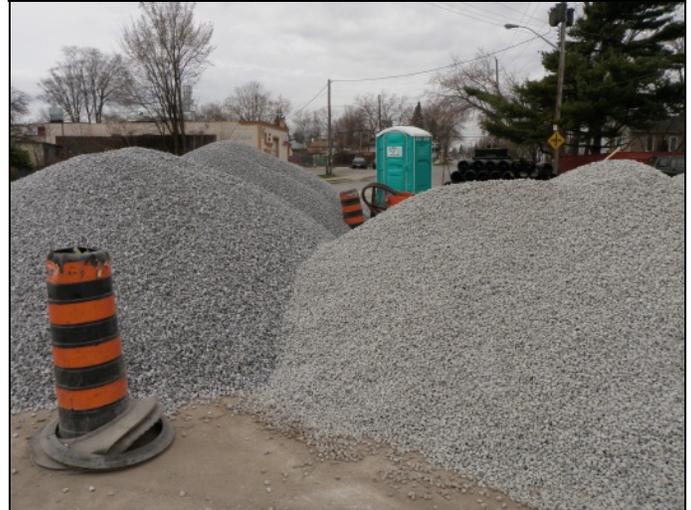
During construction, clearstone supplied to the site did not meet the specification detailed on the drawings which stated that double washed stone was to be provided. The first load supplied to the site consisted of single washed stone. Although seemingly a very minor detail to enforce during construction, the difference between the two types of material are quite distinguishable.

**Figure 56 – Double washed (left) vs. single washed (right) clear stone. Specs called for double washed**

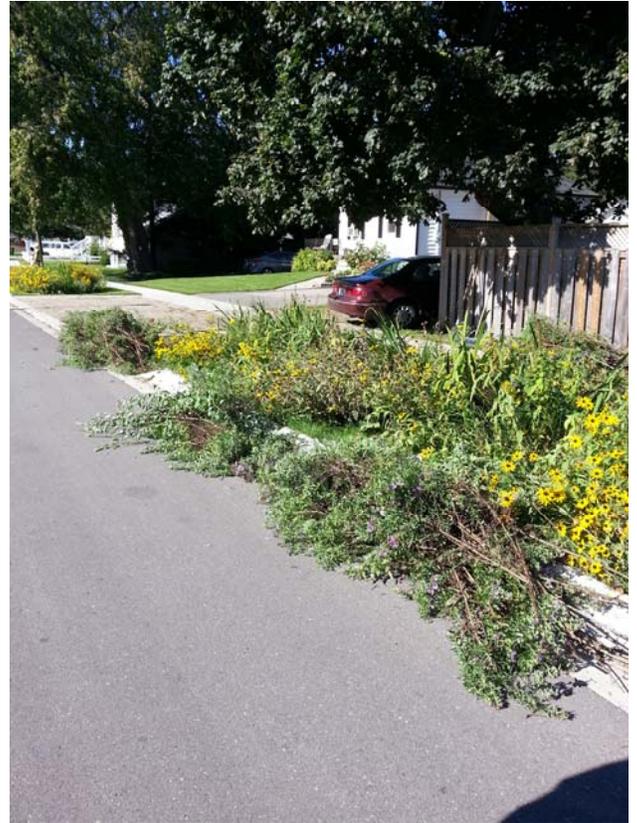
Figure 64 - Overgrown New England Asters that were removed from the bioretention unit.

Figure 65 - Plants chosen to replace green headed coneflower based on this bioretention unit. Irises in the center, black-eyed Susans, and bee balm

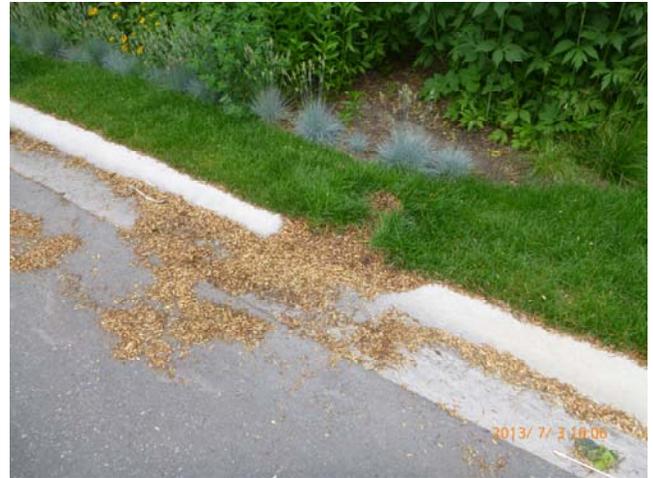
**Figure 67 - Accumulation of debris in the inlets from nearby tree**

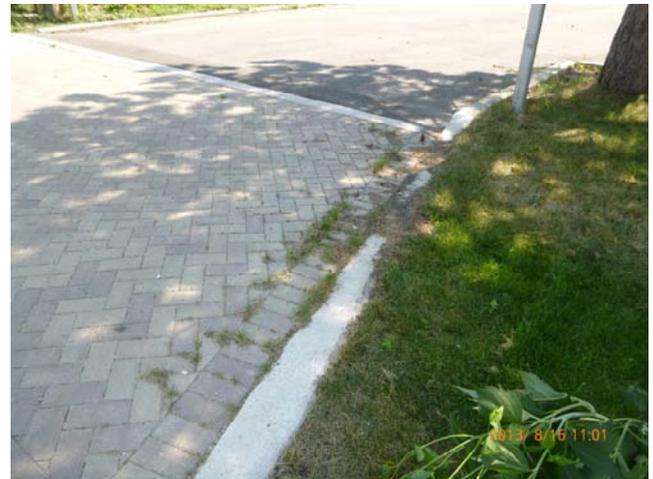
**Figure 68 - Sediment build-up and subsequent weed growth in between permeable pavers**

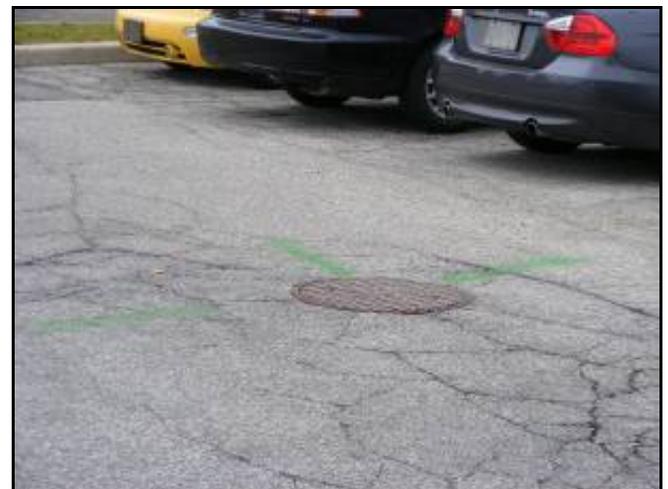
Figure 6: Pre-retrofit conditions - degraded asphalt

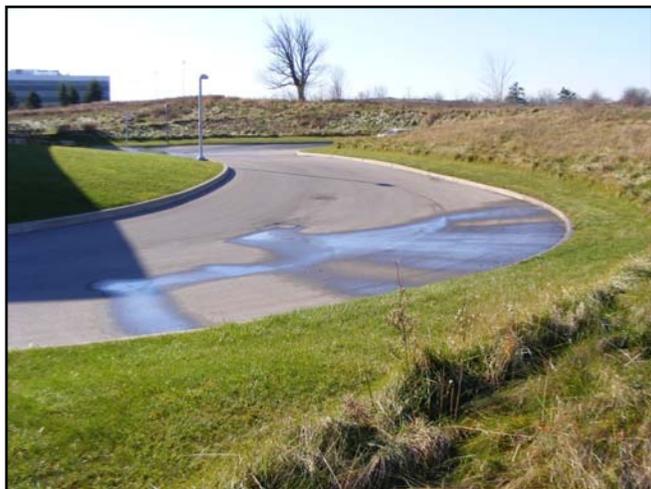
Figure 7: Pre-retrofit conditions: Groundwater seepage from surrounding high areas.

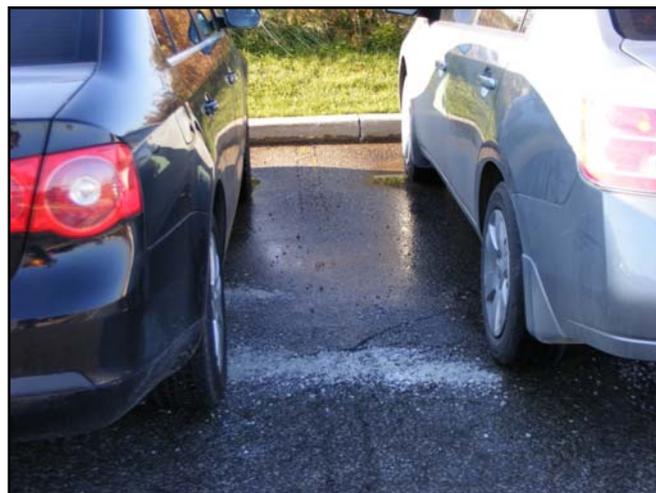
Figure 8: Pre-retrofit conditions - Excessive winter salt application

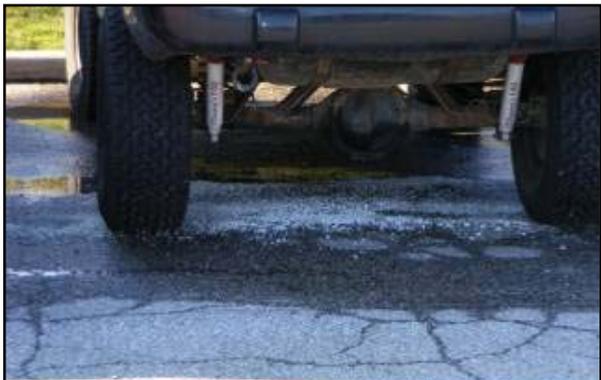
Figure 13: Asphalt degradation at IMAX parking lot and extensive salt application.

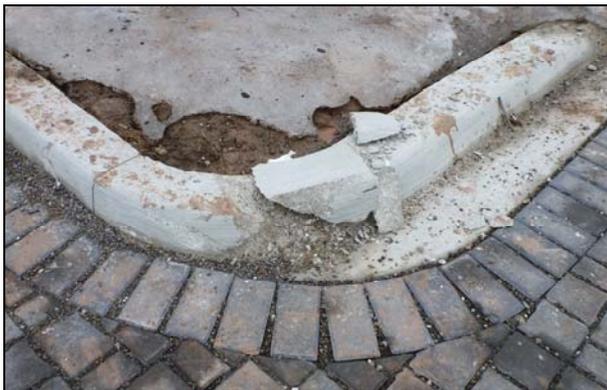
Figure 44: Curb damage due to snow ploughing.

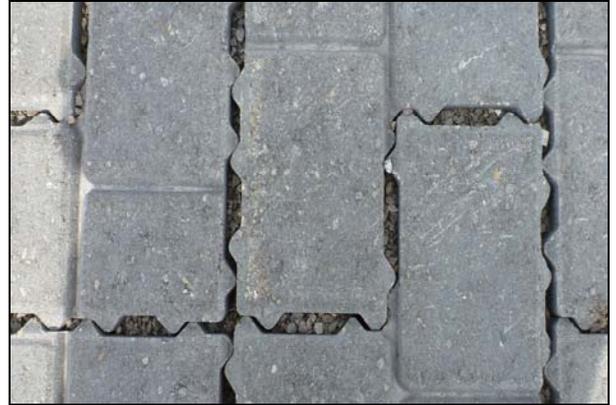
Figure 45: Paver scraped by winter plough.
