# Green Glade Sr. Public School Rain Garden Retrofit

Location: Mississauga  
Constructed: 2011

### Project Objectives, Design & Performance

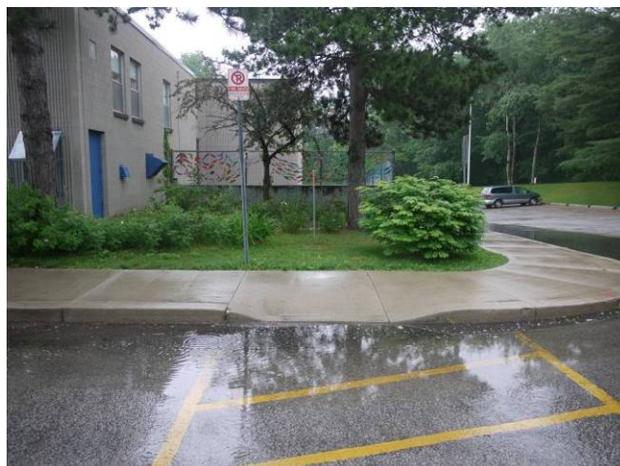
Prior to implementation of the rain garden, issues with ponding were taking place in the school's parking lot. Ponding was centralized in a pedestrian walkway area, near the front entrance to the school. An example of this ponding is shown below.

Nuisance ponding in pedestrian walkway

To address the ponding issue along the front walkway the curb and walkway was cut in two locations to provide an inlet and an outlet (outlined in red in the figure below). The design of the inlet cannot address the ponding issue completely. However, when the school's parking lot is resurfaced, the grade of the lot can be modified to direct more of the water into the rain garden inlet to further reduce any ponding. In addition, the rain garden design accounted for the roof top drainage which was directed to a dry river bed which then flowed into the depression (outlined in blue in the figure below).

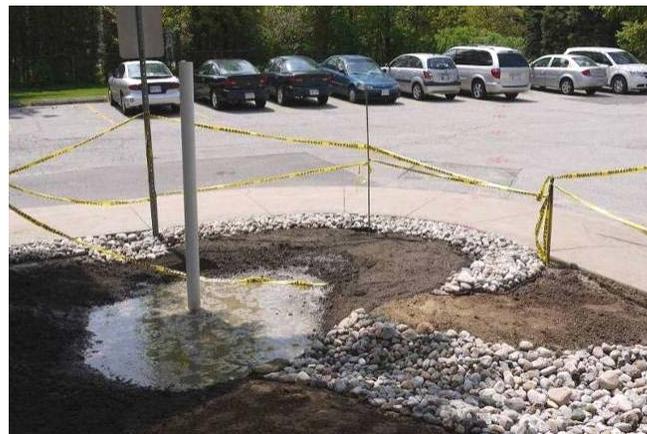
An issue that was identified shortly after construction was that the rain garden was not infiltrating runoff at an appropriate rate, resulting in a drawdown rate far greater than 24 hours. Although the first batch of soils delivered to the site did meet specifications (as determined through soil testing), further batches delivered to the site were not tested. A review of soil

test results from a composite from the as-built garden found that overall the bioretention soil media did not meet specifications, and thus the soil was the source of the problem. An example of the poor drainage conditions in the rain garden are provided in the following image.

Water not properly draining into through the soil media

The soil supplier indicated that the bioretention did not meet specification due to an improper mixing process. The supplier had used topsoil to meet the bioretention mix's organic and fines requirements. However, the composition of the topsoil was highly variable and was added to the mix without being properly measured. Thus, test results showed that the amount of fines in the mix had reached 30 – 40% although specifications

for fines by weight should only be 8 – 12%. The high amount of fines led to the failure of the rain garden to properly infiltrate runoff.

The only means of addressing this issue was through the removal of the improper bioretention soil media and replacing it with the proper mix of sand, fines and organics. The costs associated with this remediation work were incurred by the soil supplier and CVC. Excavation of the faulty bioretention mix required use of a mini-excavator, dump truck to haul the mix away, and a slinger truck to add the new bioretention mix.

To address this issue with the manufacturing process, topsoil was removed as a component material and only sand and organic mulch were used to create the mix. However, before the mix was installed, the manufacturer needed to ensure that the bioretention mix met specification. Three soil samples were provided for testing and verification prior to installation.

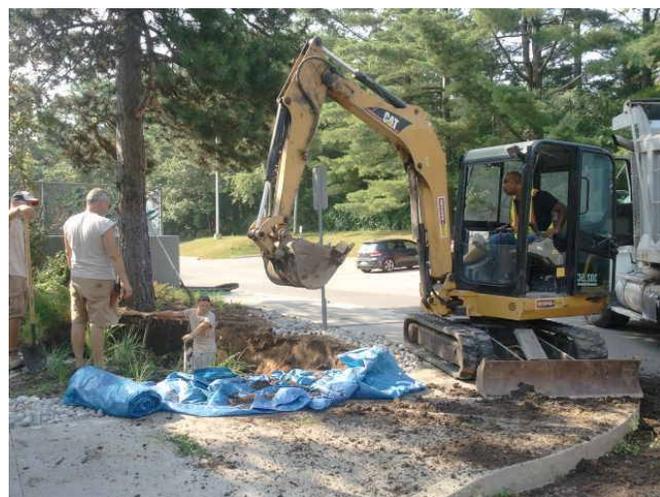
Removal of the soil media with mini-excavator
