Lakeside Park

Location: Mississauga
Constructed: 2012

Public Lands

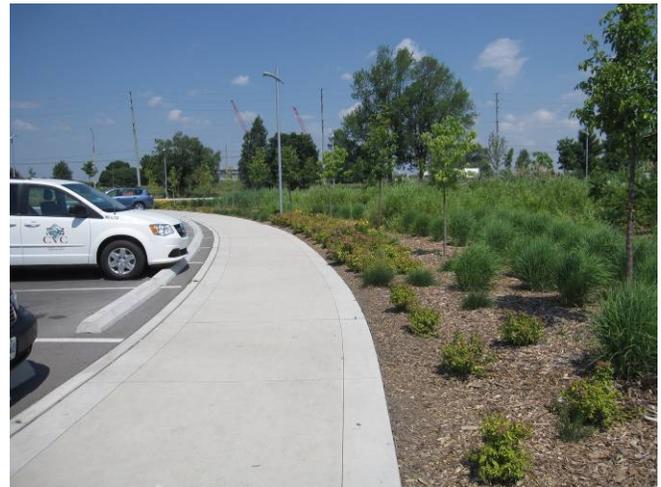
- Parking lot runoff flows over sidewalks to enter the bioswale which has resulted in some icy sidewalks in the winter requiring the use of de-icers. When designing LID practices, pedestrian and flow path conflicts should be considered.
- Implementation of LID helped preserve the natural environment while also adding aesthetic value to the park.
- Invasive species have been spotted within the bioswale and are suspected to be blowing in from neighbouring properties. Training maintenance staff to identify invasive species can help to prevent the spread of invasives plants.
- As the park included numerous innovative features, the City partnered closely with CVC and industry experts to ensure they were designed and constructed correctly.

Parking lot is graded to allow water to flow over the sidewalk and into the bioswale. This creates icing issues in winter months.

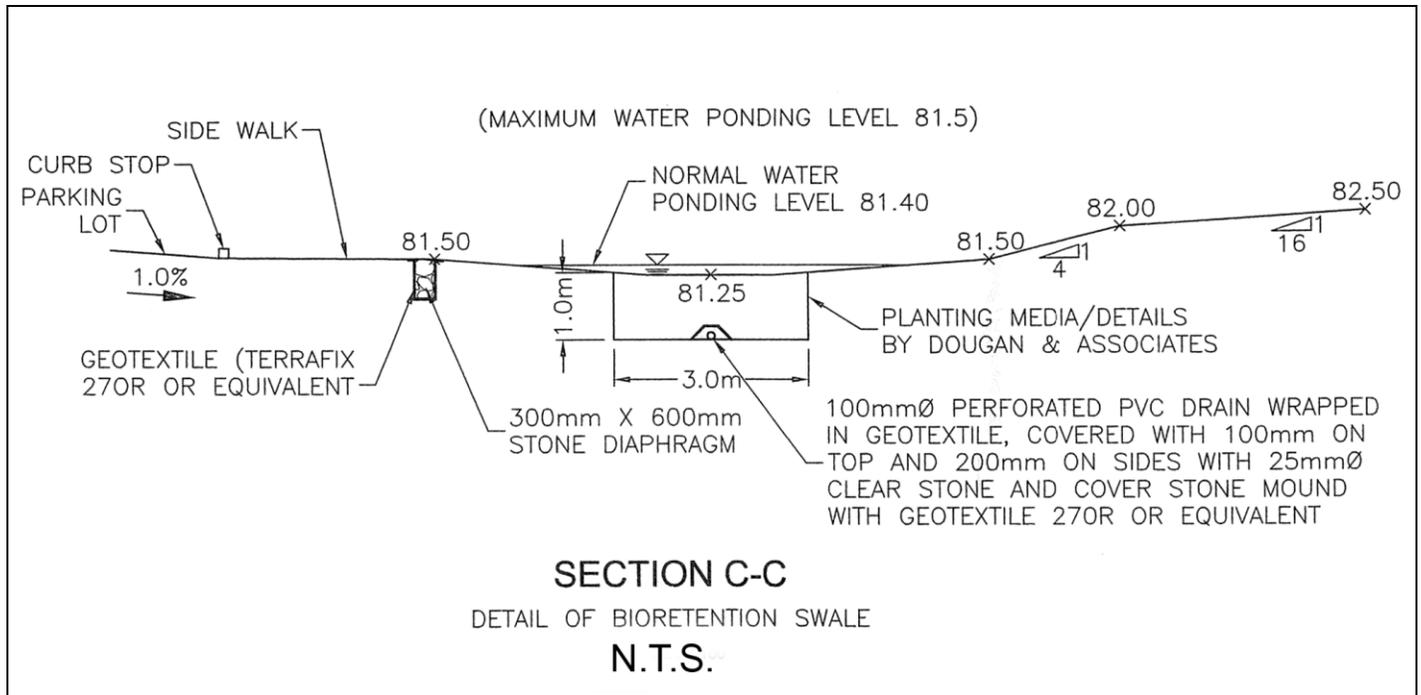
Cross section of the bioretention swale. Stone diaphragm was removed from design (Drawing prepared by AMEC Engineering and John George Associates for the City of Mississauga)

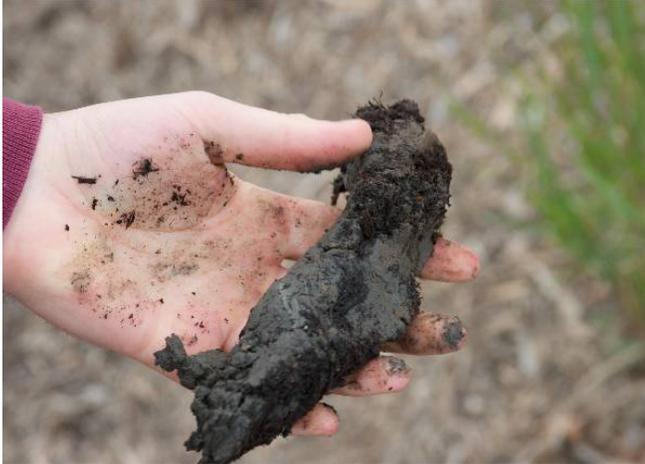
As previously discussed in the design section, soils were specified based on the draft 2010 CVC/TRCA Low Impact Development Stormwater Management Planning and Design Guide. CVC staff visited the park after construction was complete to verify the LID features met the design specifications. CVC staff found that the bioretention soil media did not fully meet specifications. Site instructions were issued to the contractor to correct the problems. The contractor immediately replaced the soil media under their warranty obligations.

A simple ribbon test was conducted on site as a visual tool to gauge clay content. If the soil clumps into the length of a ribbon rather than crumbling, there is high clay content.

- It is important to stress to the contractor the importance of testing and approval of bioretention soil media prior to delivery on site.

- Bioretention soil media should be tested and approved by an engineer prior to delivery at a construction site.

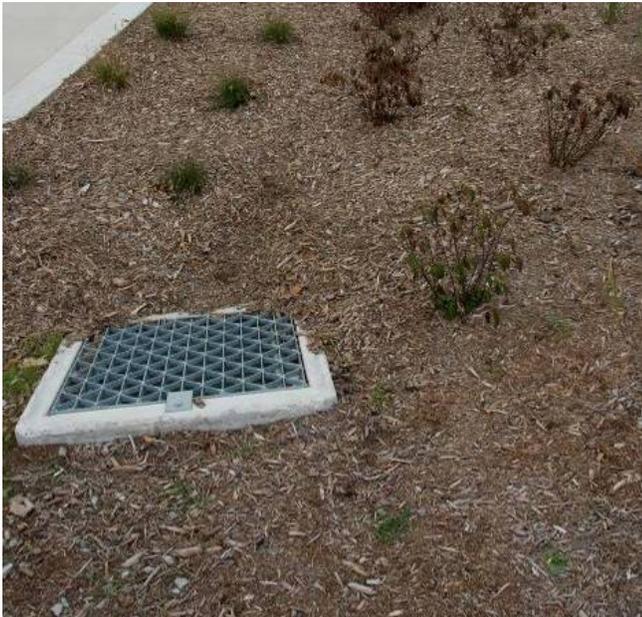
The mulch was predominantly shredded as specified, but a portion of the mulch consisted of large unshredded pieces, longer than the maximum recommended length of 100 mm. These larger pieces of mulch can dislodge and float during heavy downpours. This resulted in the minor problem of channeling and deposition of mulch near the overflow during heavy downpours.

Channeling of unshredded mulch towards overflow catch basin

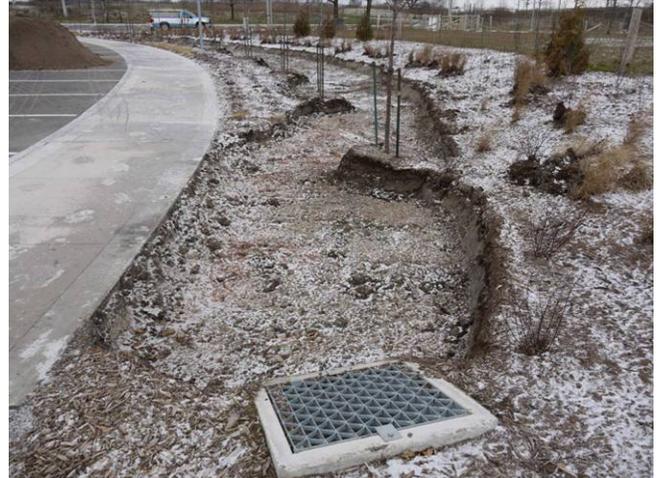
Bioretention soil media has been scrapped out of the cell after discovering it didn't meet specifications.

- Original soil in bioretention swale did not meet specifications in the design, in accordance with CVC/TRCA Low Impact Development Stormwater Management Planning and Design Guide.

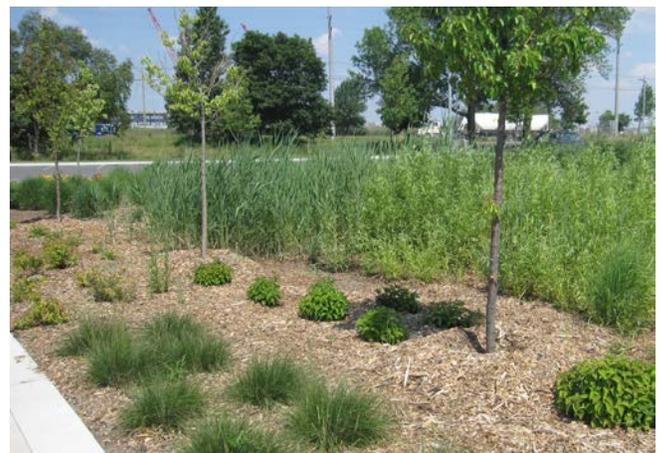
One issue that has been noted at Lakeside Park is the presence of two invasive species, European Reed Grass and Canada Thistle, within the bioswale. They are likely blowing in from the adjoining industrial sites. These invasive species pose a great risk to the establishment of native vegetation in the swale. CVC has assisted the City of Mississauga in identifying and removing these invasive species and replanting native species. Once the native plants in the bioswale are established, they should outcompete invasive species. Until then, CVC and the City of Mississauga must routinely monitor the bioswale for invasive species.

Invasive species European Reed Grass and willow colonizing the bioswale

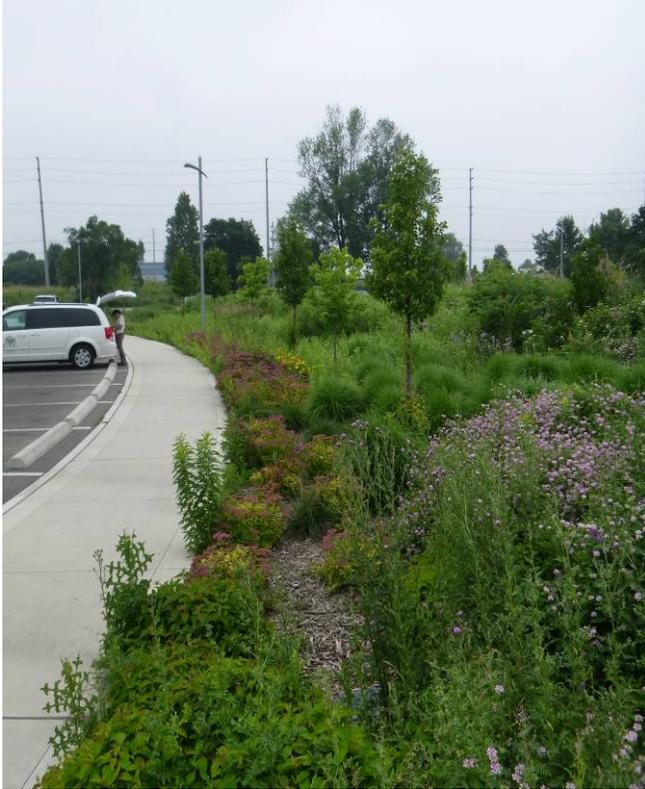
This photo was taken as one of the LID Checklist Inspection photos. Plants are established and doing well but a bit of weeding is required at this time as a part of the routine maintenance plan.
