Portico Community Church Parking Lot Retrofit

Location: Mississauga

Constructed: 2010-2012

Overview

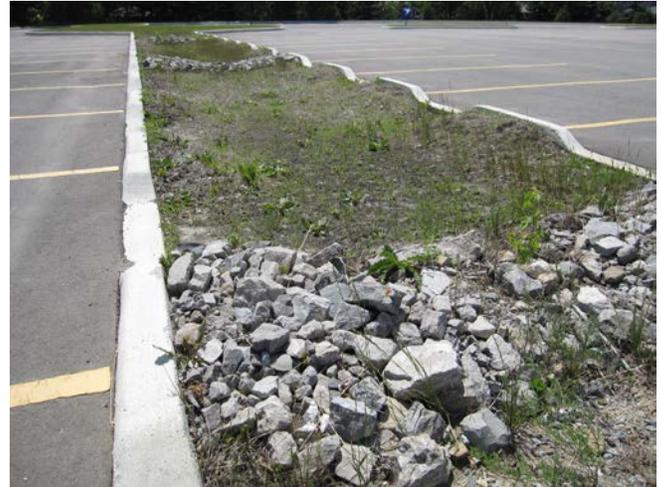
One year after seeding, the native grasses had not germinated and weeds were filling in the swales. (Source: CVC)

In June 2010 PORTICO contacted CVC to evaluate the swales and help to improve their appearance. The seed had not taken and the swales looked weedy and barren. The soil was also eroding and draining poorly.

The following year the native grasses did not come up as expected and weeds were taking over. CVC determined that likely causes were poor soils and runoff flows. The soils used were low in organic content and high in clay. The swale also had large runoff flows draining to it that could wash out seed before it had a chance to establish.

CVC worked with the site designer to find a solution that would re-landscape the swales and improve stormwater performance on site. The hard infrastructure, such as curb openings, catchbasins, and subdains, was functional and still useable. Only the plants and soils would need to be modified to make the practices work. The following actions were recommended by CVC and Dickinson & Hicks:

1. Replace soils and sod instead of seed in the long swales at the center of parking lot to make them **enhanced water quality swales or bioswales.**
2. Convert the swale in the triangular parking island to a **bioretention cell** through soil replacement, regrading and new landscaping.

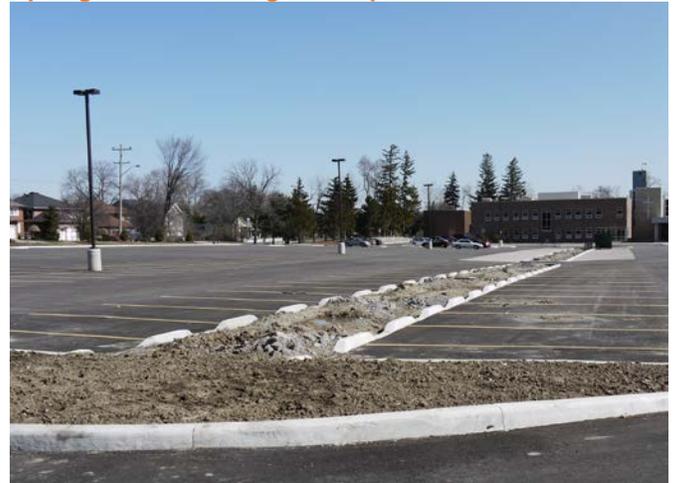
The image above was taken after the parking lot was constructed but before the landscaping was installed. Many curbscuts were required to get the large volume of stormwater runoff from the parking lot into the swale.

The original parking lot was reconstructed and expanded for a total paved area of two hectares. The swales in the parking islands were graded with low organic and clayey topsoil or subsoil. They were then seeded with a native seed mix and temporary cover crop of annual rye.

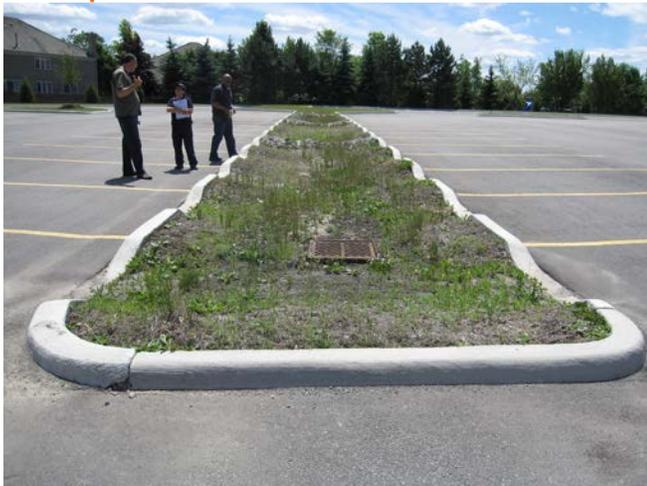
The swale in 2010 had sparse vegetation that was mainly weeds. The native seed had either washed out or could not germinate in the poor soils.

In the summer of 2010, Dickinson & Hicks and CVC identified deficiencies with the landscaping approach and ways to improve the treatment capacity of the stormwater practices. The project team developed redesign plans and raised funds over the Fall 2010 and Winter 2011.

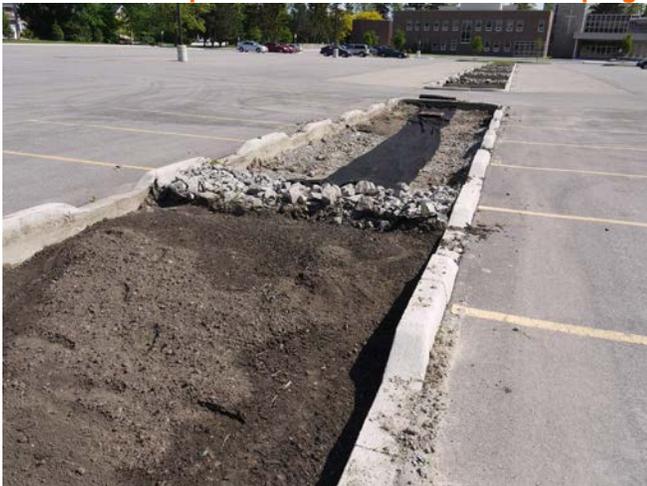
The image shows the bioswale as the replacement bioretention soil is being installed. In the background is a section of replaced geotextile drainage fabric that goes over the subdrain.

Hawkey Church Management, Inc. replaced the soils and landscaping over the course of a week in June 2011. The following steps were taken in the bioswale in the centre of the parking lot:

- The low organic clay soils in the swales were replaced with an engineered bioretention soil to the depth of the underdrain, approximately 300 mm to 500 mm deep.

- The check dams including the clay soils beneath them remained in place and continued serving the purpose of slowing flows down and encouraging infiltration.
- The existing perforated 150 mm “Big-O” underdrain pipe surrounded with 20 mm dia. clearstone remained. The filter fabric wrapped over the stone was replaced with fresh fabric because it was clogged with the clay soil.
- The bioretention soil was to be graded 150 mm below the curb cut inlets to account for the thickness of the sod and still allow runoff from the parking lot to enter the swale.
- The swales were then covered with a fescue sod that immediately stabilized the surface of the soil and readied the swale to take runoff from the parking lot.

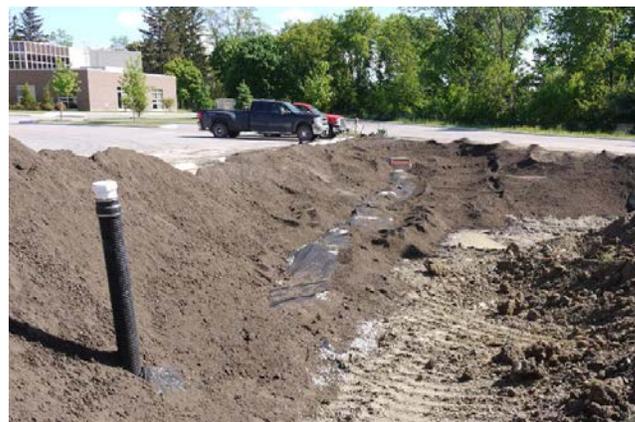
The image shows the bioretention cell excavation with the new soil being added. The stand pipe in the foreground is the cleanout at the upstream end of the subdrain. The downstream end of the subdrain outlets into the catchbasin which then drains to the Credit River.

The following steps were taken to transform the swale in the large triangle parking island to a bioretention cell:

- The cell was excavated to a depth of 800 mm with the excavated clay soils being hauled offsite.
- The existing perforated 150 mm “Big-O” underdrain pipe surrounded with 20 mm dia. clearstone was left in place. The filter fabric wrapped around the clear stone was replaced because it may have been clogged with clay soil.
- The native clay subsoil at the bottom of the excavation was scarified using the toothed bucket on the excavator to encourage infiltration.
- The excavation was then filled with about 700 mm depth of bioretention soil. This depth accounted for some settling to occur and for the necessary 75mm depth of mulch and 100 mm of surface ponding below the catchbasin overflow.

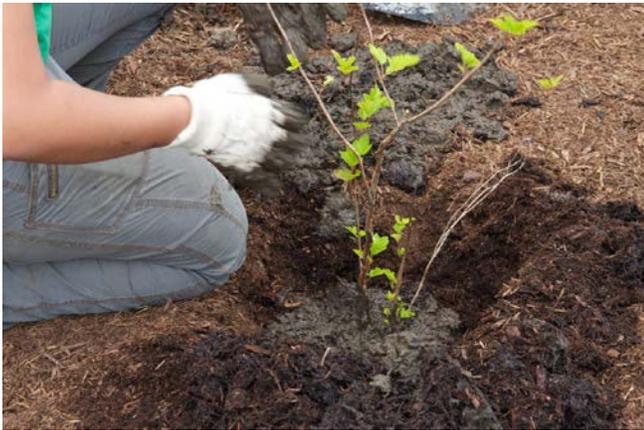
The first attempt at planting was complicated by waterlogged soils.

The soils were given about a week to settle before volunteers from CVC and PORTICO Church planted. Planting was suspended after the soils were found to be waterlogged and not draining even after several dry weather days. Only trees and shrubs were planted.

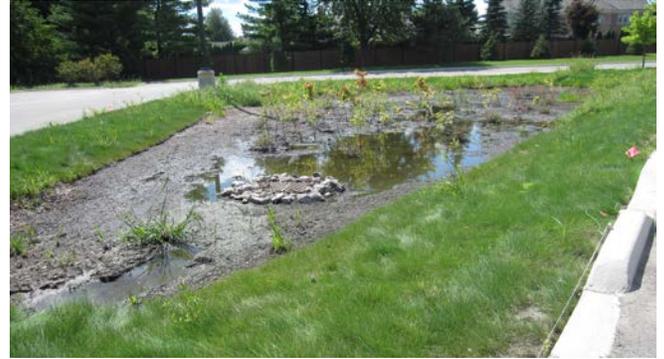
Over the course of June and July the bioretention cell soils were observed. Extended ponding and waterlogged soils continued to be a problem. The roots of shrubs and trees began to decay from the continually wet conditions. Soil samples were sent to a lab for grain size analysis and found that the clay content was 10% to 20% higher than what was specified. Based on this evidence, a decision was made to replace bioretention soil with a mix that met specification.

The bioretention soil mix had high clay content and failed to drain within 24 hours after a rain event.

To ensure that the bioretention soil brought to the site met the specification, three samples from the mechanically mixed pile were sent to an independent lab for grain size analysis. When it was confirmed that the soil provided met the specification, the new soil was brought to the site.

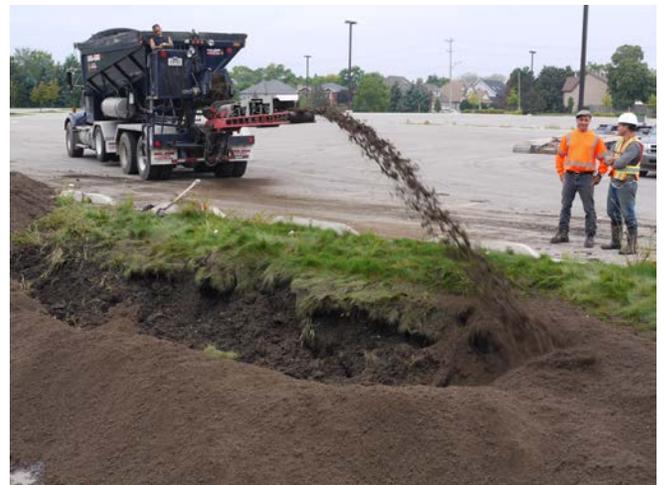
A slinger truck was used to place the soil saving time and labour. The slinger truck is able to evenly spread the soil without having to enter the facility with heavy soil movement equipment.

A slinger truck was used to place the bioretention soil saving time and labour. Dump trucks deposit a load in one place that then has to be moved around by heavy soil moving equipment or human labour. The conveyor belt spreader of the slinger truck can evenly spread the soil around the bioretention cell without using heavy equipment that could also cause detrimental compaction.

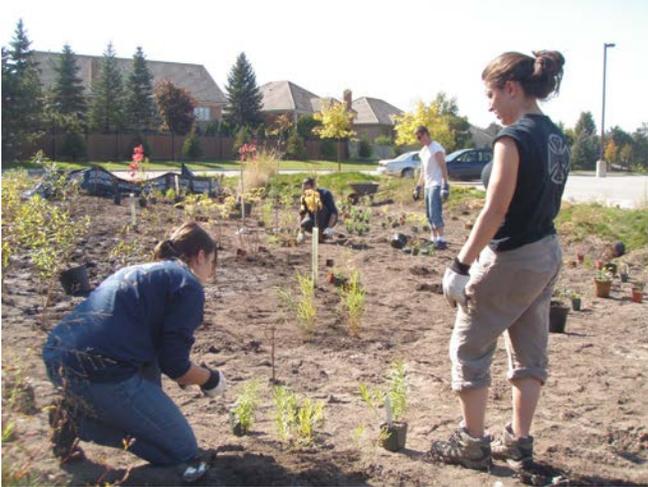
For the second planting, the mulch was added after all plants were in the ground, which was more efficient than trying to plant in the already mulched cell.

planted. This planting was limited due to budget and only partially covered the large bioretention cell area. A lesson applied from the previous planting was to wait until all plants were planted to add the mulch. This reduces the time and care needed to spread mulch around the plants.

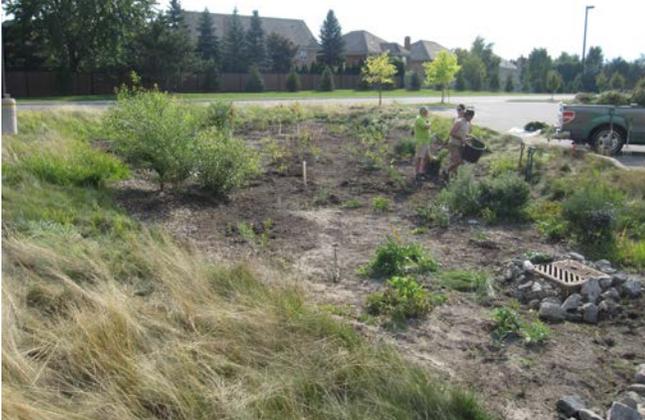
The landscaping was assessed after one year to see what plants had been successful and what could be added to fill in the sparse landscape.

After one year, CVC conducted an assessment of the plants that had been successful in the cell. Some plants bounced back after the stress of replanting the previous year while others died. The successful plants from the previous planting included New England aster, red maple and shrubby cinquefoil. Fern Ridge Landscaping was then enlisted to implement a planting plan of native and cultivar trees, shrubs, and herbaceous plants. The final design created large groupings or drifts of species that provide year round interest, texture and colour. Larger stock was used to help stabilize the soils faster and provide an instant landscape.

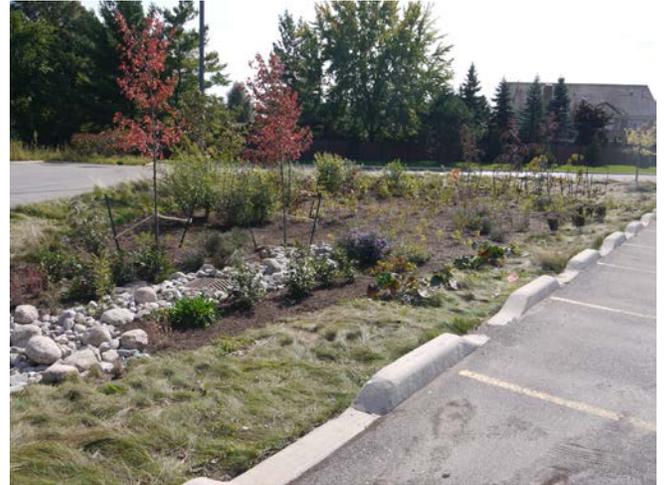
Another issue addressed in this landscape makeover was erosion channels. A year of operation revealed where preferential flow paths were in the system. An erosion channel formed near the overflow catchbasin that was several centimeters deep. When the cell was replanted a decorative river stone channel was used to cover and stabilize the eroded channel.

The improved landscaping added more trees and shrubs plus a decorative river stone channel that also addressed an area of concentrated erosive flow.

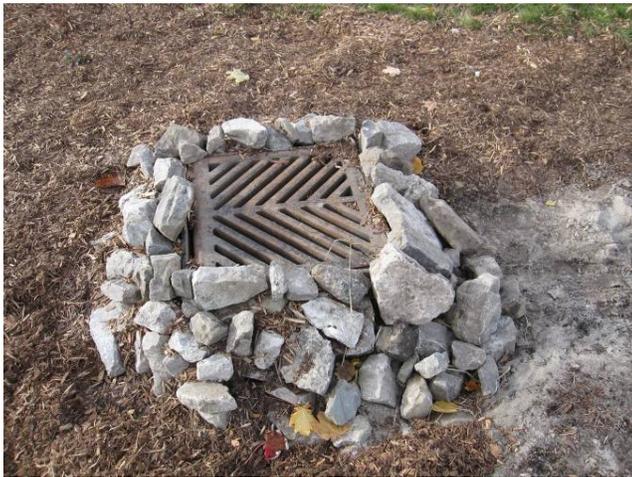
Stone stacked around the catchbasin helps to screen floating mulch from overflowing into the catchbasin.

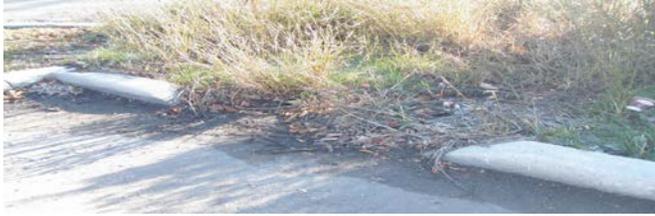
The most recent visual inspection was performed on October 29, 2013. Overall the bioretention cell passed most of the visual inspection criteria; however a few deficiencies were identified:

- The inlets have sediment build up and some are obstructed with tall vegetation. This is causing ponding and sedimentation in the parking lot.
- There is no drop behind the inlet into the sod. Even a small buildup of vegetation and sediment can cause stormwater to backup into the parking lot. Lowering the sod and creating a channel for the flows into the bioretention cell will reduce this problem, but some ponding in the parking lot will continue to be a problem due to the grading of the asphalt.
- The mulch depth is less than the desired range of 50-100 mm with many spots of the bare bioretention mix exposed. A layer of mulch should be reapplied to increase mulch depth. This will sustain vegetation and protect bioretention mix from erosion.

Visual Inspection - Inlet obstructions with sediment build-up and tall grass

While the facilities are functional, addressing these issues will help to improve performance of the practice. Once these recommendations are implemented, the facility is expected to pass the visual inspection.

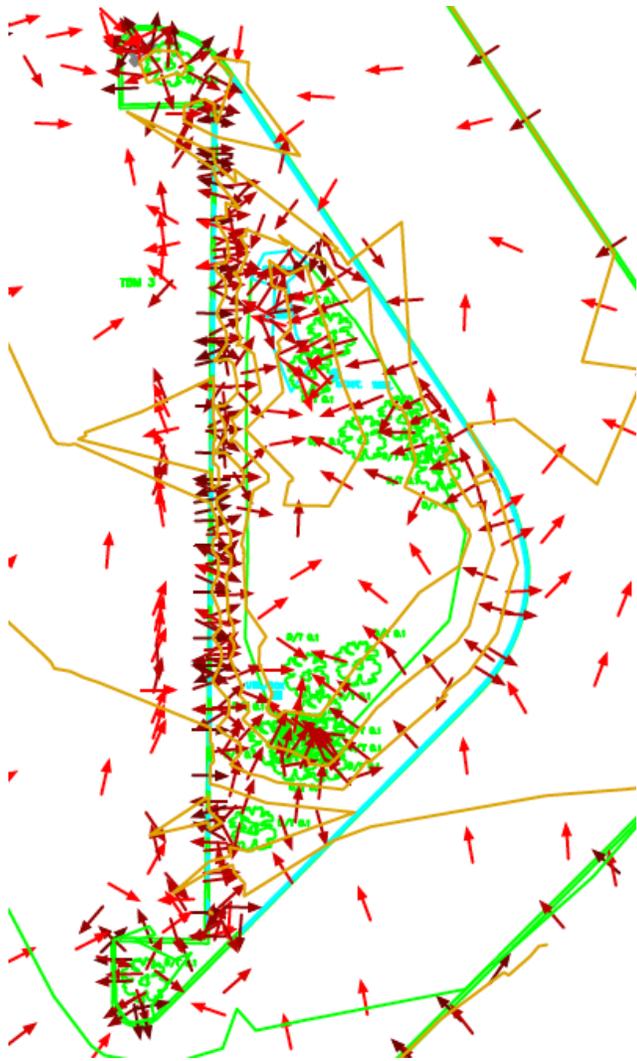
An analysis of flow paths was conducted using the topographic survey of the site. The arrows in the plan view above show the direction of flow toward the bioretention cell.

Analysis of drainage flow paths show that many inlets are bypassed and the majority of flow enters through the curb openings at the east end of the cell. All the flow from the parking lot still enters the cell, but only through one location. Regrading the asphalt in the parking lot to address this problem would be costly. Alternatively, adaptations can be made to the area receiving the majority of flow such as additional erosion control and pretreatment.

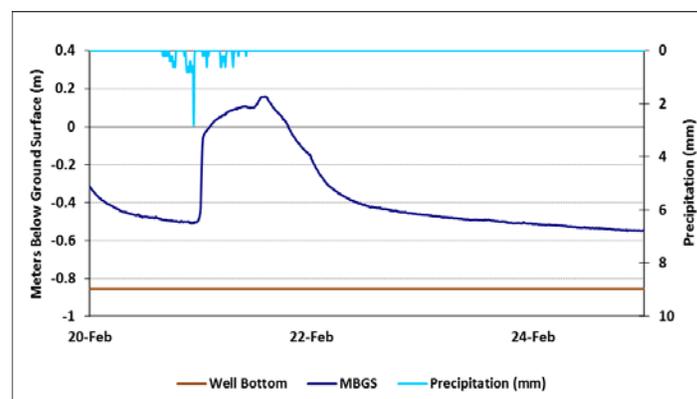
The following figure shows that the bioretention facility can still function in the winter when the ground is frozen. This event had a total of 19.8 mm of precipitation fall and the bioretention facility was able to infiltrate all the runoff received from the adjacent parking lot with ponding for approximately 16.5 hours. Subsurface drawdown took place within the 48 hour threshold, demonstrating that bioretention facilities can still function in colder conditions.

Precipitation event and measured water level in February 2014

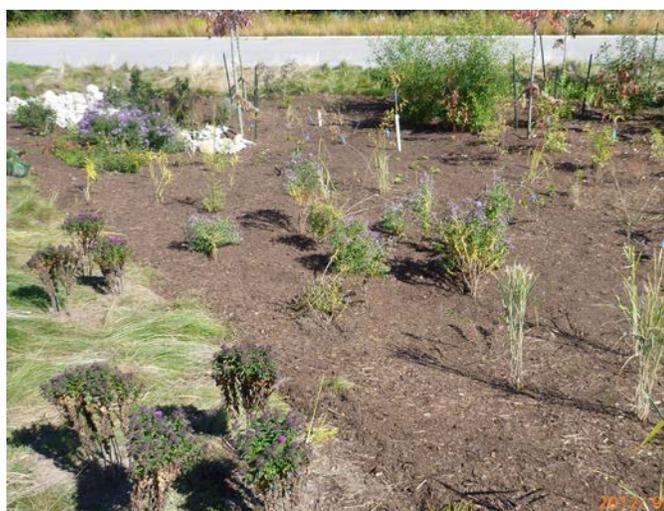
This photo was taken as one of the LID Checklist Inspection photos for the photo log in order to track site progress and maintenance needs over time. Plants are still establishing and require extra maintenance at this time in order for them to survive.

A few trends were identified while reviewing the inspection checklist data from the past three years. The vegetation cover has improved from 2013 to 2014 as the plants have had another growing season and species that were struggling were replaced with a heartier species that can tolerate wet conditions better.

In 2012 some plants died off due to wet conditions as the soils were very saturated and some of the plants in the original plan did not survive, resulting in a failure rate of 14 per cent, and requiring action. In July 2014 additional plants were added to the facility to replace some of the original choices. By August 2014 the vegetation cover had reached 75 per cent and by September 2014 vegetation cover had reached 100 per cent. The additional plants that were added were well suited for the site conditions and are doing very well.

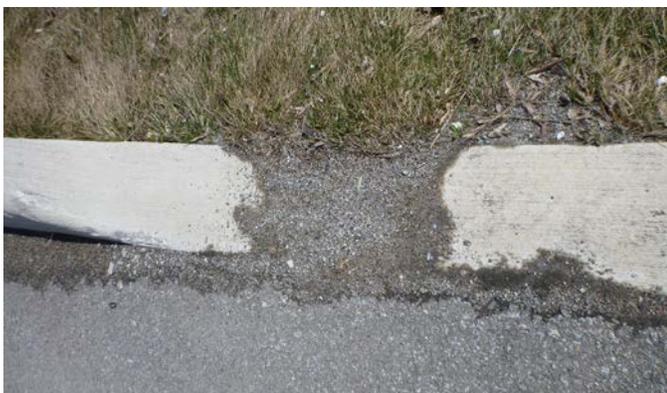
The image shows how sediment builds up in the inlet rather than in the filter strip due to sod partially blocking the inlet.

Having sediment build-up and block the inlets was an issue as it was preventing flow from entering the

bioretention facility. During one-third of the inspections performed, the inlets failed as they were blocked. The issue with the curb cut inlets was addressed in August 2014 as the Conservation Youth Corp volunteers helped to lower them. The sod was lifted so that soil from underneath could be removed, resulting in a lower grade for the grassed area. This helps to increase flow of water into the bioretention facility. The contractor hired to perform site maintenance will be clearing them now as needed.

Design	Observations	Recommendations
Areas of concentrated flow entering the bioretention cell	Sediment accumulates in the parking lot where flow enters the swale	Remove flow blockages and install a concrete sediment trap behind the inlet where sediment will drop out and collect.
Curb cut inlets	Sod and soils behind the curb inlet are too high	A drop of 50 mm is recommended behind the curb inlet; do not assume sod and soils will settle.
