Terra Cotta Conservation Area Rain Garden

Location: Town of Caledon

Constructed: 2011

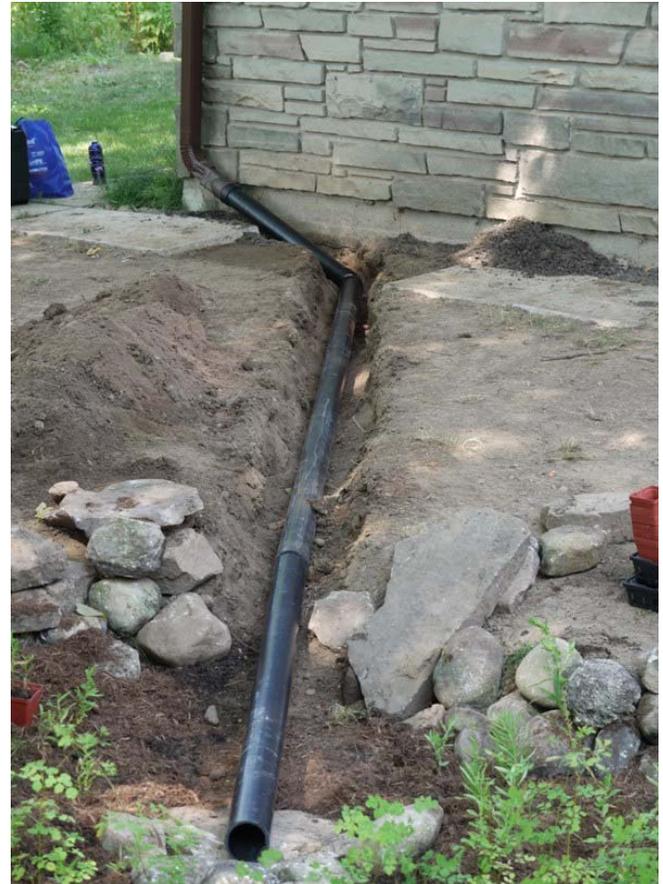
- Rain garden area was more shaded than originally thought, affecting the health of some plants.
- The downspout directed runoff onto a sidewalk. The sidewalk also blocked the drainage path toward the rain garden.

Downspout was buried under the pathway and directed towards the rain garden

- Adding additional shady plant species to the rain garden.
- Installing a downspout extension beneath the sidewalk. This eliminated winter ice hazards on the sidewalk and brought roof runoff into the rain garden.

The downspout on the roof of the Visitors Welcome Centre was then redirected to the garden using downspout pipe extensions. This is a product available at any local hardware supply store. The downspout was buried under the pedestrian walkway and routed into the rain garden. The downspout was left unconnected until the garden was planted and mulched.

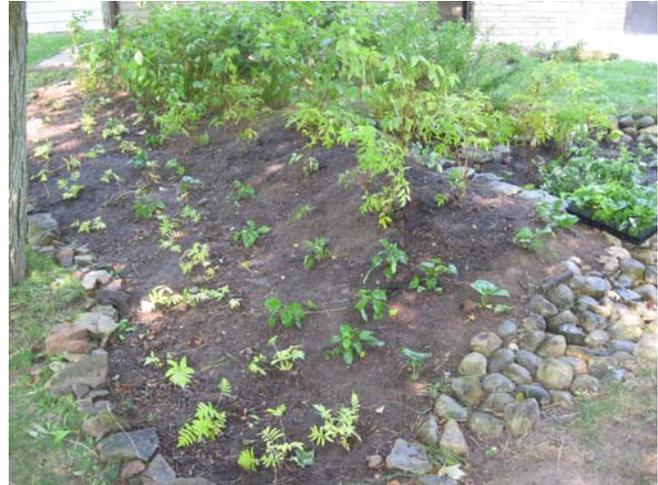
Supplemental shade-tolerant plantings completed in July 2013

The rain garden at Terra Cotta is operating as expected. For the most part, plants are establishing well. The rain garden has experienced some die back, caused by shady site conditions. A large tree next to the rain garden affected growth more than was expected. In the summer of 2013, additional native shade-tolerant plants were added to the garden, including common elderberry, sensitive fern and heart-leaved aster. They were planted by CVC's Conservation Youth Corps, a volunteer environmental education program for high school students.

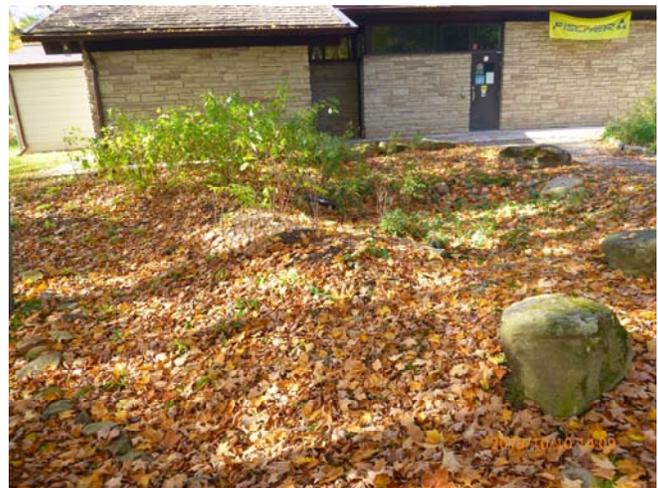
Since June 2012, CVC monitoring staff has been inspecting conditions of the rain garden at Terra Cotta on a biweekly basis. Preliminary data shows that leaf debris accumulation is a recurring maintenance issue. The area is heavily forested and the depressed landscape traps the leaves. Erosion and weeds were also seen in moderate to high amounts during early establishment but has lessened overtime.

Leaves accumulating in the rain garden, October 2013.

which needs to be cleared and additional mulch needs to be added to top up to a depth of 50-100 mm.

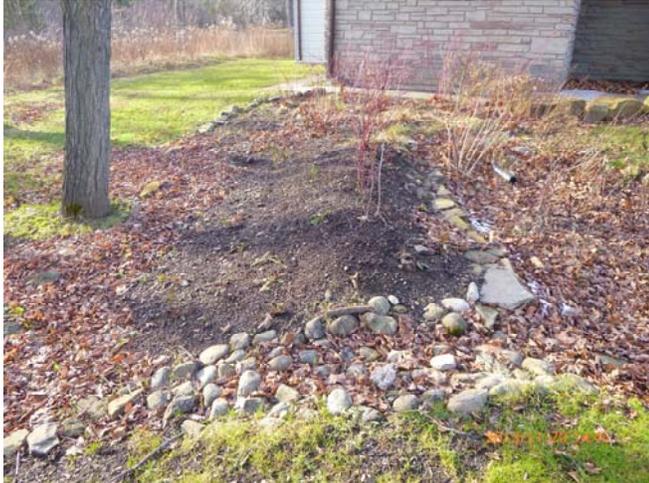
Erosion of the berm outside the rain garden. The overflow channel is in the foreground.
