# LID Monitoring Projects

## Mississauga Valley Community Centre – Parking Lot Retrofit

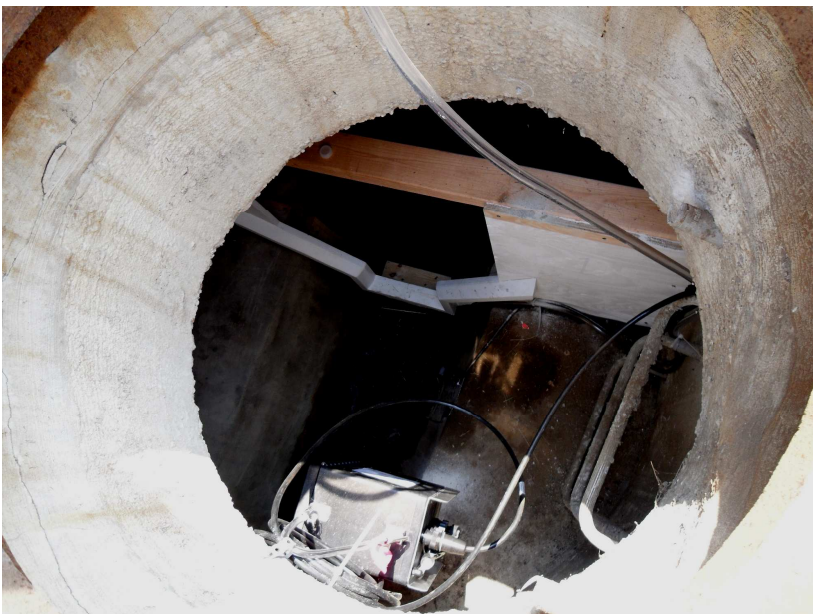
- We are measuring water flow using a continuous level logger and a weir.
- We are also taking flow weighted water samples during precipitation events.
- In addition, we are using a water quality meter to measure some basic water quality parameters continuously.
