# George Richardson Stormwater Management Pond Retrofit

Location: Newmarket  
Constructed: 2010-2012

### Project Objectives, Design & Performance

## Overview

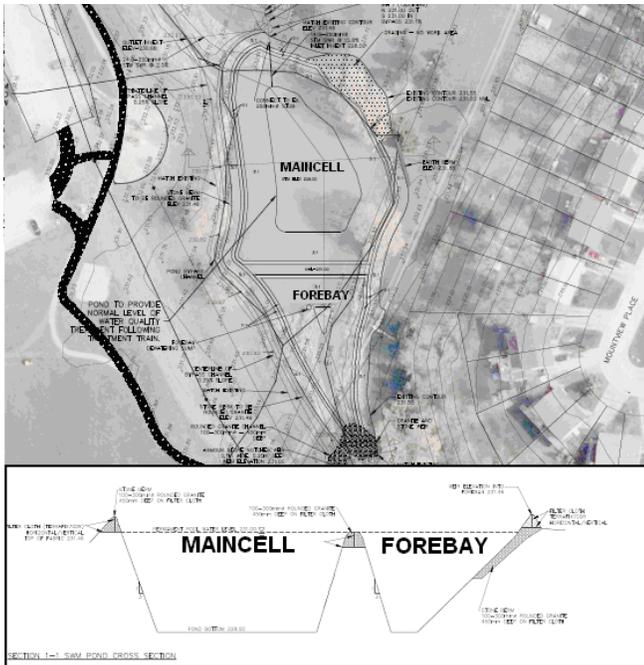
Both the forebay and main cell were excavated from an existing depth of 30cm down to 3 metres. The excavated soil was considered contaminated and had to be transported to a licensed treatment facility at a cost of \$250,000, which was included in the construction costs.

Stormwater management pond forebay and main cell

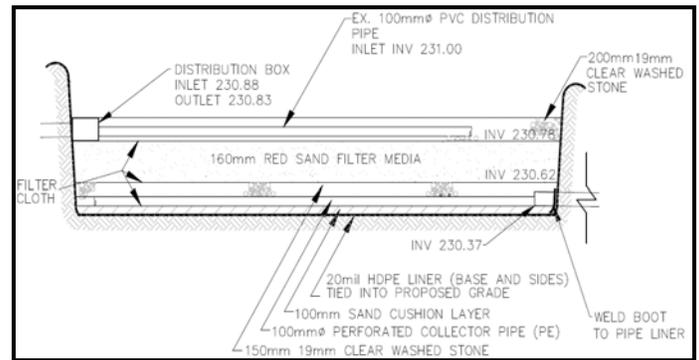
Through testing of numerous sand mixes, the red sand was found to have adequate percolation and phosphorus retention capability, allowing it to reduce greater than 99% of total phosphorus and other minerals. This technology was installed as the last part of the treatment train to function as a final polishing unit. The underground system was first lined with a Bentonite liner to minimize groundwater exchange, with various layers of clear stone and red sand sandwiched between nonwoven geotextile fabrics.

The water is distributed via a system of perforated piping covering the top layer of the underground system just above the red sand filter media. Collector pipes are located near the bottom. The cross section of the underground system with the red sand filter is shown below. The system is estimated to have a reduction in phosphorus of 23 kg/year.

Red sand filter cross-section

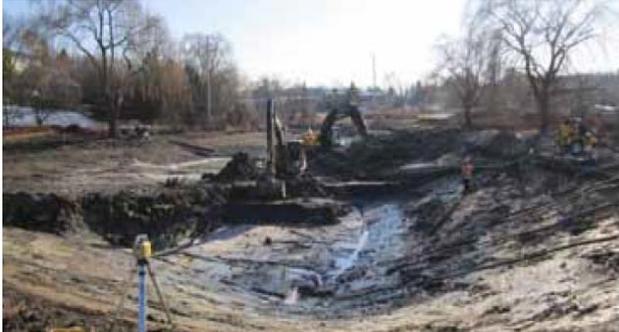
Excavating the main cell of the stormwater management pond

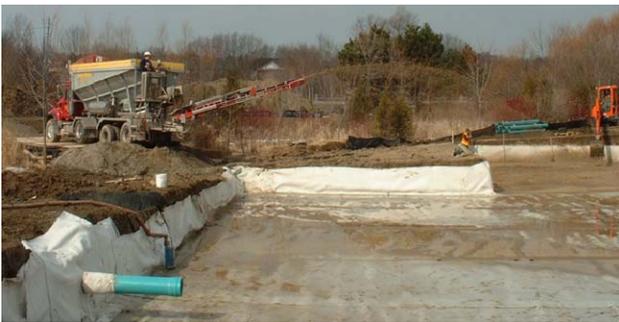
Excavated underground System

The first phase of this project was finished in March 2010 and included the installation of a red sand filtration system. The final steps involved retrofitting the stormwater management facility on town-owned lands. In September 2011, construction began on the creation of a sediment forebay (permanent pool) and main cell, the creation of a flow splitter to connect the by-pass stream channel and extensive landscape restoration.

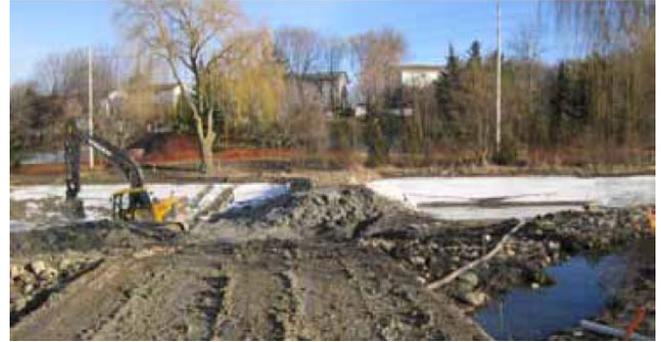
Creating a stone covered berm between sections of the pond

Several minor changes were made to the drawings in reference to the rock flow splitter and final berm elevations in order to address some fisheries issues and backflow concerns. These changes were fairly minor in nature and simple for the contractor to accommodate.

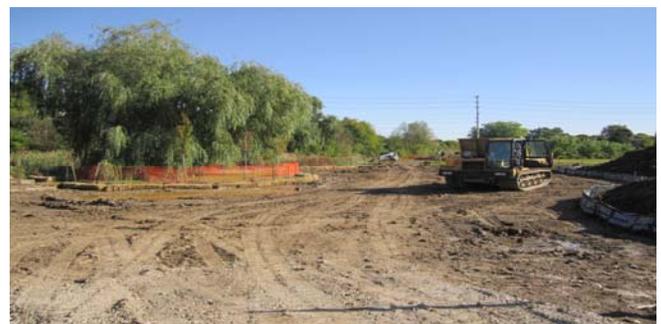
Protection of existing grassland vegetation/wooded areas during construction

- Reducing topsoil stripping as much as possible and seeding individual lots as soon as possible
- Placing silt fencing downstream of all excavated material to prevent sediment transport
- Maintaining the existing grassland vegetation/wooded areas along the development limits to provide a natural barrier to filter potentially sediment loaded overland flow
- Providing conveyance protection by placing rock check dams and straw bales at intervals along constructed ditches and at the outlet culvert prior to construction.
- Using a mud-mat that consists of large diameter rip-rap at the entrance to control mud tracking from construction traffic.
