Ontario Ministry of Transportation Carpool Parking Lot (Campbellville)

Location: Campbellville

Constructed: 2007

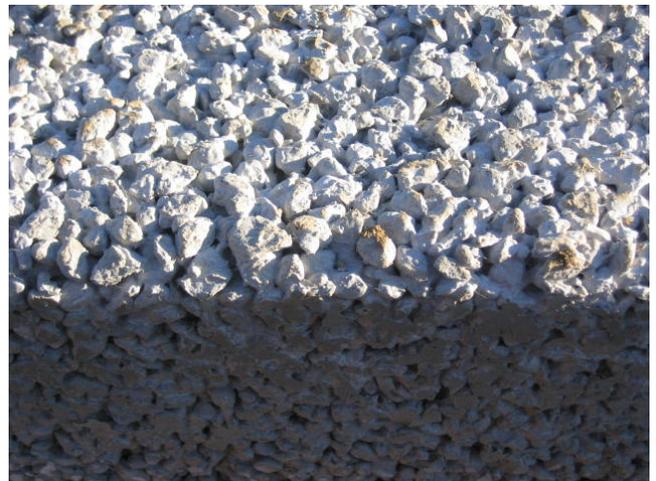
Pervious concrete cross section, showcasing the porosity of the material

The parking lot is approximately 1800 m² in area. The pervious concrete layer is 240 mm over 100 mm of clear stone and 200 mm of dense graded granular base over sandy sub-grade material. A geotextile-wrapped clear stone with perforated sub-drain is located immediately below the top of the sub-grade. Infiltrated water is directed to a catchbasin for testing purposes.

A concrete thickness of 217 mm was determined following the *StreetPave* software guidelines distributed by the American Concrete Paving Association. However, this thickness was increased to 240 mm to match the top of pavement height originally tendered when the project had originally specified hot mix pavement. A 30-year design life with 85% reliability, low traffic, and a flexural strength of 1.7 MPa was used for the pervious concrete. A cross section photograph of the permeable pavement is provided below and highlights the low fines present within the material.

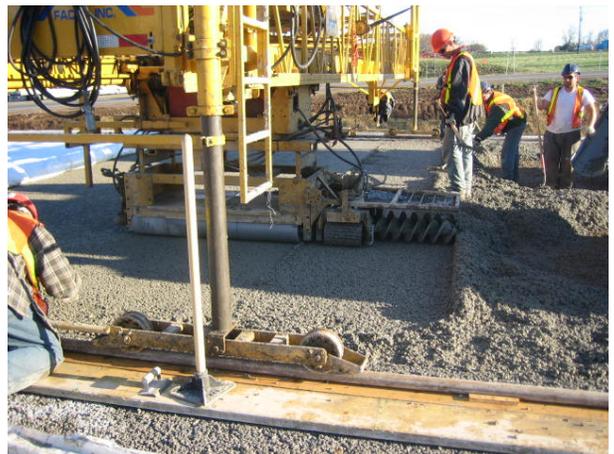
Bid-well deck paver tested for pervious concrete placement

To evaluate the best construction technique for placing pervious concrete three sections were placed using a Bid-well Bridge Deck Paver and one section was placed with a Razorback Paver.

Based upon the experiences of the construction crew and the performance of the material following construction, the use of the bridge deck finishing machines are not generally recommended for placing the pervious concrete. A hydraulically actuated rotating tube (roller) screed has become the preferred screed of choice for slab thicknesses up to 2000 mm using the new mix specifications. A photograph showing this technique follows.

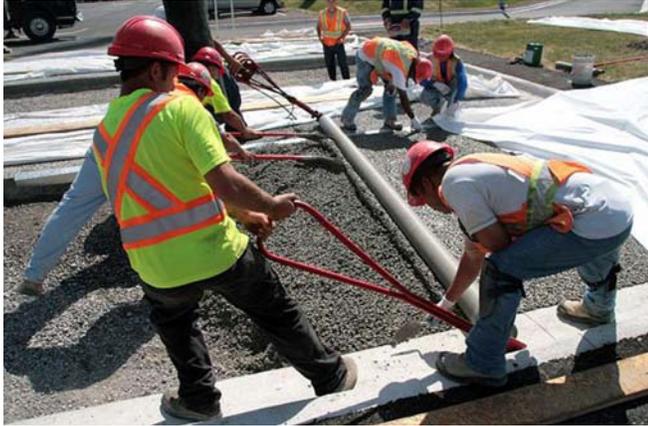
Installation of pervious concrete by hydraulic roller screed
