Credit Valley Conservation
Belfountain Complex

Belfountain Conservation Area, Willoughby Property, Cox Property

Management Plan Background Report
DRAFT

Credit Valley Conservation
Background Report for the Belfountain Complex

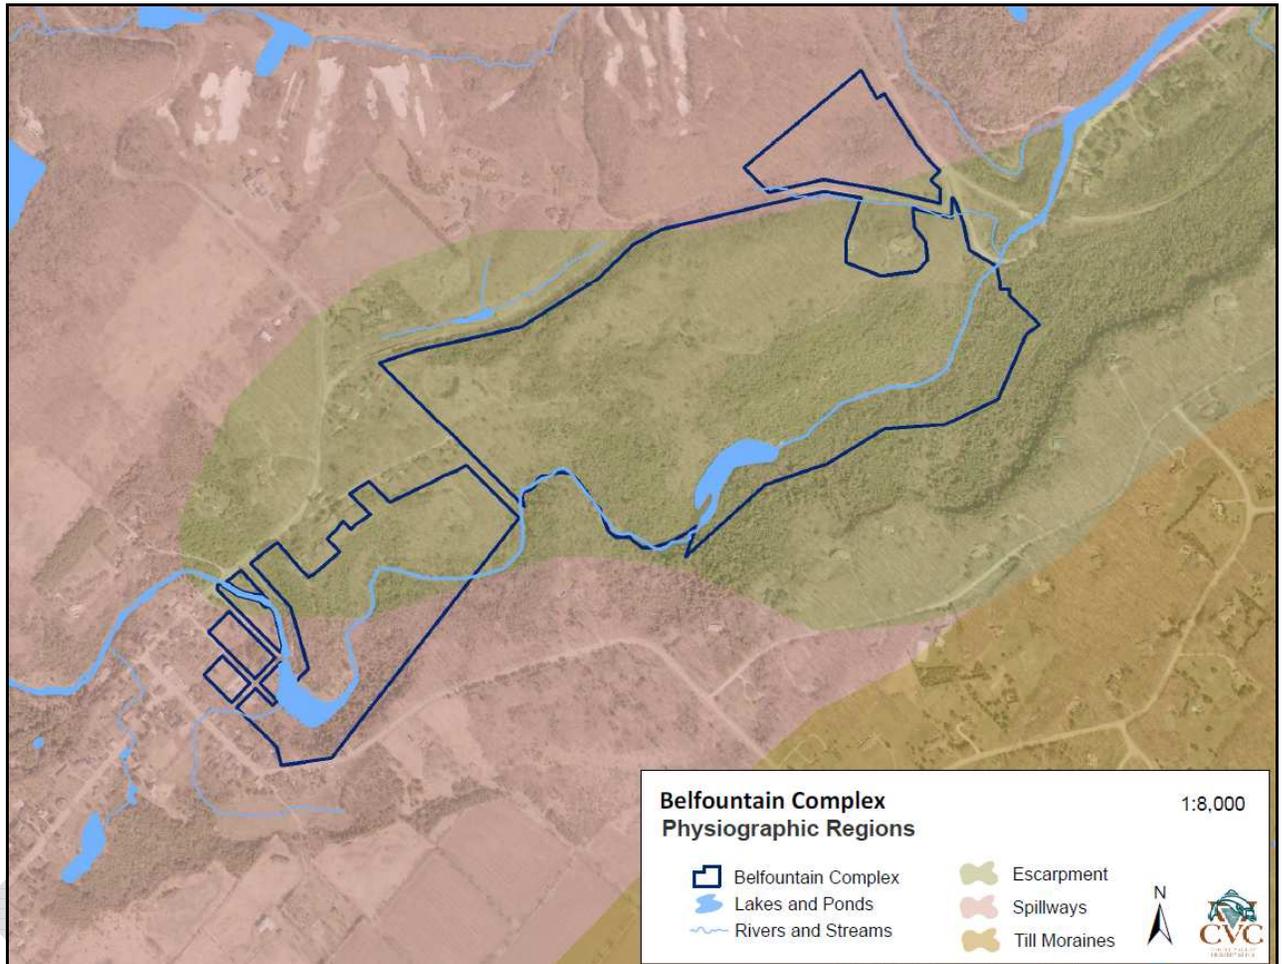
Figure 3 - Physiographic Regions of the Belfountain Complex

swampy. The Niagara Escarpment physiographic region is characterized by an escarpment that forms a significant break in the bedrock of the region. The Complex is situated in the outlet area of the West Credit River valley at the front of the breach point of the Paris Moraine. Physiography of the study area is influenced by three distinctive physiographical and geological units: the Niagara Escarpment; the Paris Moraine; and the Eramosa Meltwater Channel.

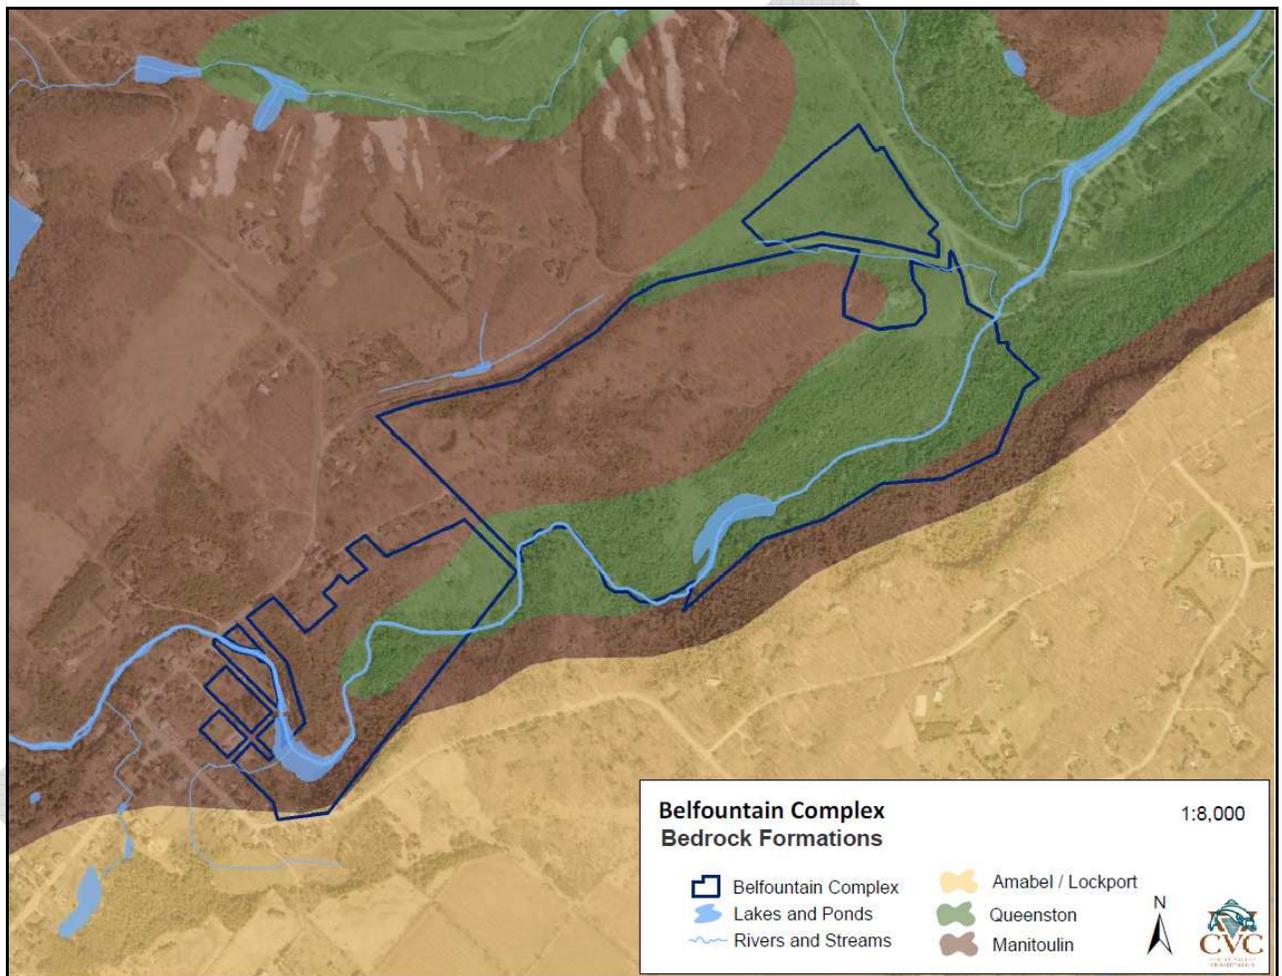
Figure 4 - Bedrock Formations of the Belfountain Complex

Bedrock outcrops are widespread on the valley slopes and river bed and play an important role in the geologic environment of the study area; the river valley itself is essentially a bedrock valley with a thin layer of slope complex. Two sequences of bedrock are present in the Complex; the Cataract Group and Queenston Formation (Figure 4). The Queenston Formation underlies the Cataract Group and outcrops only on the east end of the Complex. The Cataract Group contains three distinct formations, all which occur in the study area: the Whirlpool Formation, the Manitoulin Formation, and the Cabot Head Formation.

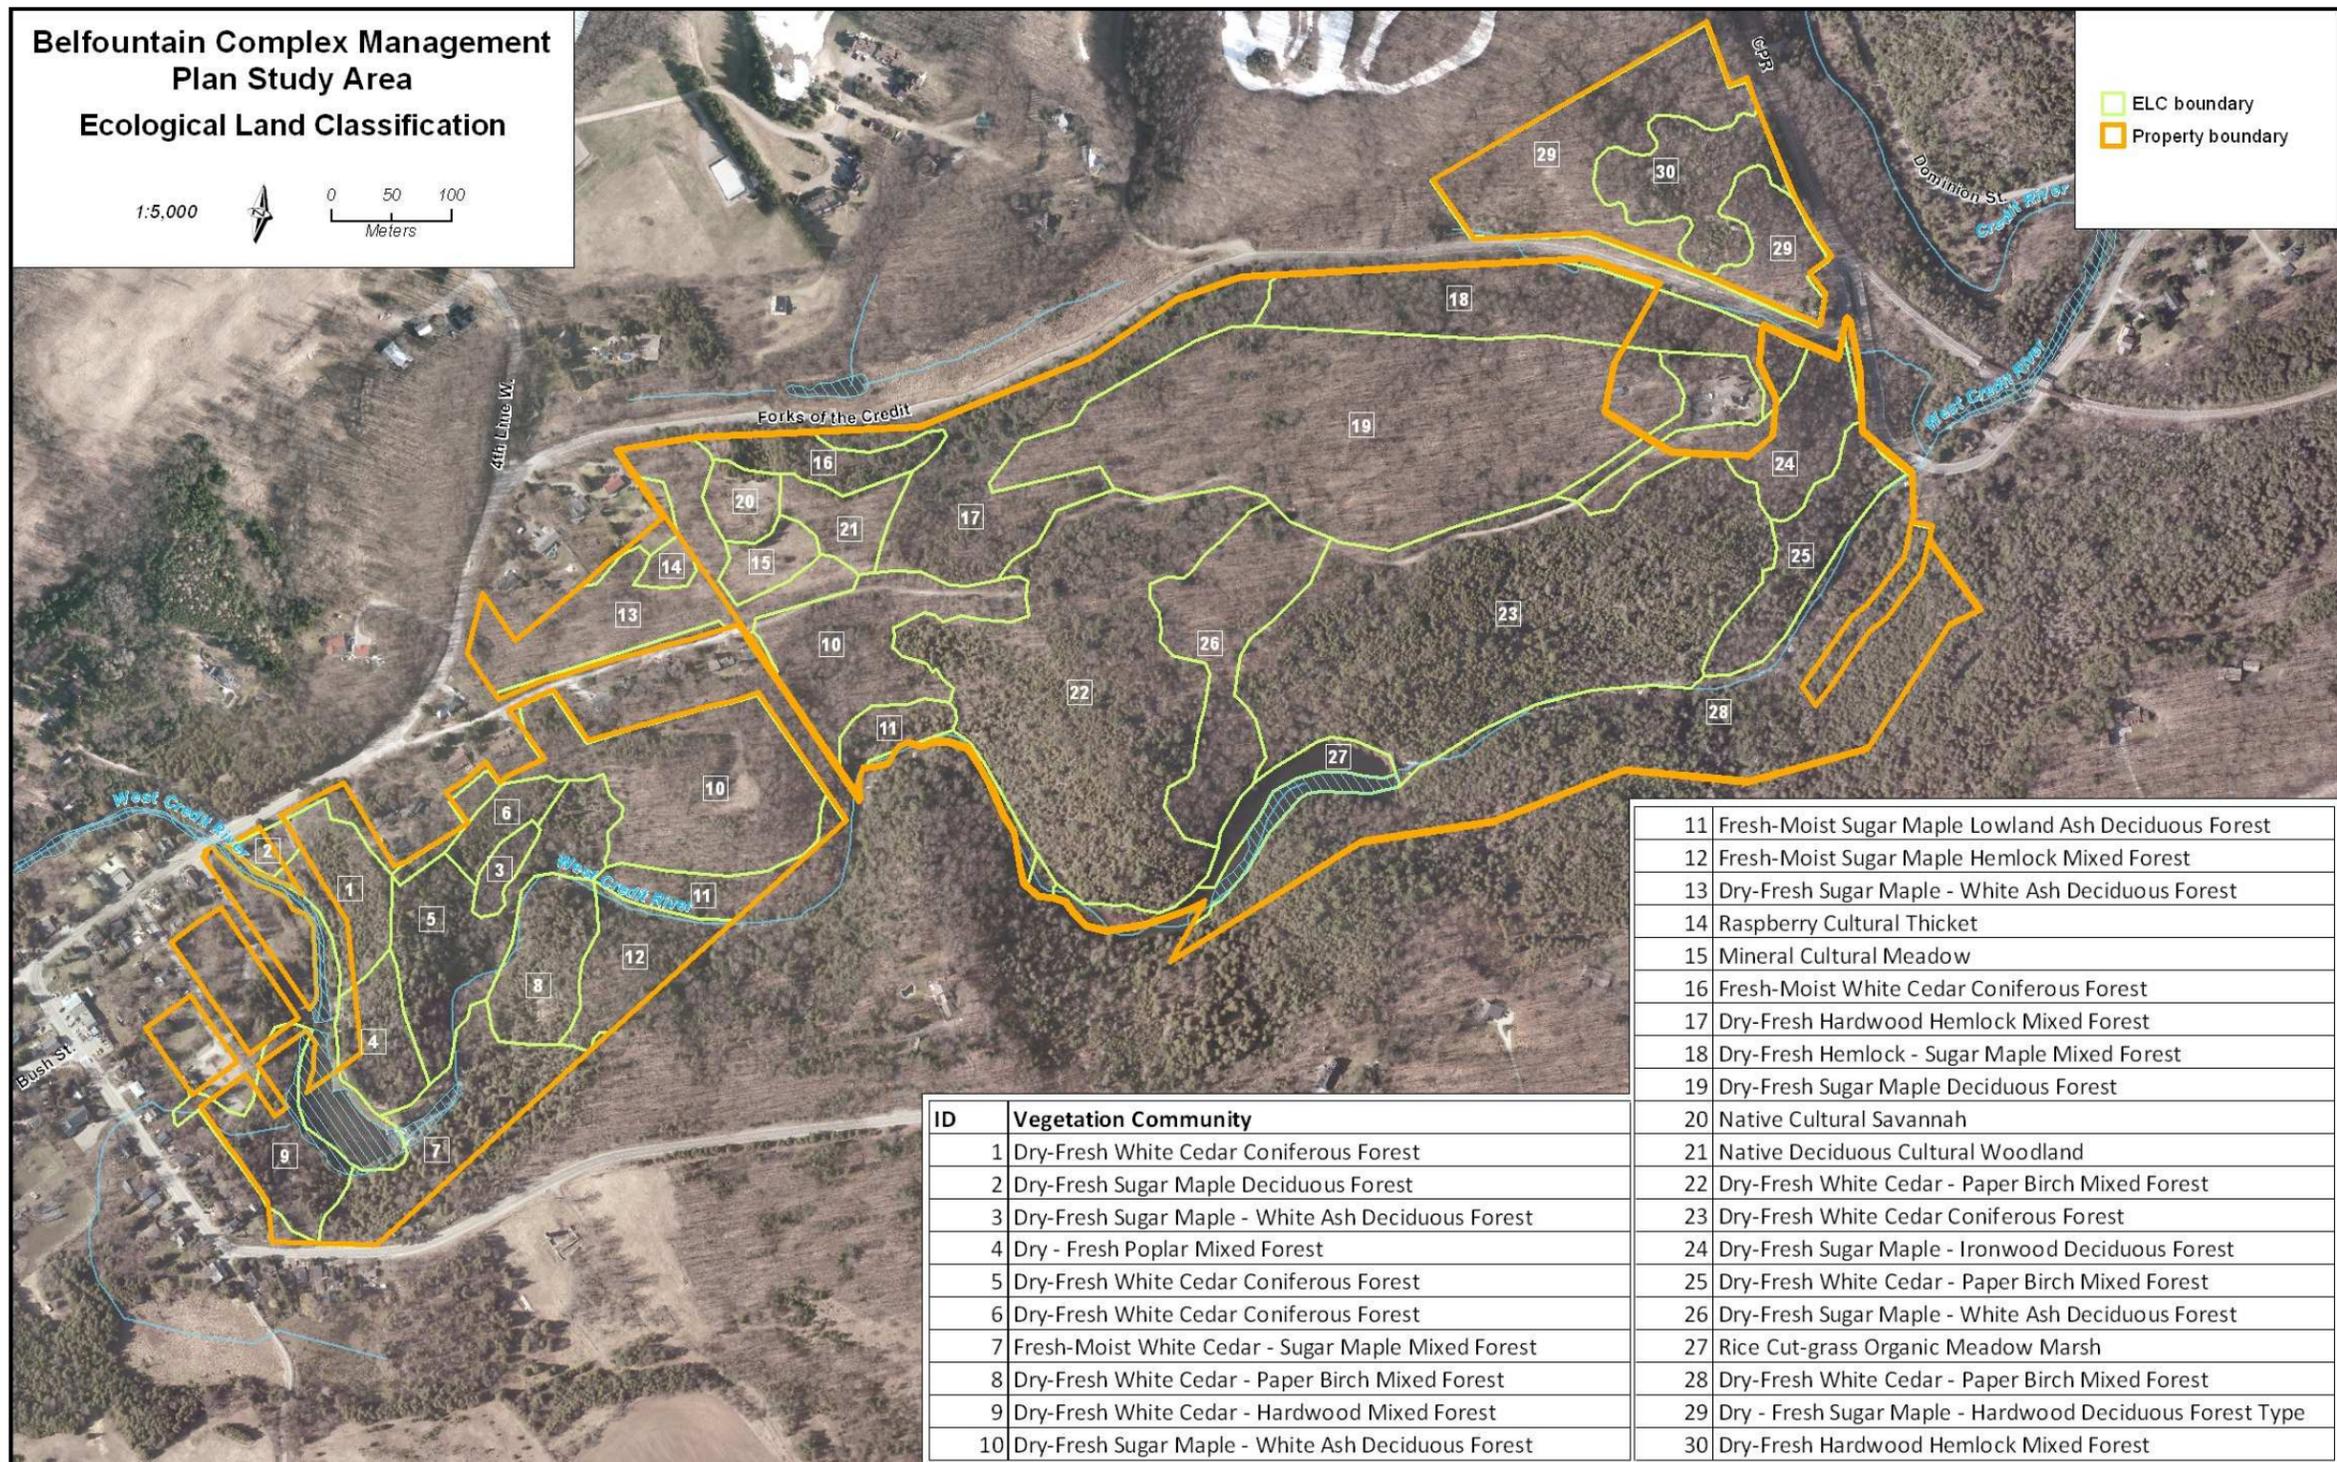
Figure 7 - Ecological Land Classification Mapping at the Belfountain Complex

Thirty vegetation communities were surveyed and mapped within the Complex and encompassed forest, wetland, and cultural communities (Figure 7, Figure 8).

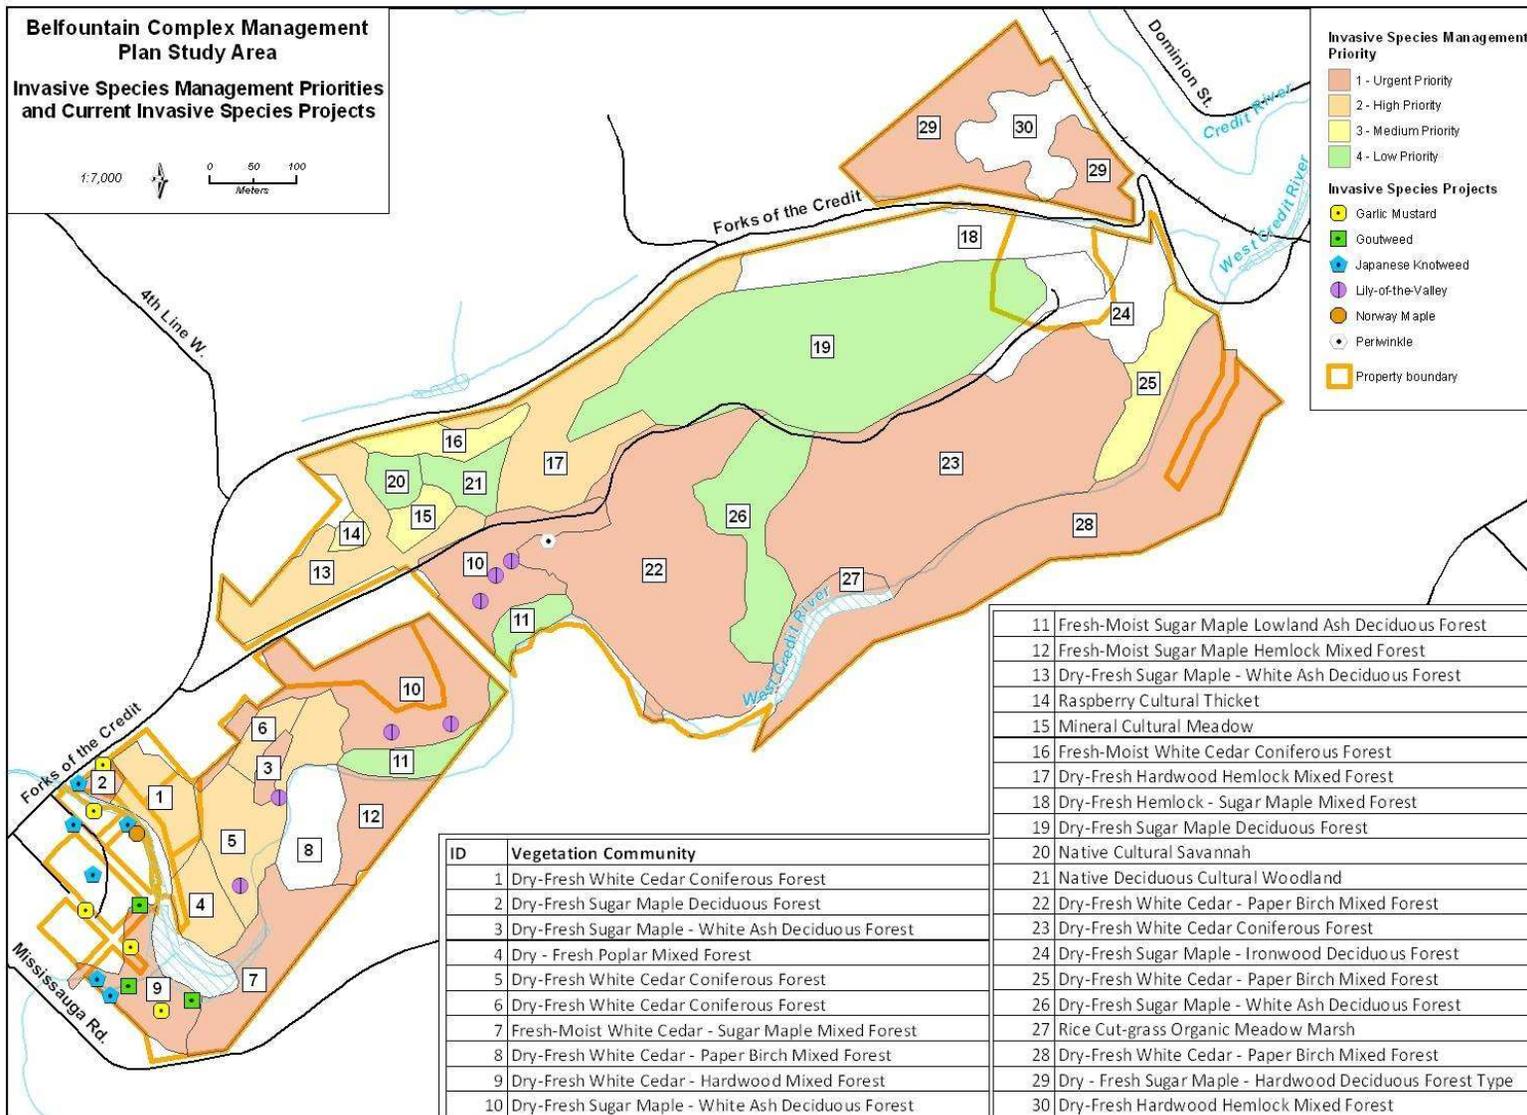
Figure 9 - Priority Mapping for Invasive Species Management within the Belfountain Complex

Other Transformer species recorded within the Complex include Common Buckthorn (*Rhamnus cathartica*), Purple Loosestrife (*Lythrum salicaria*) and Tartarian Honeysuckle (*Lonicera tatarica*). Removal of these species is highly recommended particularly where habitat quality is high. Preliminary mapping (Figure 9) illustrates the priority communities for invasive species management based on invasive species presence and the existing quality of the habitat. While the Natural Heritage Characterization Report for the Belfountain Complex Management Plan describes additional determinants for identifying communities for invasive species removal (such as accessibility and extent of the invasion) additional work is required to prioritize and create a strategy for removal and management.

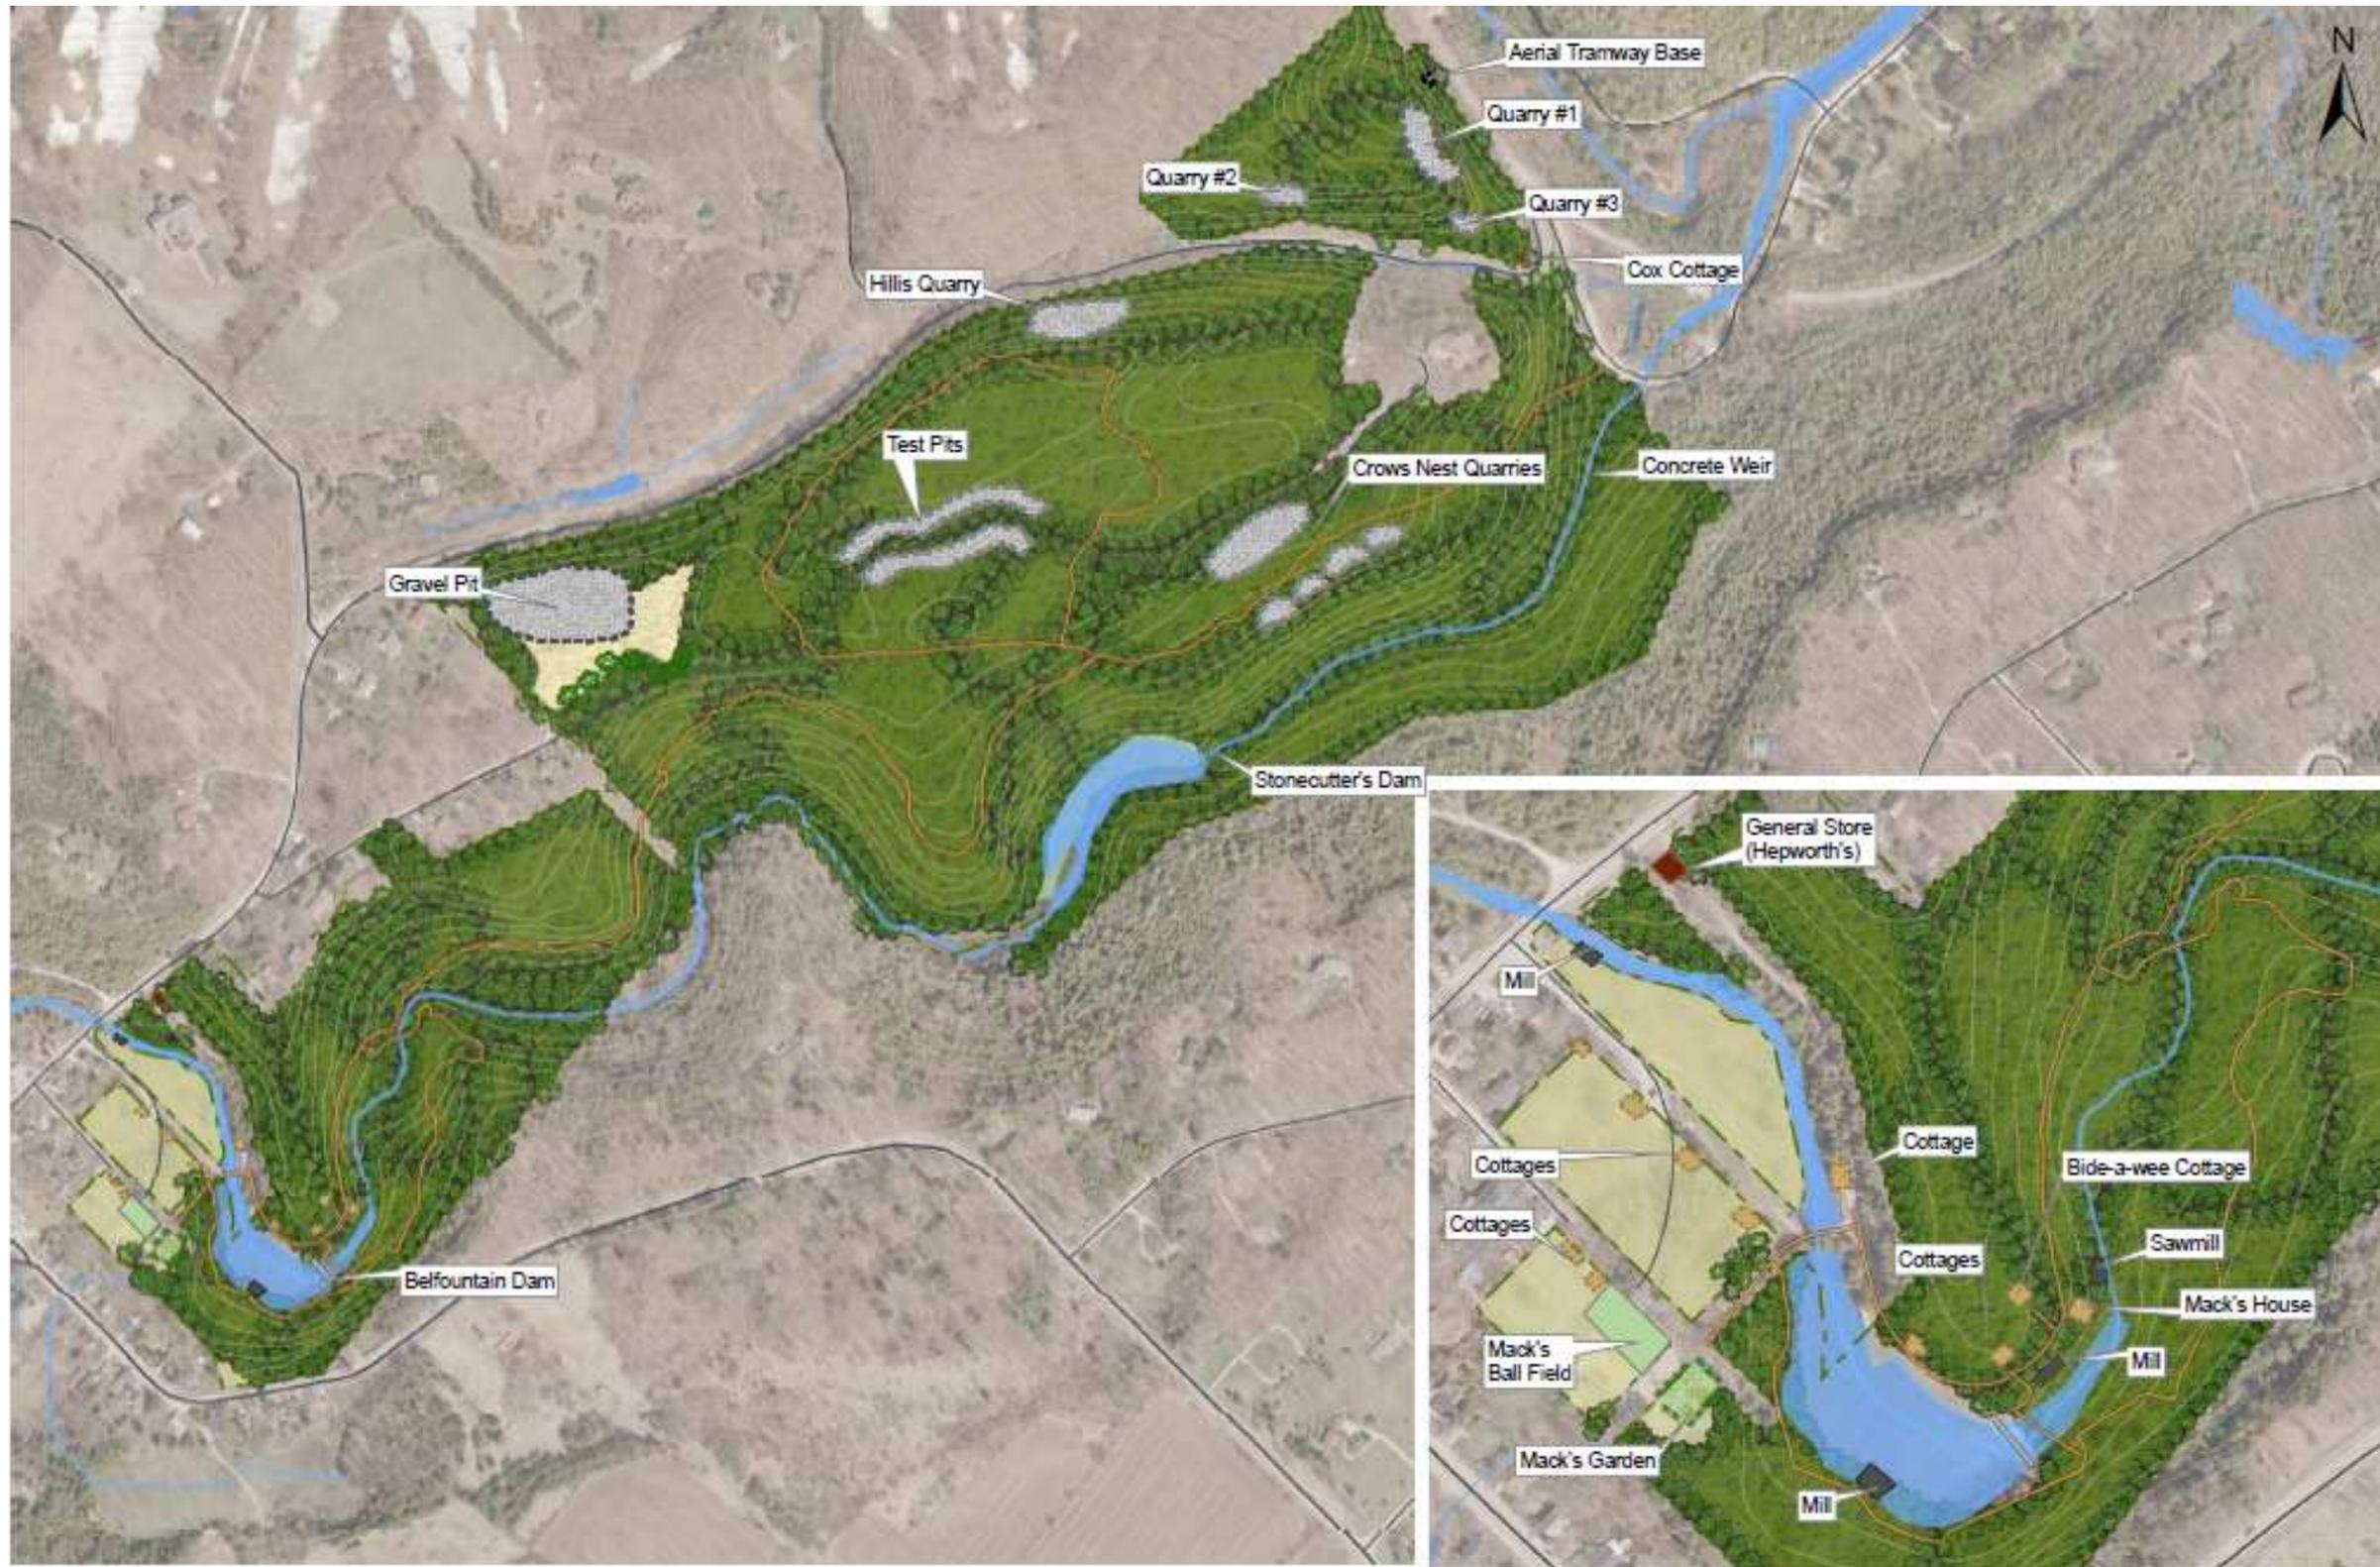
Figure 14 - Estimated Positions of Historical Resources within the Complex

In the late 19th century and early 20th century several houses were built on lots that now represent the entrance to Belfountain Conservation Area. The approximate locations of some of the buildings are represented in Figure 14.

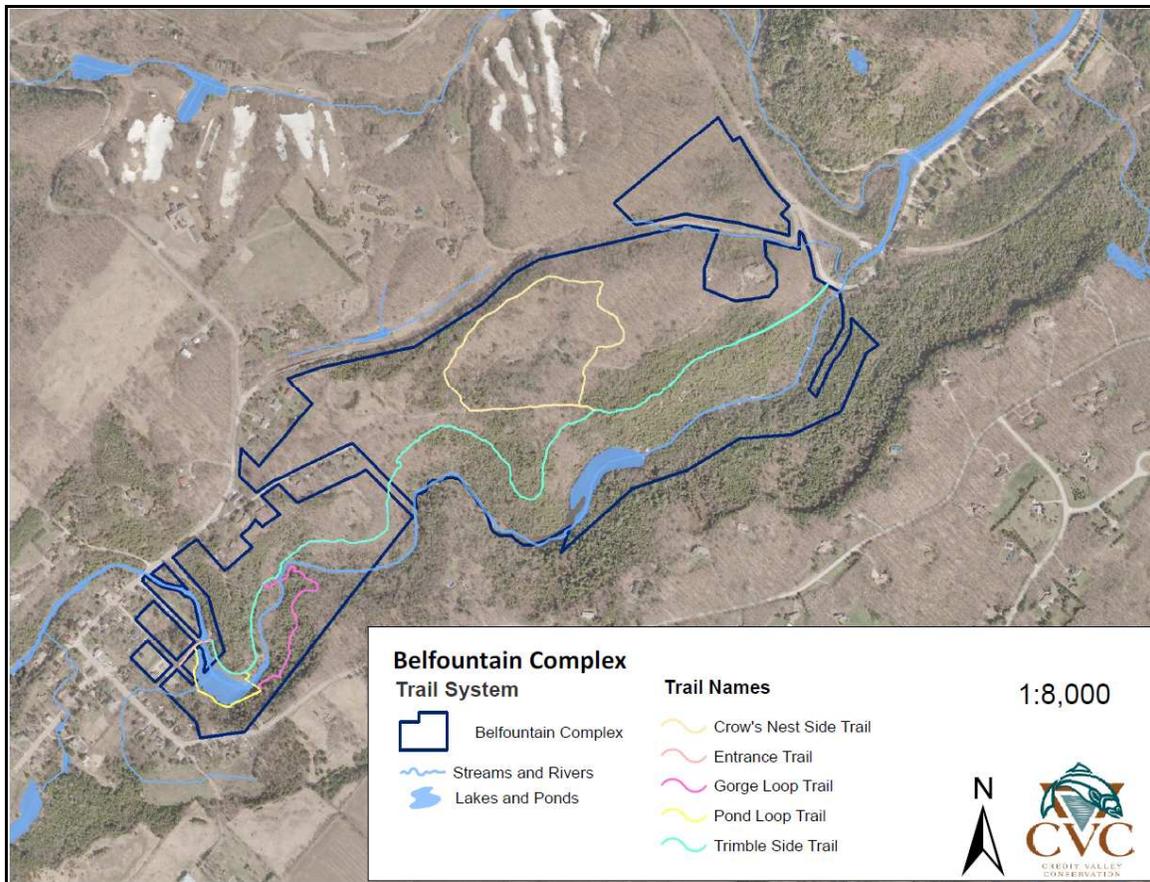
Figure 20 - Sanctioned Trail System of the Belfountain Complex

Trail Name	Length	Surface Material
Trimble Trail	2.6km in total: 1615m located within the study area (276m overlap with Gorge Loop)	Natural Duff (and pavement access trail)
Crow's Nest Trail	1024m	Natural Duff
Gorge Loop Trail	795m	Mostly Natural Duff and Boardwalk
Pone Trail Loop	218m	Mostly Woodchips and Boardwalk
Unsanctioned Trails	unknown	Natural Duff

The steep topography and springs located in the valley slopes contribute to erosion and saturated, muddy areas—less than ideal conditions for a trail system. Specific trail issues are outlined in Appendix E and include wet trail, erosion and unsanctioned trails. In order to mitigate these issues, a network of boardwalks, stairways, trail siding and erosion control measures have already been installed in some areas, and include:

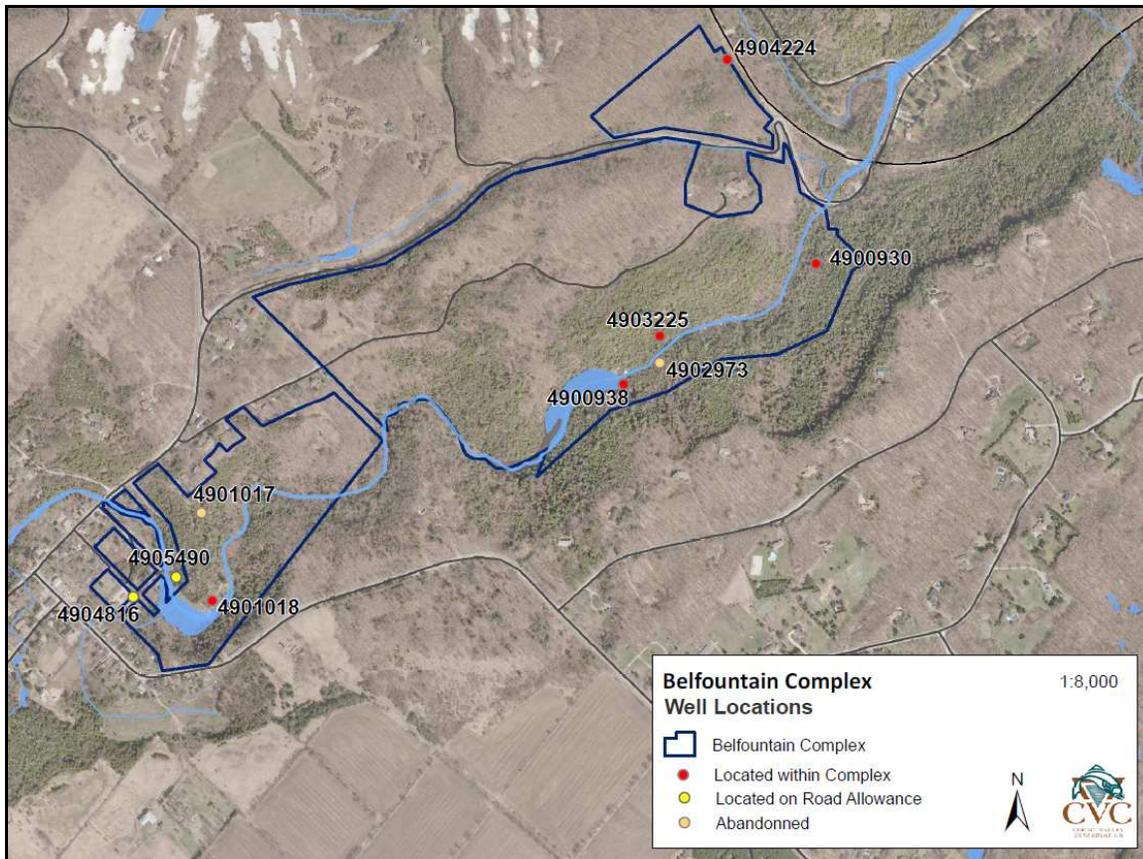
Figure 21 - Well Locations within the Belfountain Complex

While a several wells are located on road allowances or have been abandoned, it would be worthwhile formerly abandoning any wells that no longer service a purpose in order to protect groundwater resources.

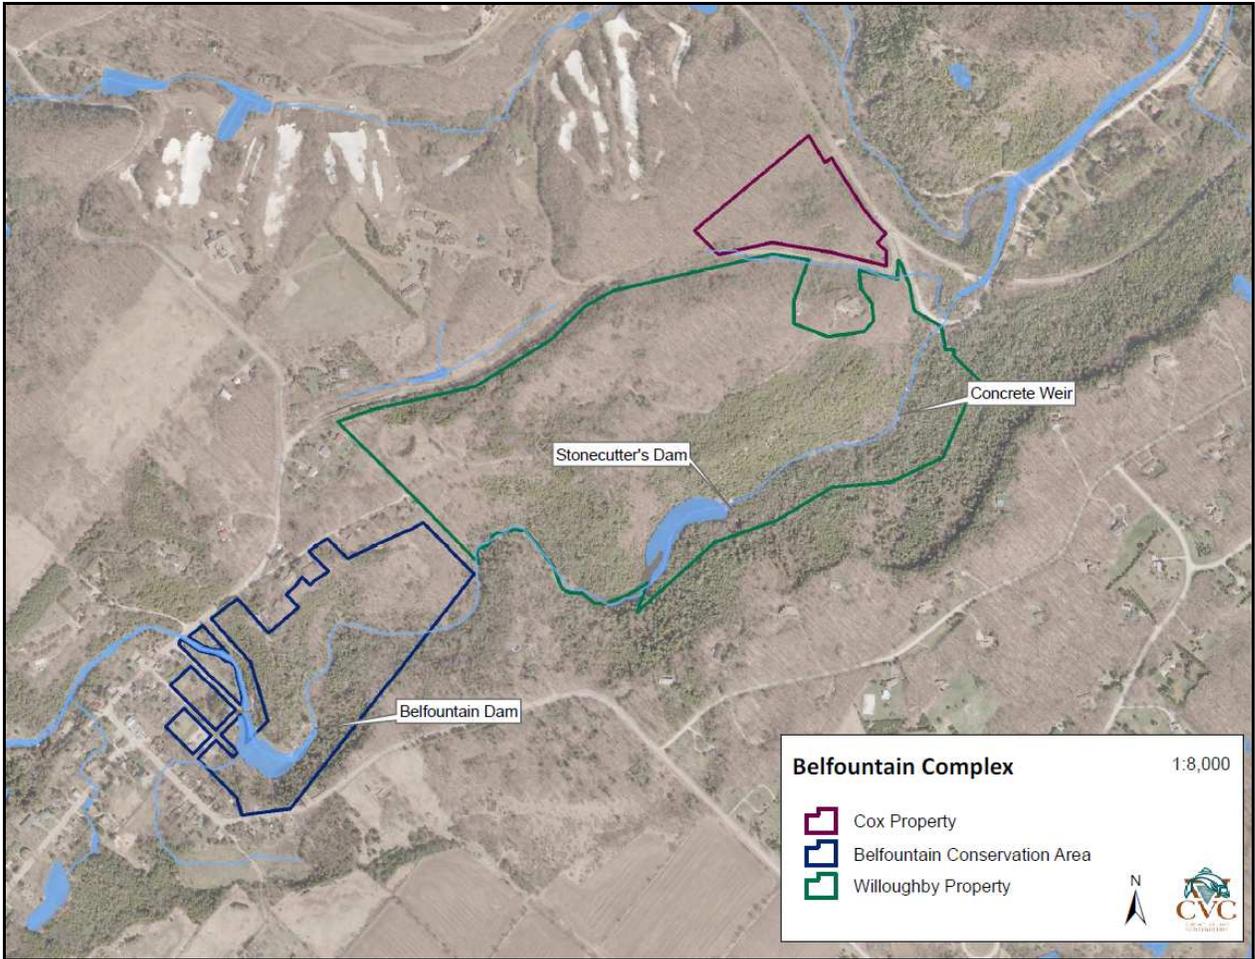
Figure 22 - Situation of Water Control Structures within the Belfountain Complex

Concrete Weir	Willoughby Property	~1900	- unknown; likely built for water power	- serves no current function	<ul style="list-style-type: none"> - Provincially culturally significant - at one time the top 4 – 5ft was constructed with stop logs or a concrete wall, however this is not missing

The dams located within the Complex are all aging and require maintenance. A discussion regarding the future management of these aging structures is required; any decisions must take into account a variety of competing values. Future management of these structures must balance the natural and cultural heritage values of the area, of the structures themselves, as well as public and visitor perceptions.

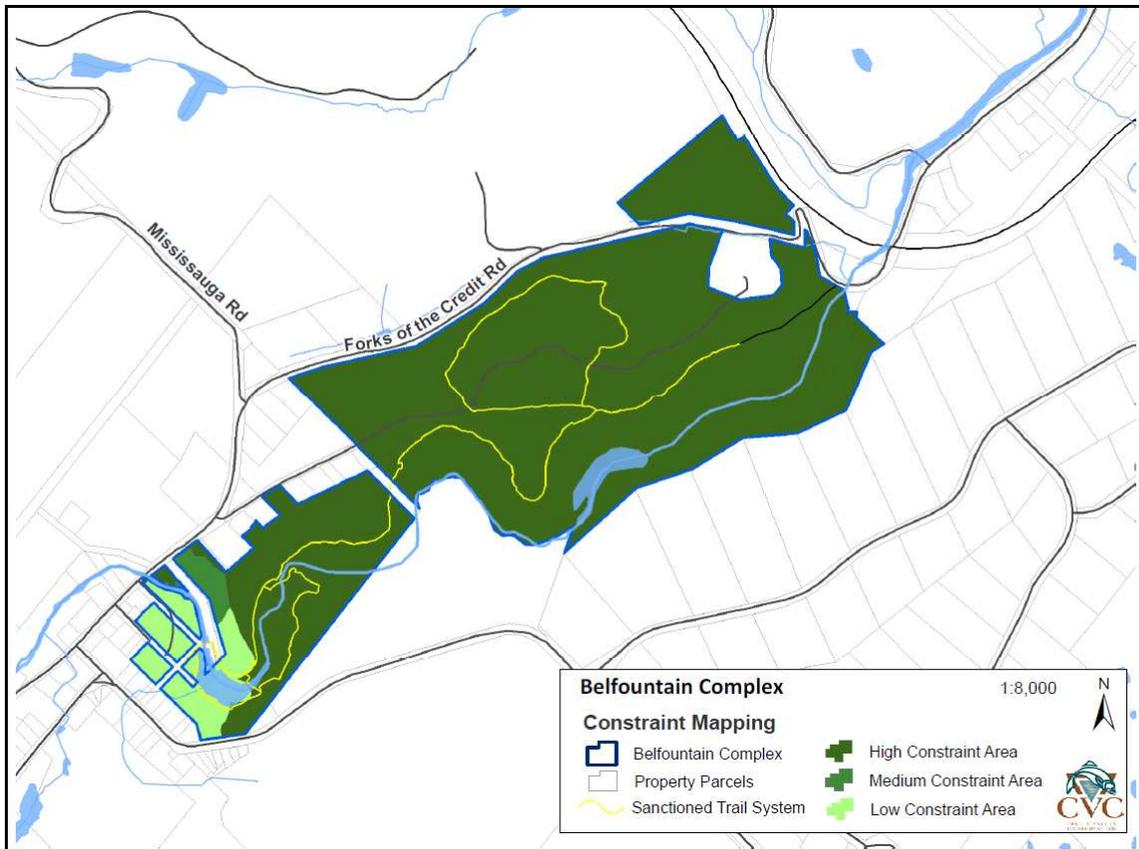
Figure 25 - Constraint Mapping for the Belfountain Complex

Figure 25 illustrates the overall coverage of significant features on the Complex.
