Conestoga College Cambridge Campus

Project Objectives, Design and Performance

Overview

Conestoga College Cambridge Campus is an expansion to the existing Dome Campus located south of Highway 401 at the intersection of Fountain Street and Dickie Settlement Road.

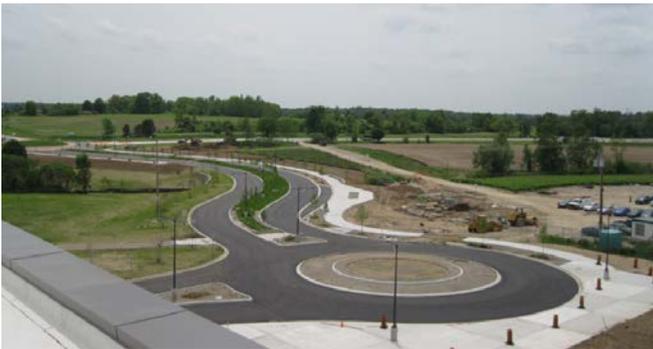
The main entry is a divided roadway featuring a wide median with traditional curb and gutter along its length. Catchbasins are used for drainage on the road. They are routed along the entire length to an oil grit separator and stormwater management pond via the catchbasin-to-storm sewer network.

Main entrance road to the college

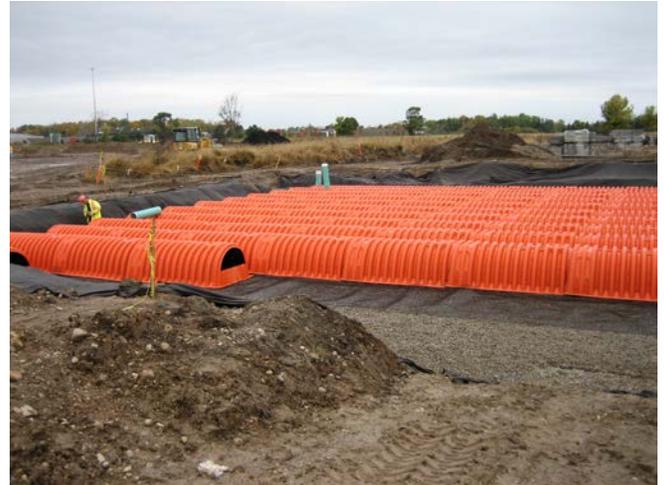
South central green infiltration gallery

The main building drains to an infiltration gallery located in the south central green. The infiltration gallery has a capture capacity of 700 cubic meters and provides Level 1 treatment based on the MOE best management practices guidelines. The infiltration gallery is designed to capture and infiltrate all runoff from currently

proposed and future buildings for 25 mm and 2-year storm events. Overflow from the infiltration gallery drains into the detention pond.

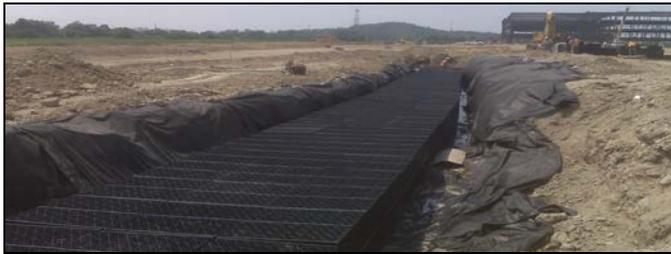
Bioswale plastic infiltration galleries wrapped in filter cloth

structural plastic infiltration galleries wrapped in filter cloth that features a 95 per cent void ratio.

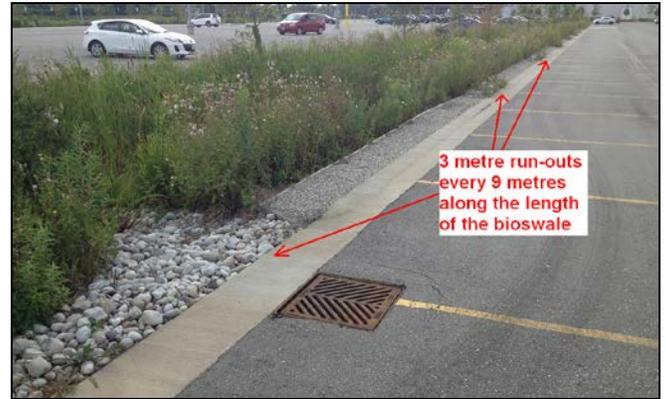
3 meter run-outs

The design of the bioswales provides a three-stage approach to drainage. The asphalt parking lots are graded toward the bioswales. The bioswales are bounded by a roll-over curb (typical OPSD 600.100). The curb features regularly spaced 3 m wide run-out (i.e. curb cut) locations every 9 m along the length of the bioswale. These run-outs facilitate drainage of surface runoff into the bioswales.

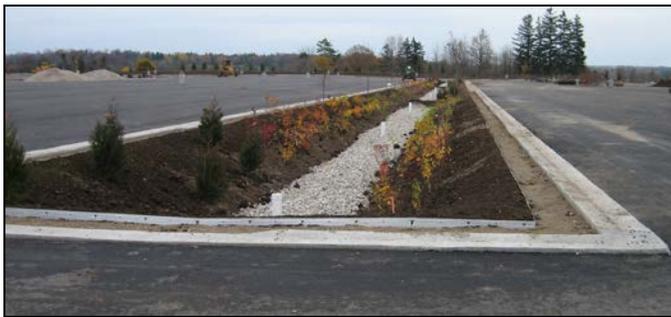
Bioswales in early establishment period

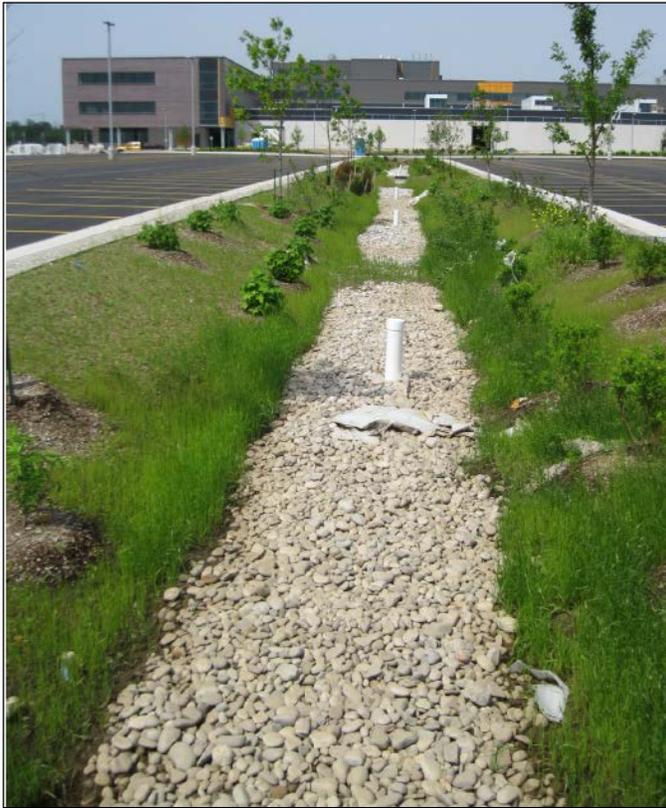
Centerline of the bioswale lined with 500 mm riverstone

A 0.6 m wide ribbon of riverstone disrupts the flow path. This provides a primary settling area for suspended sediment as the flow drains into the bioswale. The bioswales are fully vegetated and provide a natural filtration strip 3-4 m wide as the flow drains into the swale. Along the center of the bioswales, the design incorporates a 1 m wide flat bottomed invert lined with 500 mm of riverstone. Pea gravel is placed on top of

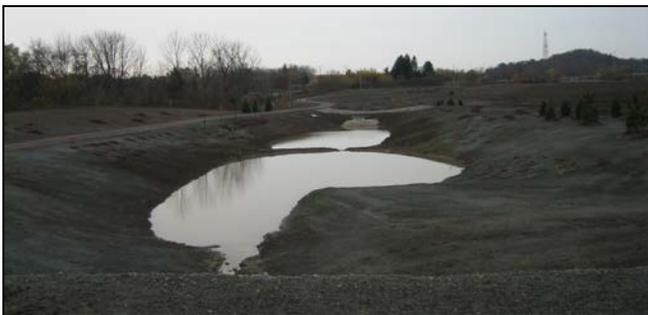
Stormwater management pond micropools

The remainder of the pond features numerous micropools and an extended flow length to maximize settling opportunities for flow that surcharges the low flow outlet. A second outlet in the pond is located at an elevated level featuring a 0.2 m wide weir draining to the common outlet structure.

The pond was constructed in native soils. The soils are granular and support infiltration of runoff captured in the micropools. Water quality treatment is provided through the oil/grit separator at the pond inlet after which the runoff is considered clean per MOE guidelines. It is then suitable for infiltration. Micropools were designed to provide opportunistic infiltration at limited grading cost, above and beyond the MOE guidelines.

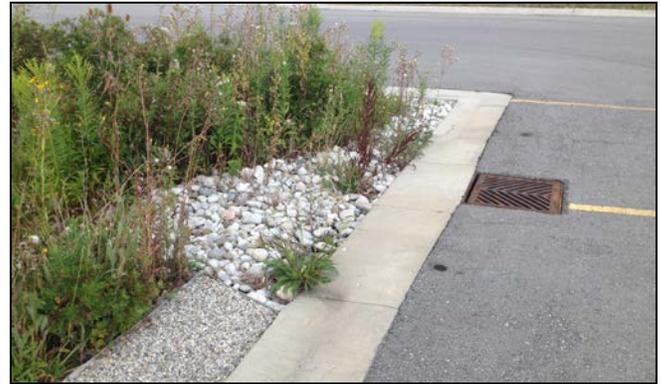
Catchbasin installed by run-out causing short circuiting of the bioswale

The contractor overlooked the need for inspection ports and struggled with the concept of draining surface runoff from the parking lot into swales instead of normal overflow catchbasins. Construction drawings illustrated the precise location of the catchbasins but one was aligned along the curb per the design. One catchbasin grate differed in relation to the gutter line in the curb. The contractor recognized this as an “error” because its orientation was different than all other catchbasins on site. The contractors had to relocate some of the structures after installation to correct this issue.

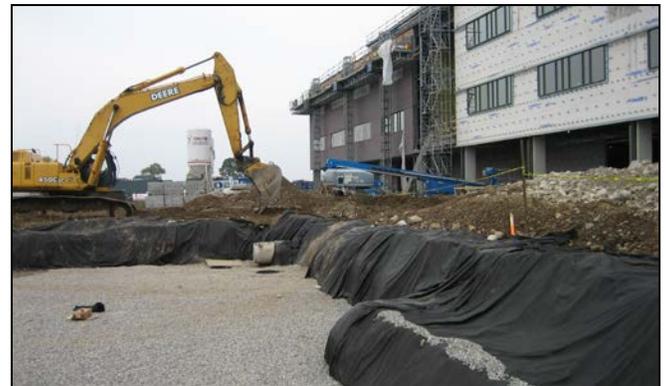
Infiltration gallery - fill material falling into gravel bed

Care was taken during construction to minimize traffic over infiltration areas. This prevented unnecessary compaction of the native soils which would have hindered infiltration potential. Protection of the infiltration areas was emphasized fill material was seen falling in the gravel bed layer of the infiltration gallery during inspection visits. Techniques used to protect the infiltration areas included educating of the contractor, signage, flagging tape and fencing.
