IMAX Parking Lot Retrofit

Location: Mississauga
Constructed: 2013

Project Objectives, Design and Performance

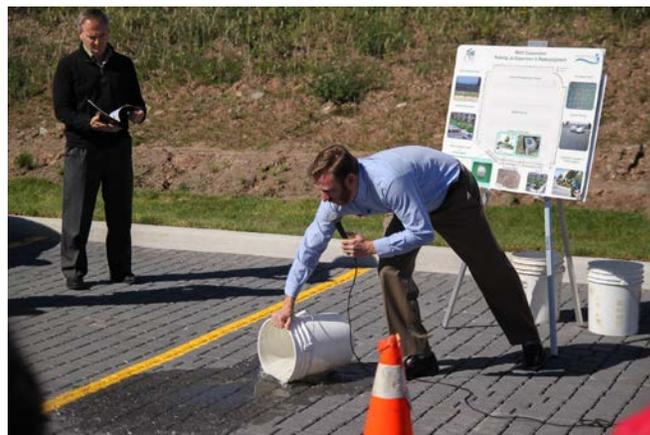
Figure 3: CVC staff demonstrating the effectiveness of the permeable pavers at infiltrating water

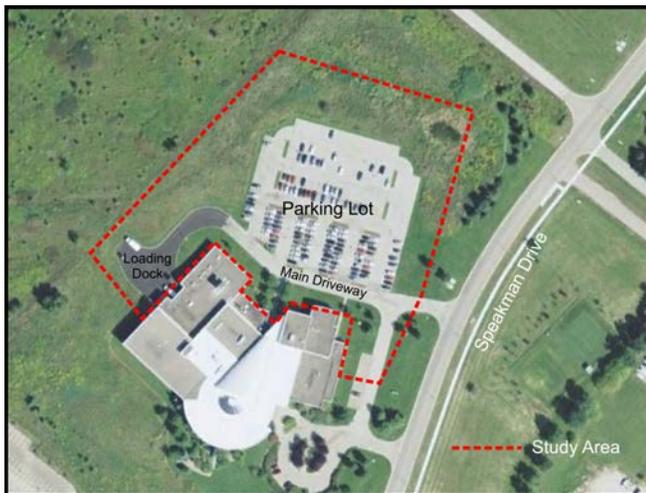
The IMAX retrofit site included the existing employee parking lot (0.62 hectares) and a portion of the main driveway (1370m²) which connects the main entrance from Speakman Drive to the loading docks located along the west side of the building (Figure5). It also includes some of the surrounding natural area.

Figure 5: IMAX retrofit site – Pre-retrofit conditions

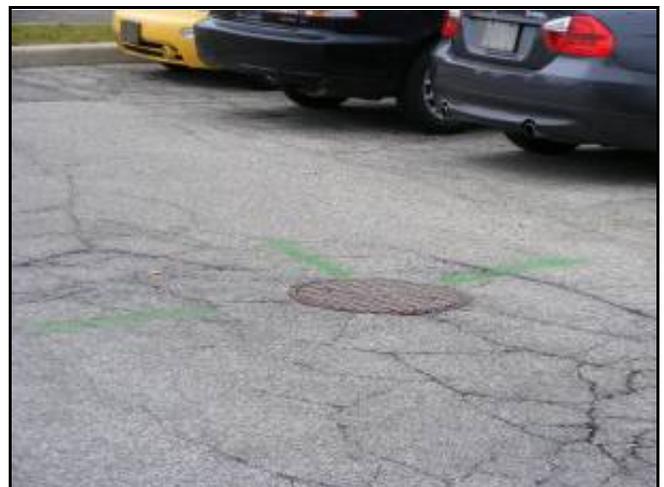
The pre-retrofit parking lot surface was in poor condition with signs of severe cracking, rutting, and spalling throughout the facility (Figure 6).

Figure 6: Pre-retrofit conditions - degraded asphalt

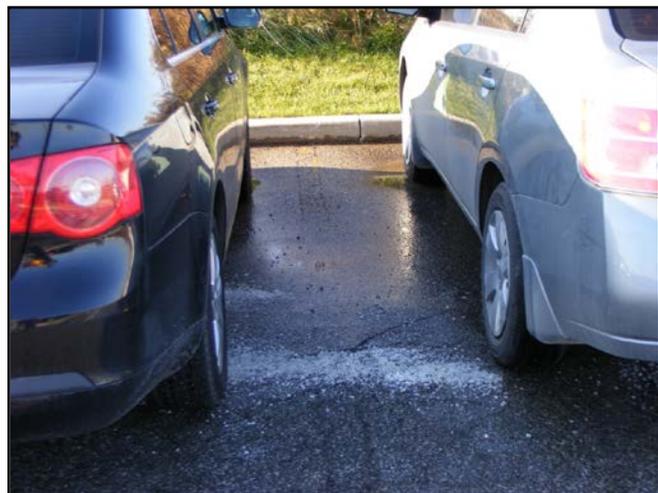
Poorly draining subsoils created saturated conditions that quickly degraded the asphalt surface, causing frequent ice build-up during winter months. Build-up resulted in increased salt application during de-icing operations (Figure 8). This salt negatively impacted the quality of stormwater runoff leaving the site.

Figure 8: Pre-retrofit conditions - Excessive winter salt application

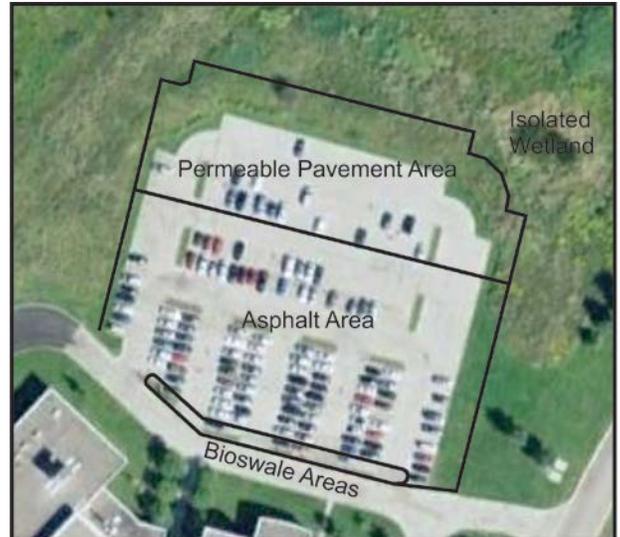
The proposed parking lot surface was a combination of traditional asphalt and permeable pavement. The north part of the parking lot was set to be reconstructed using permeable pavement, whereas the south two thirds used asphalt paving. The proportion of permeable pavers to asphalt was a result of project budget and bedrock constraints. These constraints are described in subsequent sections (see *Pre-design Tasks* and *Detailed Design*). The stormwater runoff that infiltrated through the surface of the permeable pavement was designed to outlet to the isolated wetland where it can infiltrate and evaporate prior to discharging to the municipal storm sewer.

Figure 9: IMAX Retrofit Site – Retrofit Concept

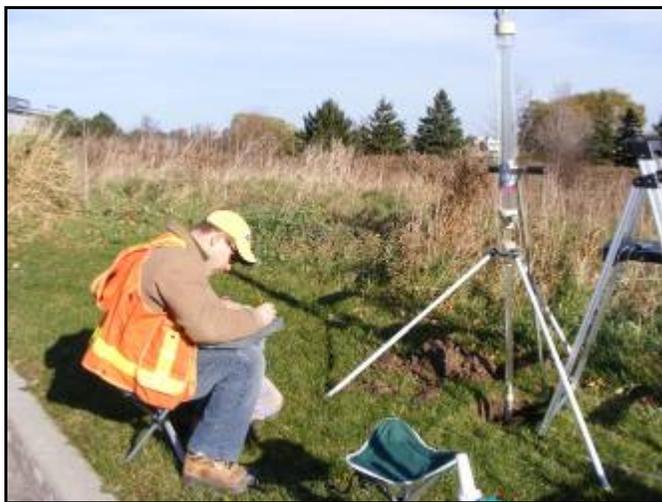
Guelph Permeameter testing was performed in December 2011 to determine the saturated hydraulic conductivity (Kfs) of the in-situ soils. The experimentally determined Kfs was converted to infiltration rate (mm/hr) and a factor of safety corresponding to the non-stratified soil condition was

Figure 10: Infiltration testing conducted at IMAX.

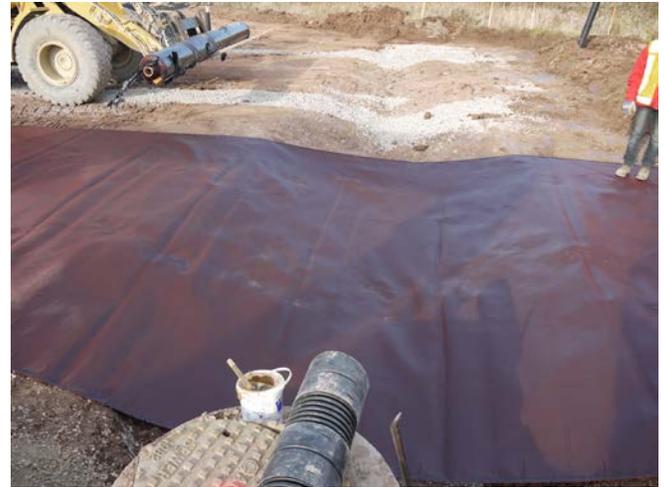
To augment the low soil stability of the sub-soils, the project team selected a high-strength woven monofilament geotextile (RS380i) to provide reinforcement strength and base course confinement, as well as high flow rates for infiltration and soil retention capabilities (Figure 12).

Figure 12: Tencate's Geotextile (RS390i).

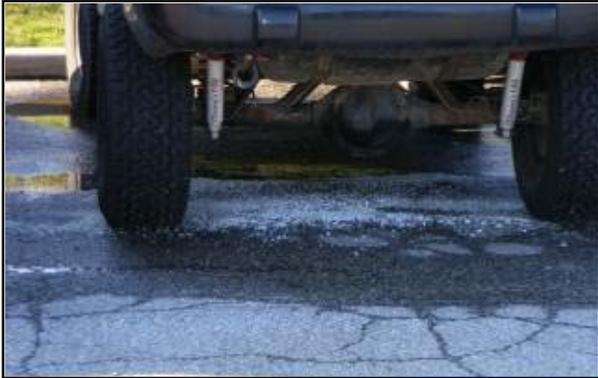
subsoils caused saturated conditions for days following wet weather events. The constant saturation of the subsoils weakened the supporting structure for the existing asphalt surface causing severe asphalt degradation. Throughout the winter, water would build up in the potholes and turn to ice which put employees at risk for slipping. Salt was extensively applied to eliminate the ice and risk of slipping (Figure 13).

Figure 13: Asphalt degradation at IMAX parking lot and extensive salt application.

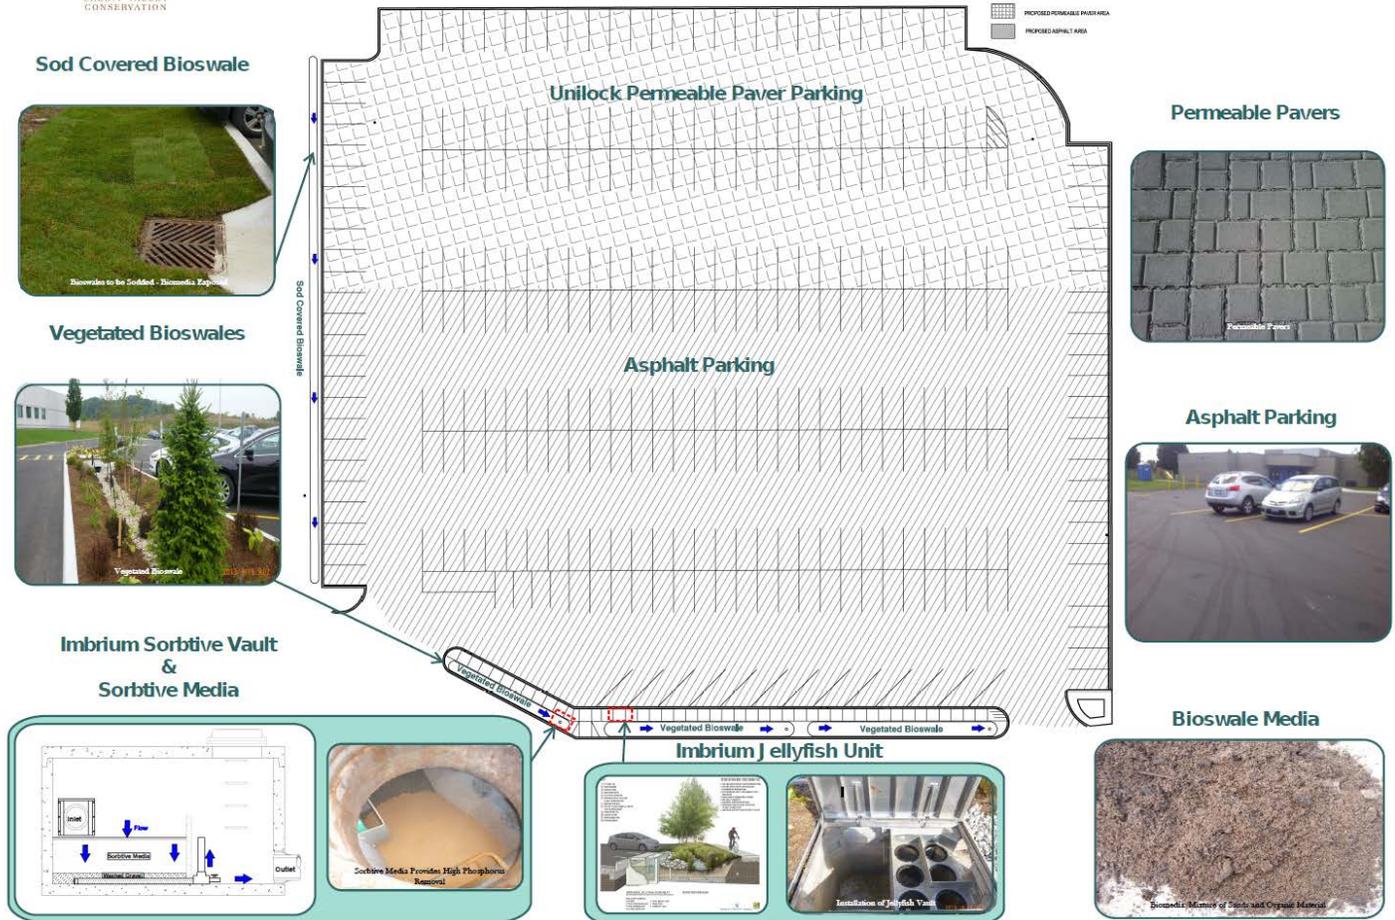
Figure 14 identifies the locations of the LID practices on the site.

Figure 14: General layout and location of LID practices in the IMAX parking lot retrofit.

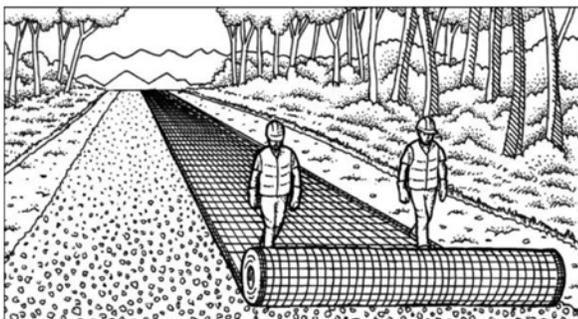
In preparation of the base material installation, the geotextile was placed directly on the prepared subgrade and rolled out flat and tight with no folds. Adjacent rolls were overlapped and held in place by workers as base material was placed on top as demonstrated in Figures 15 and 16.

Figure 15: Roll geotextile onto flattened subgrade surface.

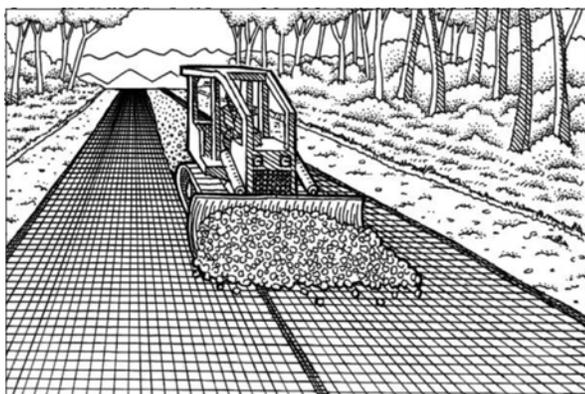
Figure 16: Base material placement onto geotextile.

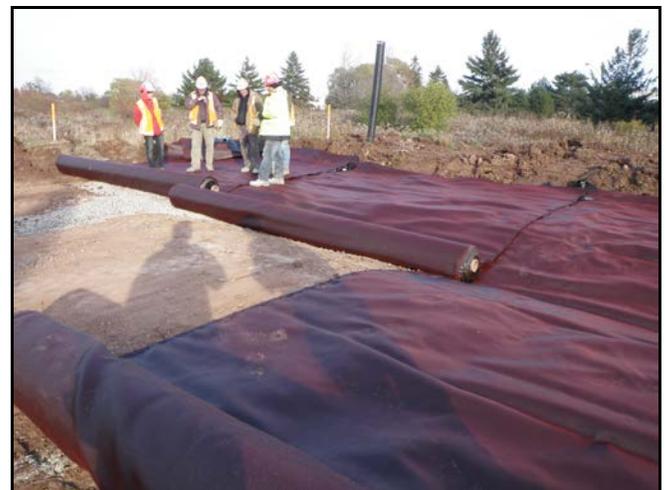
Figure 17: Geogrid laid on subgrade.

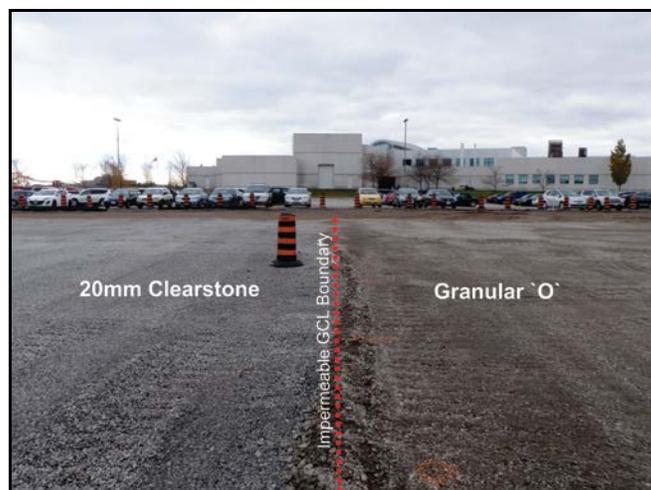
Granular "O" material was placed under the west half of the permeable pavement area while the 20 mm ϕ clearstone was located on the east half. To effectively monitor the water quality and quantity performance of the two base materials, a Geosynthetic Clay Liner (GCL) spanned the boundary of the two base materials and permeable pavement to asphalt interface. The liner was keyed into the subgrade and sides of the excavation to ensure the base materials are fully separated, hydraulically. This configuration is shown in Figures 18 and 19.

Figure 18: 20 mm ϕ angular clearstone and Granular "O".

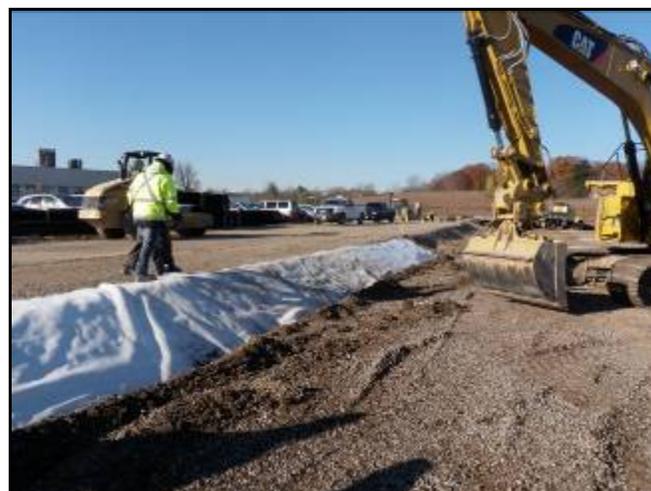
Figure 19: Impermeable liner separating asphalt from permeable paver sections.

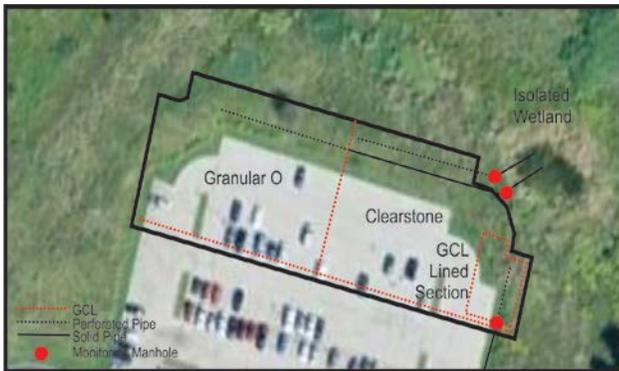
Figure 21 shows the layout of the underdrains and maintenance hole in which the water samples and flow monitoring are conducted.

Figure 21: Permeable pavement underdrain layout

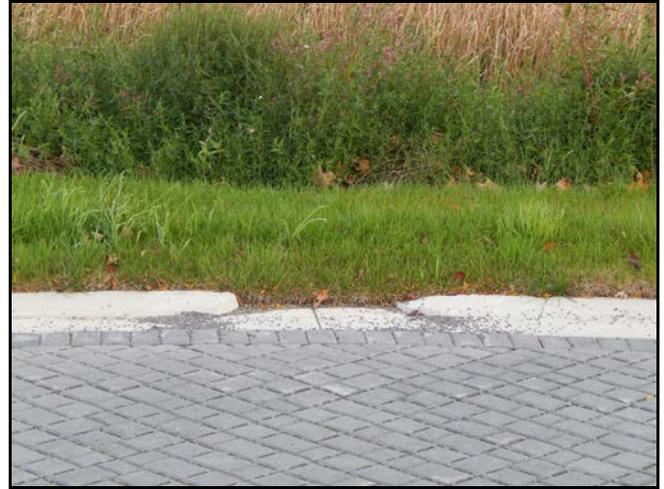
In the event runoff volumes exceed the capacity of the permeable pavers and underdrain system, excess flow discharge through a curb cut located at the northeast corner of the pavers (Figure 22) to an isolated wetland, and ultimately, enters the municipal storm sewer.

Figure 22: Overflow curb cut to wetland.

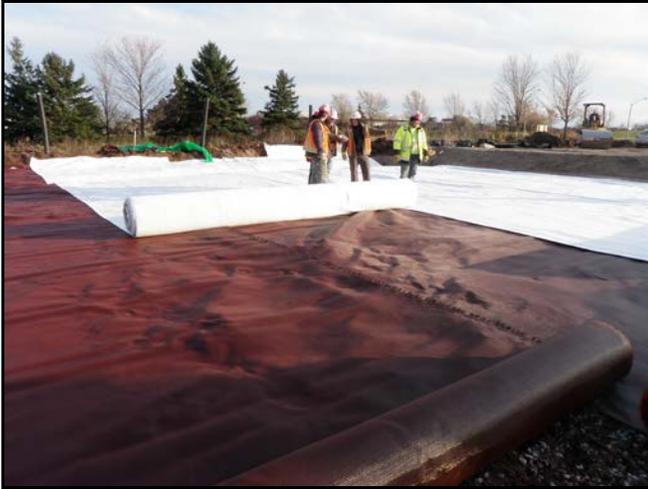
An area of permeable pavement and the entire base structure beneath it was isolated using the GCLs. The GCL was installed on top of the geotextile and wrapped up the sides of the excavation and the boundary between adjacent base materials and terminated just below the permeable paver surface (Figures 23 and 24). The overlapping seams were sealed with bentonite.

Figure 23: GCL installed along base material on top of the geotextile.

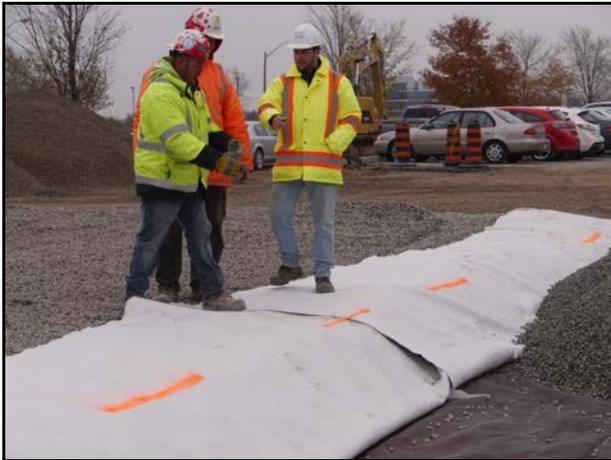
Figure 24: 20 mm \varnothing clearstone being wrapped with GCL.

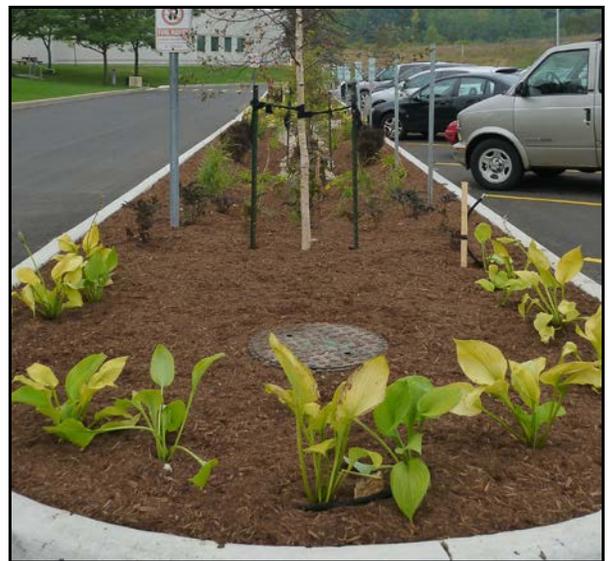
- Bioswale #1: West end, upstream of the Sorbtive® Vault polishing unit.
- Bioswale #2: Between the other bioswales and downstream of the Jellyfish® Filter pre-treatment system.
- Bioswale #3: Furthest east within the median, closest to the driveway entrance from Speakman Drive. Figure 25 is an example of a completed bioswale.

Figure 25: Bioswale #3 after construction and landscaping.

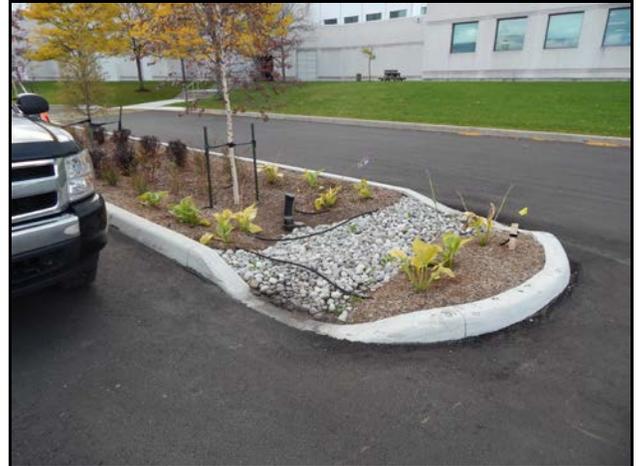
Inlets to each of the three bioswales consist of a simple curb cut in the barrier curb separating the parking lot and driveway areas from the bioswales. Following the inlets, a 150 – 300mm thick layer of 100 – 150 mm Ø round stone was embedded into the media acting as a flow dissipater and spreader for inflows.

Figure 27: Completed bioretention cells, showing flow dissipater and curb cuts.

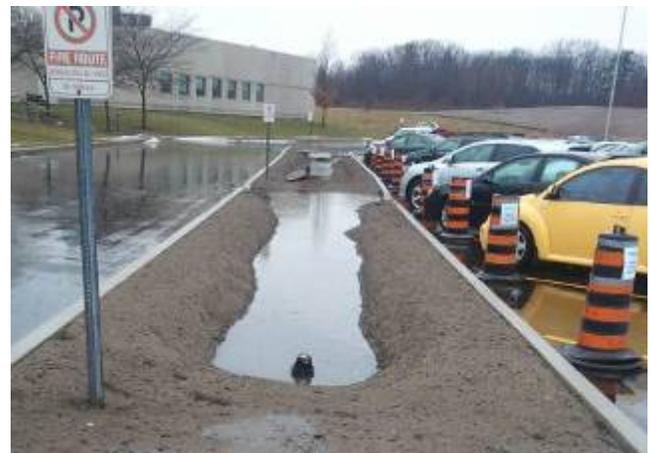
Runoff volumes that exceed the capacity of the bioswales are conveyed through overflows situated at the downstream limits/low point of the bioswales.

Figure 28: Completed bioretention cell showing ponding. The overflow bypass will be conveyed through a riser stand pipe connecting to the underdrain.

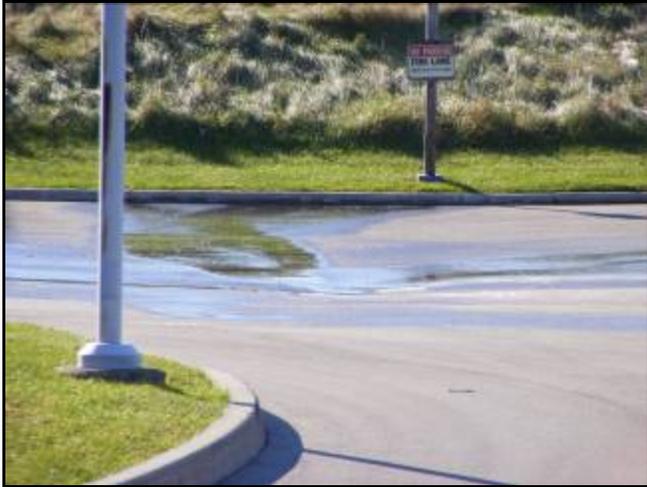
atop the bioretention soil media is manicured sod. The primary function of the swale is to intercept groundwater seepage before upwelling to the asphalt surface (Figure 29).

Figure 29: Groundwater seeping onto asphalt parking lot at IMAX prior to retrofit.

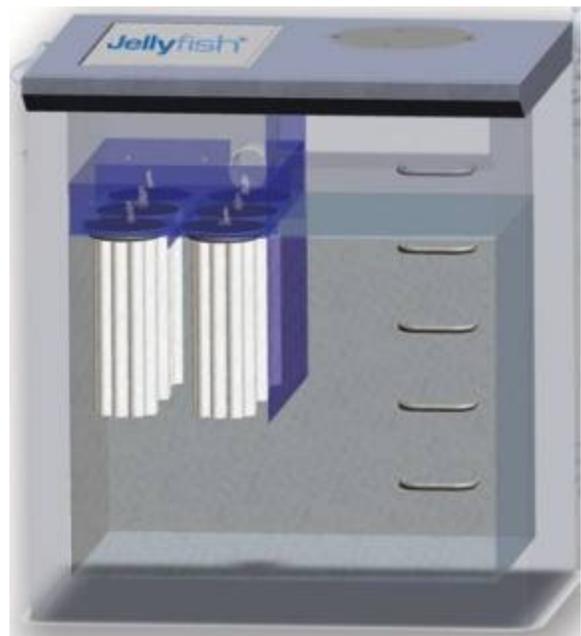
The Jellyfish® Filter is an engineered stormwater quality treatment technology featuring pre-treatment and membrane filtration in a compact stand-alone treatment system that removes a high level and wide variety of stormwater pollutants. Pollutant removal is achieved at high treatment flow rates with minimal head loss and low maintenance costs. Each lightweight Jellyfish® Filter cartridge contains an extraordinarily large amount of membrane surface area, resulting in high flow and pollutant removal capacity.

Figure 31: Jellyfish® Filter conceptual. (Source: Imbrium Systems)

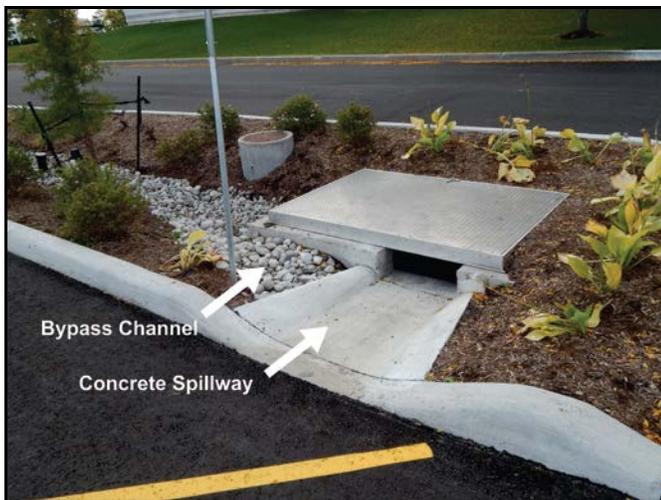
The unit installed at IMAX is situated upstream of Bioswale #2. It acts as a pre-treatment measure for stormwater runoff. Flows from the parking lot area enter a curb cut, flow down a concrete channel, and inlet the sump half of the Jellyfish® Filter unit.

Figure 32: Jellyfish® Filter installed at IMAX.

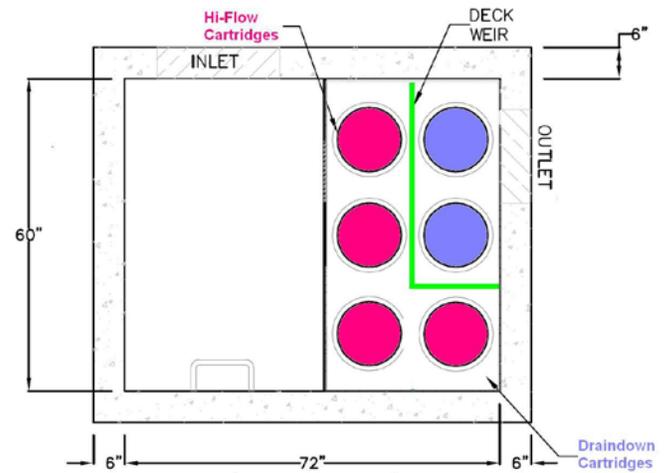
Figure 33: Jellyfish® Filter Plan View (Hi-Flow and Draindown cartridges).

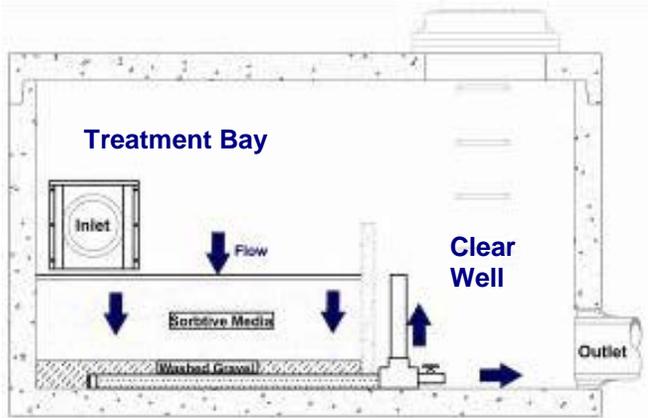
The Sorbtive® Vault will be situated at the downstream limit of Bioswale #1 and acts as a tertiary treatment unit to polish treated stormwater from the Bioswale #1 underdrain. Treated stormwater from the bioswale underdrain shall be distributed to the treatment bay and Sorbtive® Media. Figure 35 shows the various components of the Sorbtive® Vault.

Figure 35: Conceptual of the Sorbtive® Vault installed at IMAX.

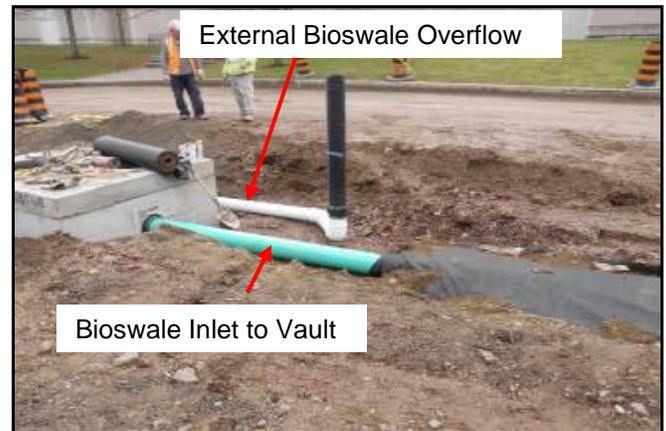
Figure 36: Sorbtive® Vault installed at IMAX and upstream bioswale.

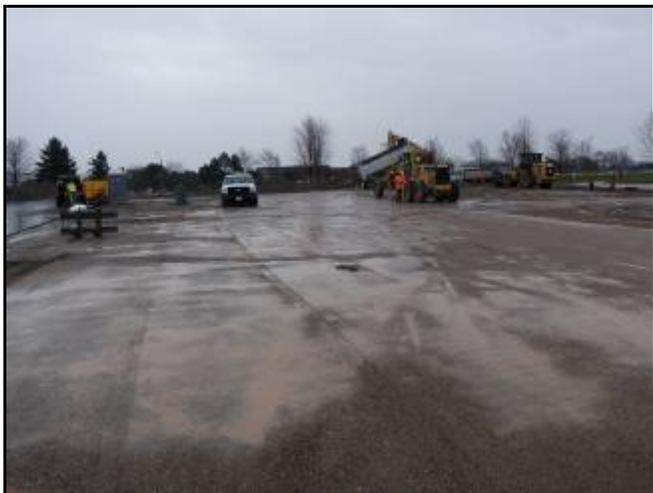
Figure 37: Wet conditions during construction due to severe weather.

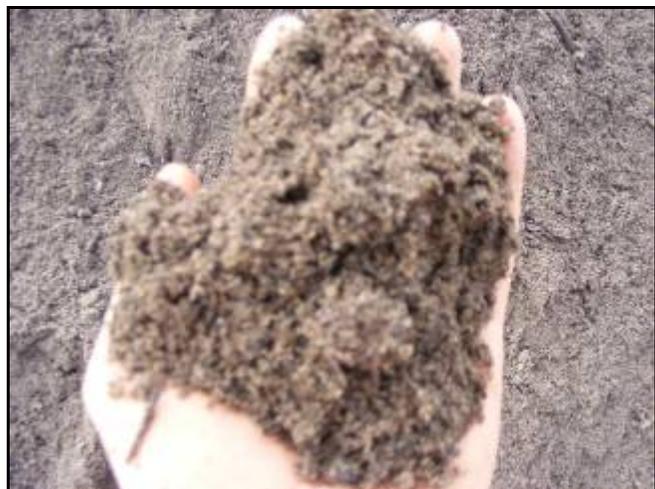
Filter media manufactured for the bioswale were analyzed to verify that the mixtures met the standards outlined in the Low Impact Development Planning and Design Guide.

Figure 38: Bioretention soil media consisting primarily of sand and organic material.

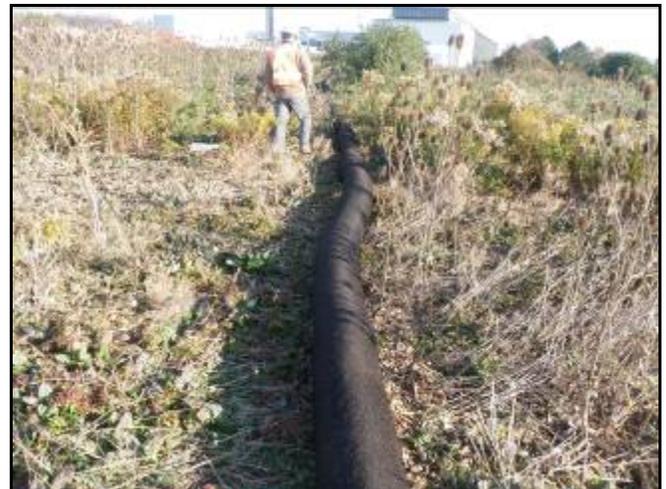
A typical erosion and sedimentation control plan was included with the design drawing. It consisted of catch basin inlet controls and filter socks. No excavated material had to leave the site, so road cleaning operations were limited.

Figure 40: Filter sock installed to protect wetland.

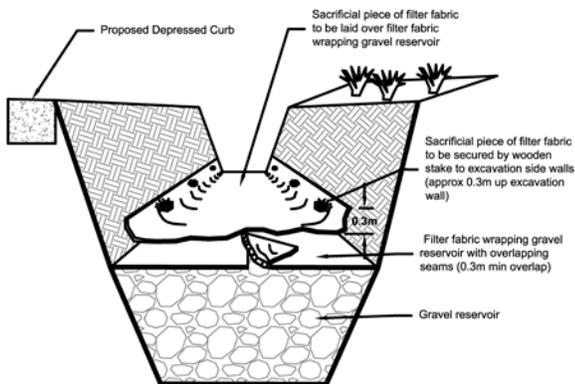
Prior to the installation of the bioretention soil media and paving of the asphalt parking areas, sediment socks and sacrificial pieces of filter cloth were installed to protect the bioswale infrastructure from contamination. Sacrificial pieces of filter cloth were installed over the cloth-wrapped clearstone reservoir of the bioswales. Prior to the installation of the bioretention soil media; this filter cloth was removed and included any captured contaminating fines. Figure 42 shows how the filter cloth was used.

Figure 42: Conceptual of the sacrificial piece of filter cloth used to protect bioswales.

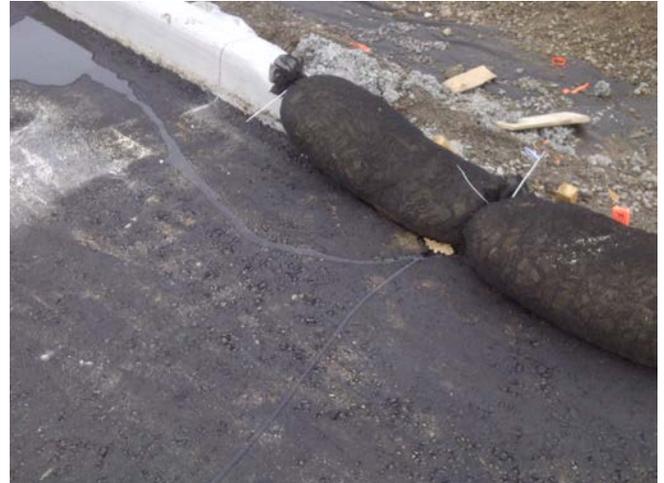
Filter socks were staked in place at the bioswale curb cut to prevent sediment laden runoff from entering the bioswales. These measures were removed once the bioretention soil media was installed and asphalt areas were stabilized.

Figure 43: Sediment socks installed at bioswale curb cuts.

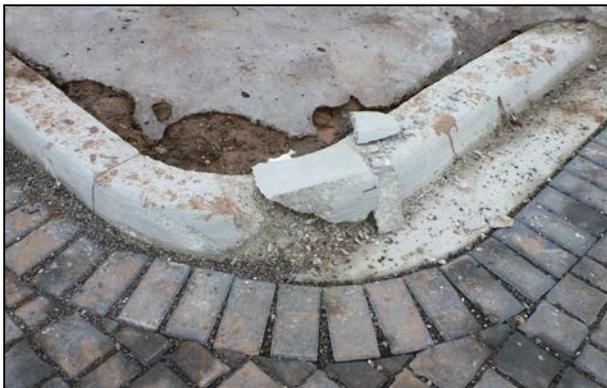
It was a challenge for the contractor to perform maintenance operations such as ploughing. Curbs were not clearly visible to the contractor which resulted in curb damage (Figure 44) and replacement. To address this issue, the project team installed marked stakes by the curb line to inform the contractor when ploughing.

Figure 44: Curb damage due to snow ploughing.

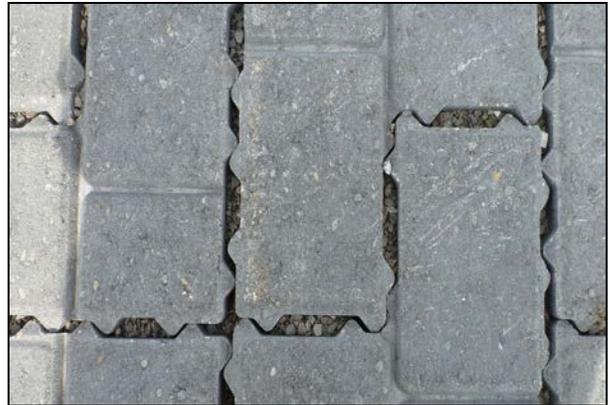
The steel plough used by the contractor scraped the surface of the permeable pavement (Figure 45). Rubber edging was installed on the steel plough to prevent further damage.

Figure 45: Paver scraped by winter plough.

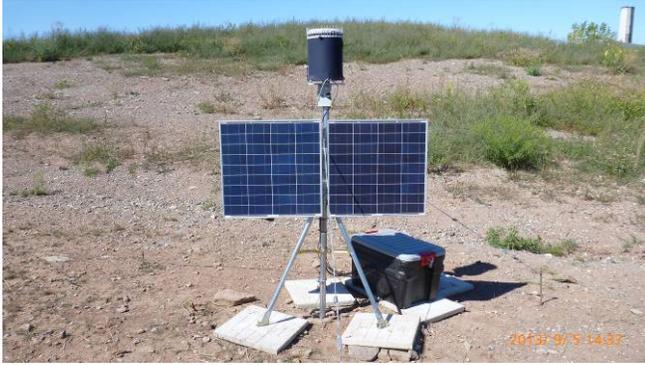
rain gauge was selected and installed on site to collect precipitation data (Figure 46). Precipitation data is logged at a five-minute interval.

Figure 46: Heated rain gauge installed on-site.

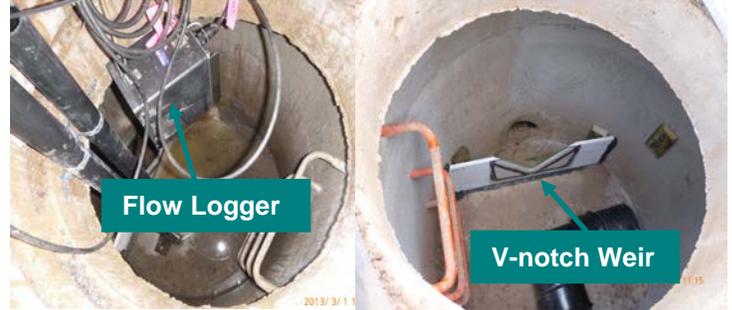
Figure 47: Water quantity monitoring set-up.

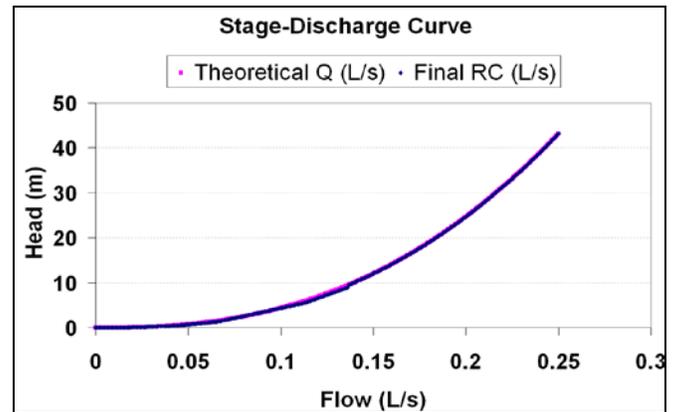
Figure 48: Stage discharge curve from IMAX

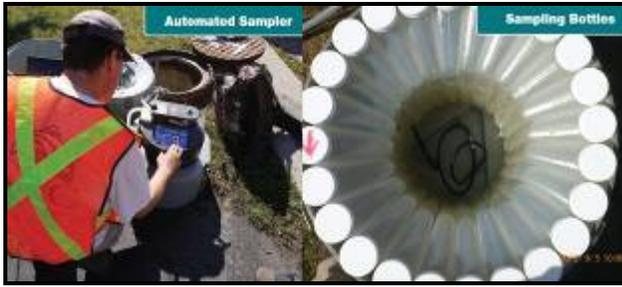
Figure 49: Water quality sampling.

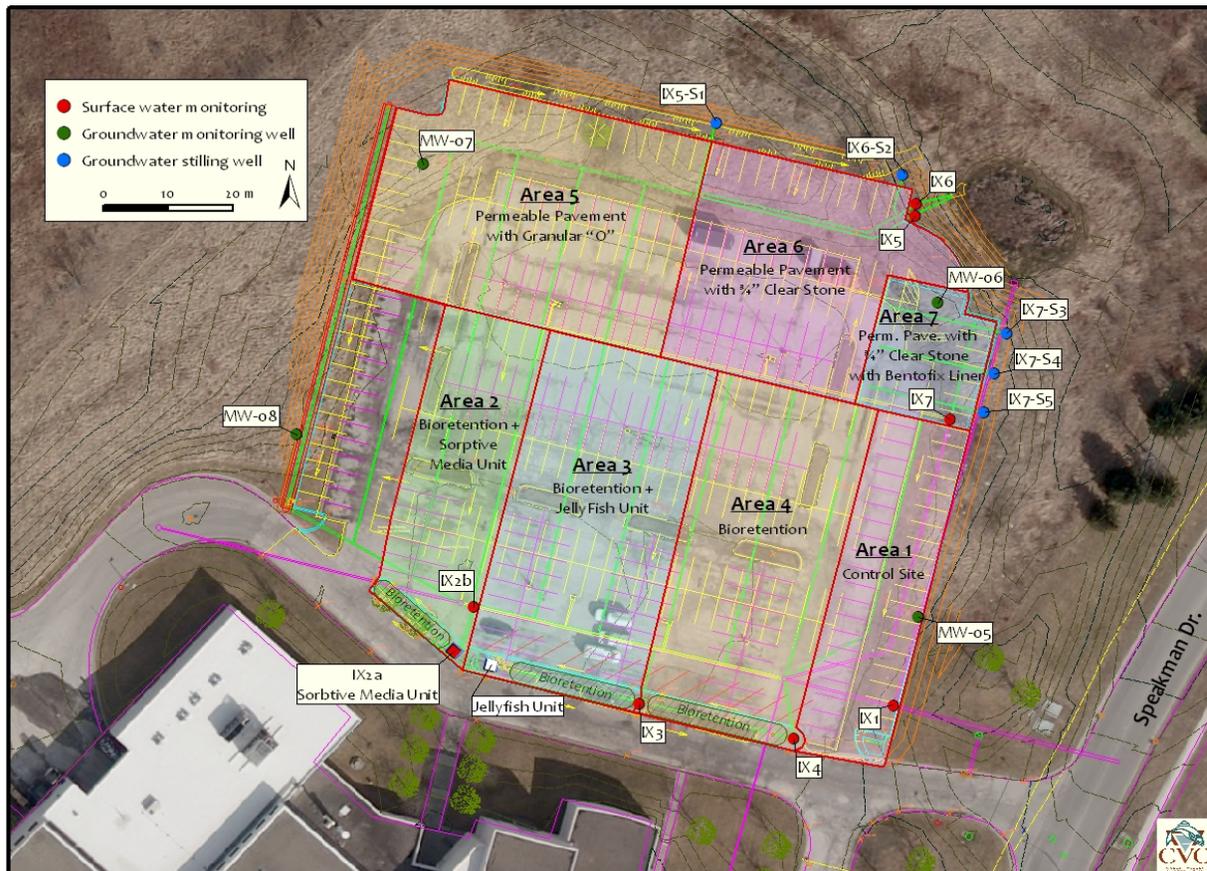
Figure 50: Retrofit IMAX parking lot, LID systems and monitoring stations.

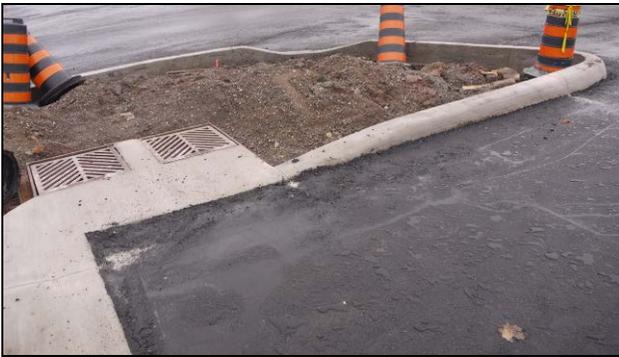
Figure 51: Control Site Receiver– Twin Catch Basin

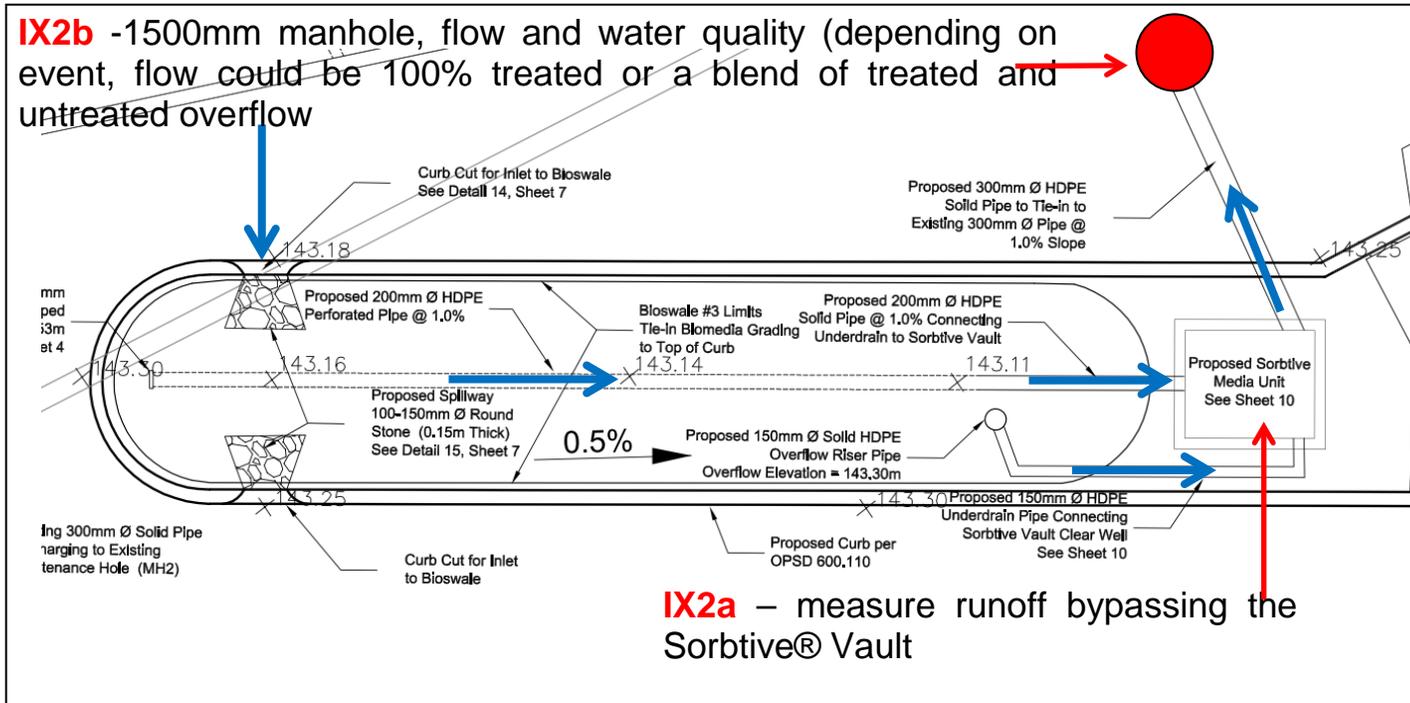
Figure 52: Bioswale Cell 1 Layout (Aquafor Beech, 2012).

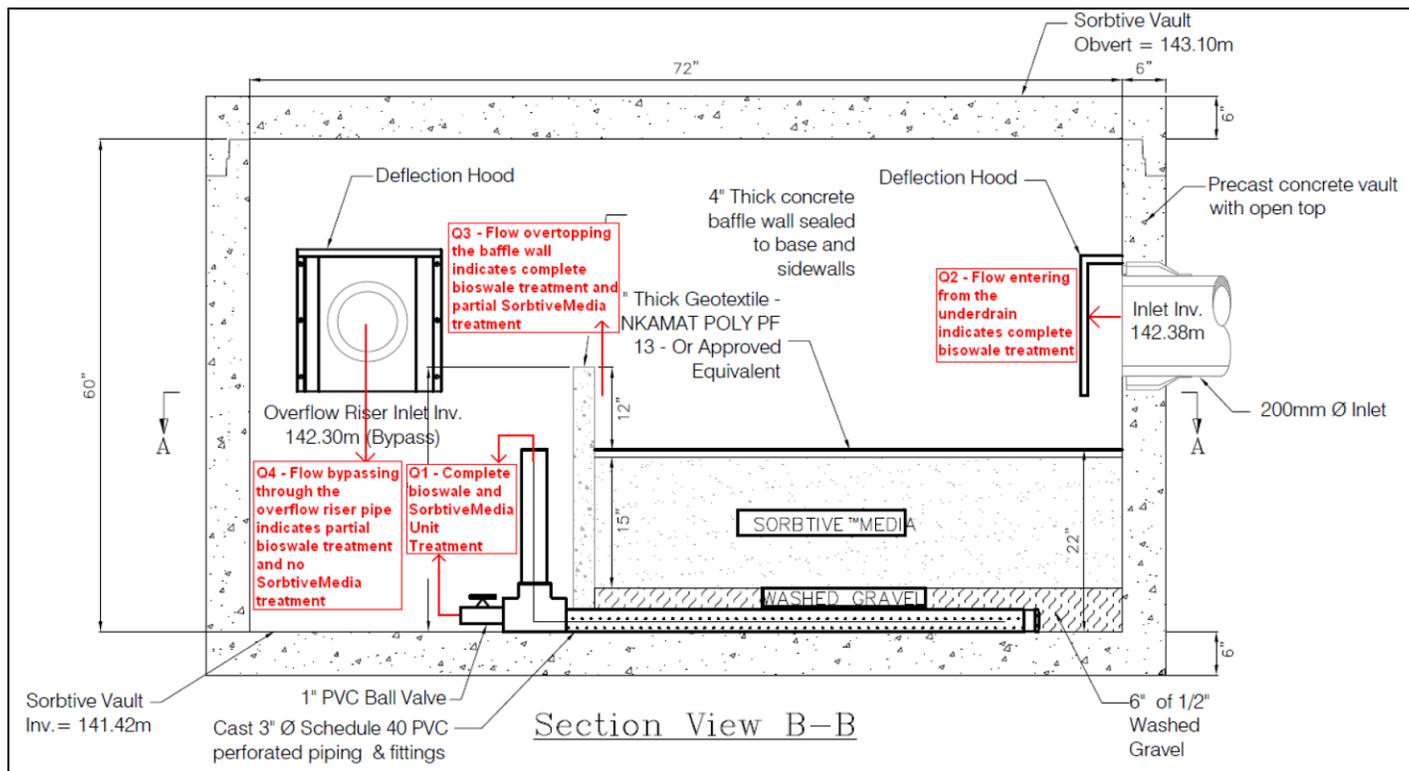
Figure 53: Sorbtive Media Bypass (Aquafor Beech, 2012).

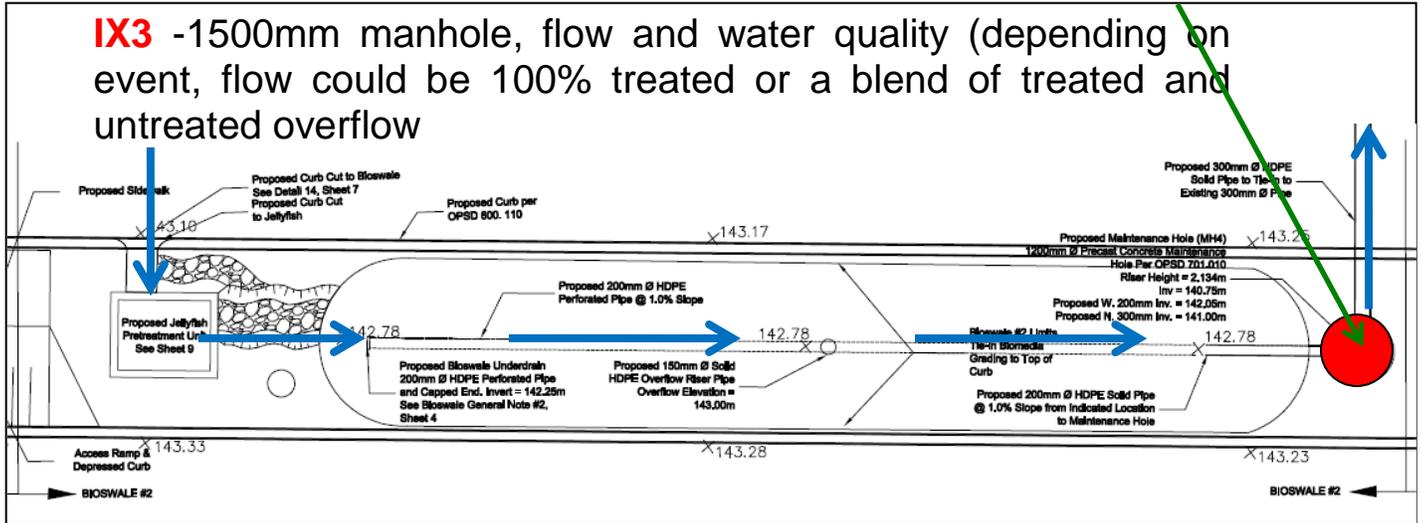
Figure 54: Bioswale Cell 2 layout (Aquafor Beech, 2012).

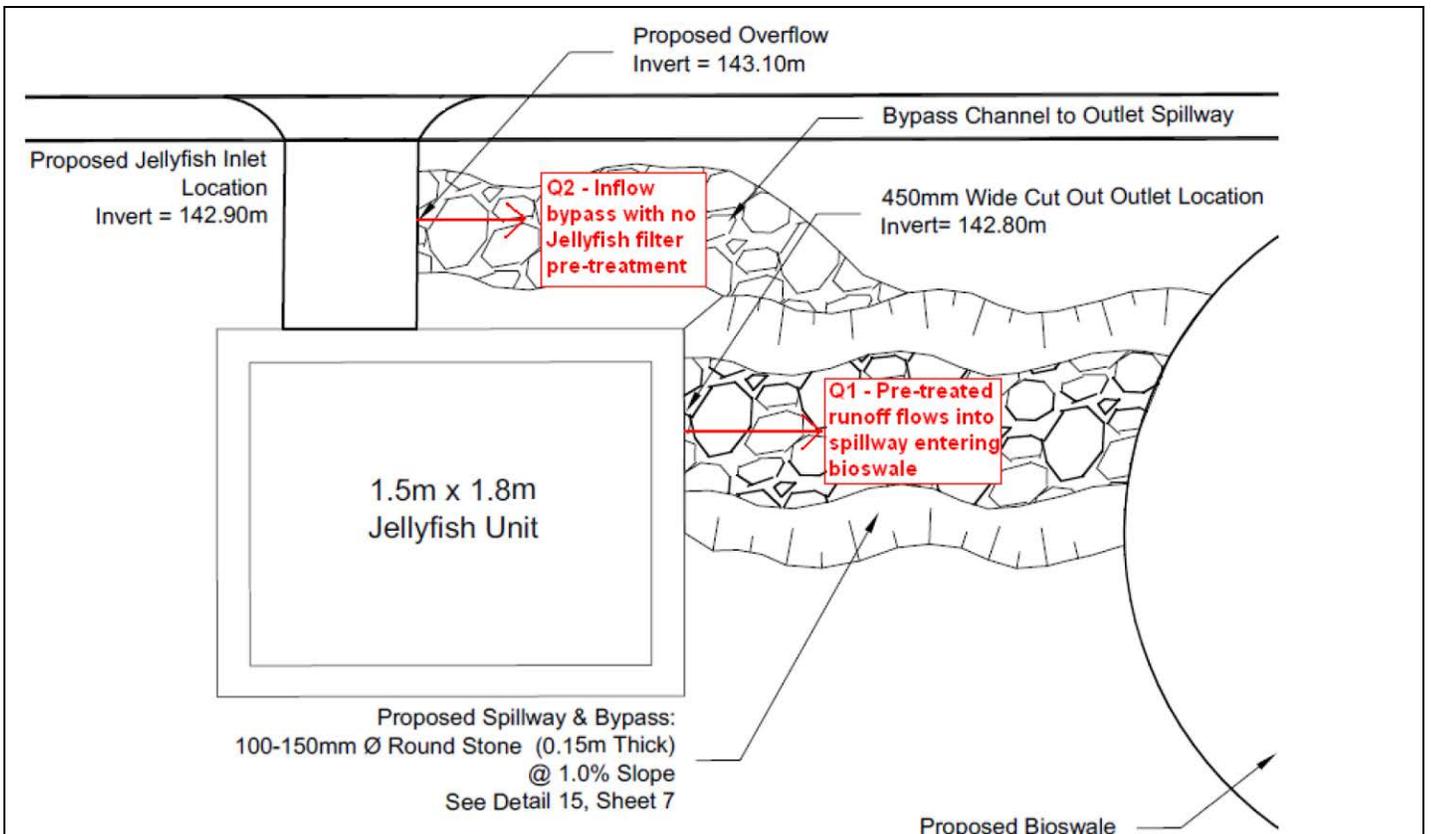
Figure 55: Jellyfish® Filter bypass.

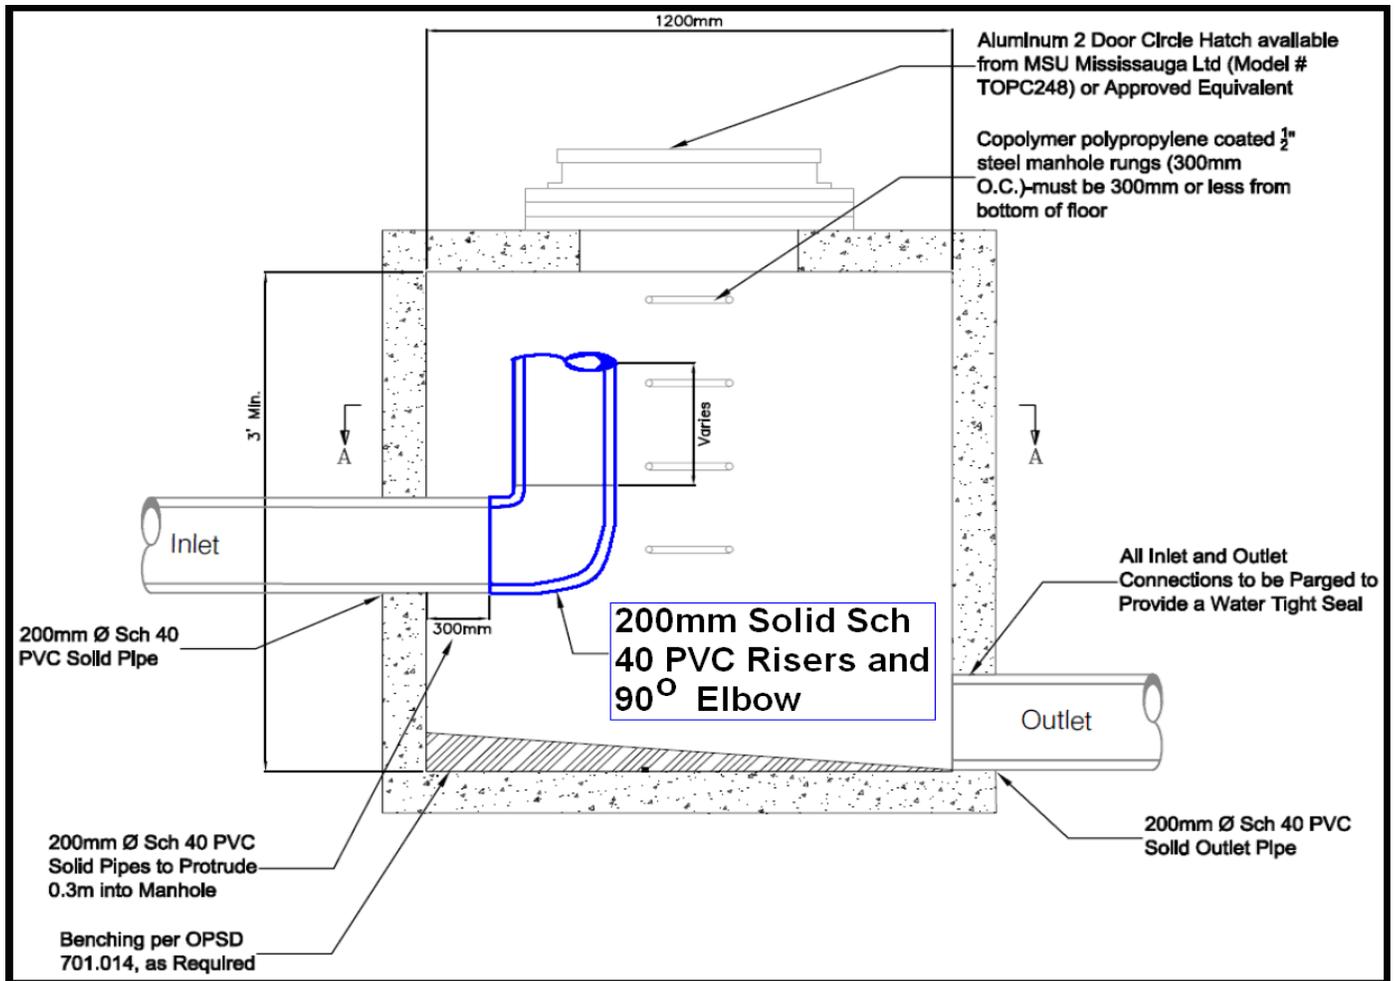
Figure 57: Moveable 90° elbows (Aquafor Beech, 2012).
