IMAX Parking Lot Retrofit

Location: Mississauga
Constructed: 2013

Project Objectives, Design and Performance

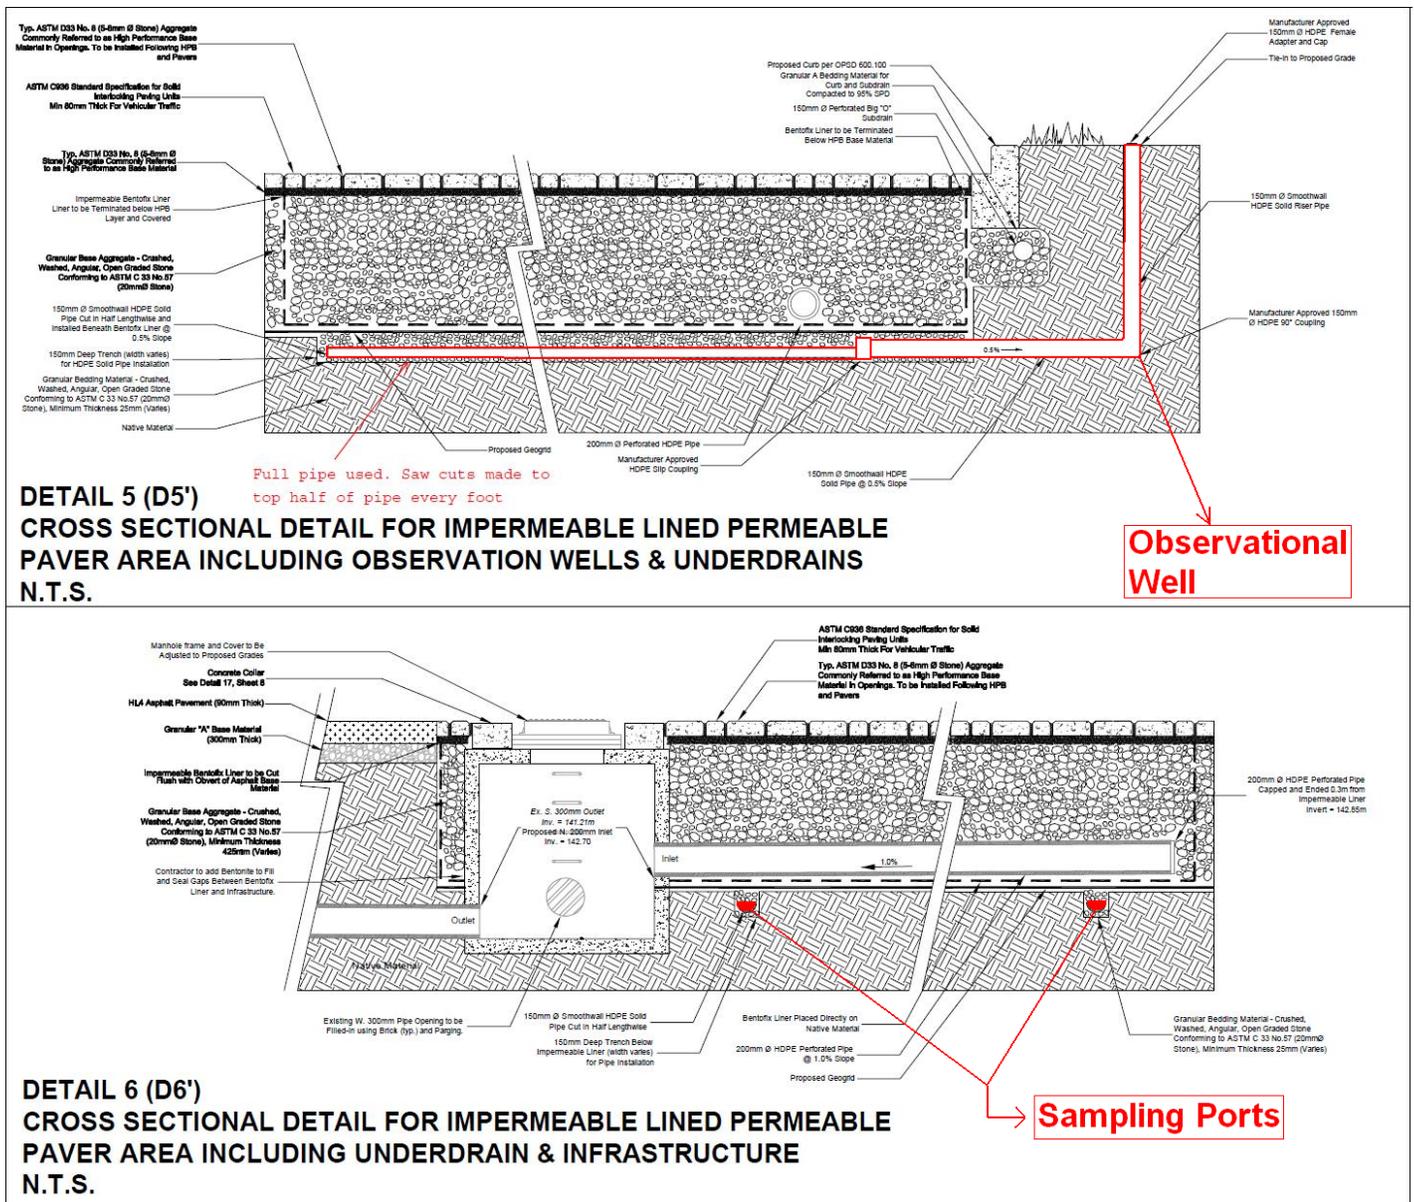
Figure 58: Sampling ports and observational wells for subcatchment 7 (Aquafor Beech, 2012).

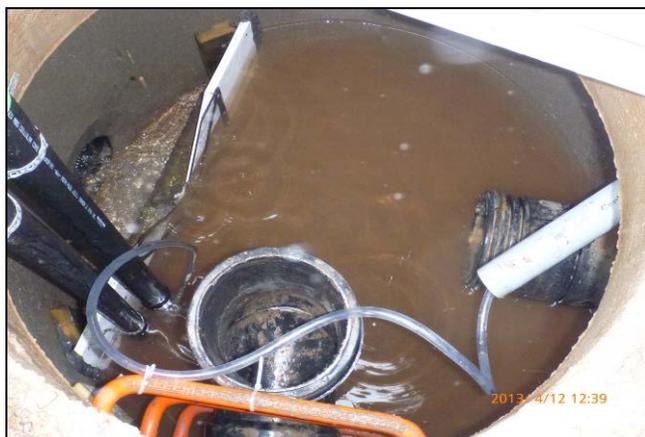
Figure 59: IX-5 – weir structure.

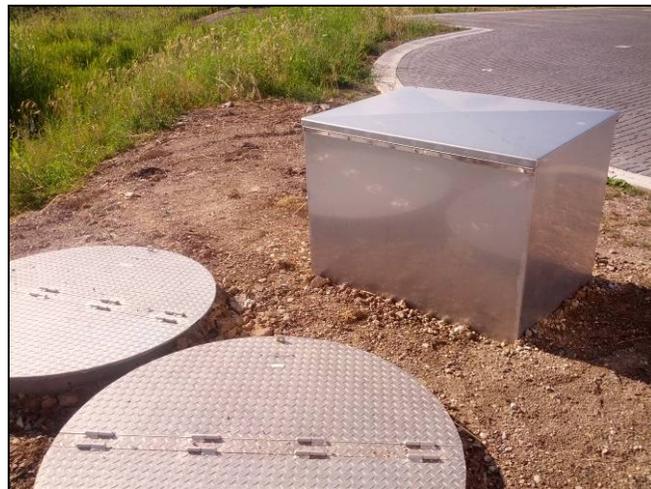
Figure 60: Steel box to accommodate Autosamplers.

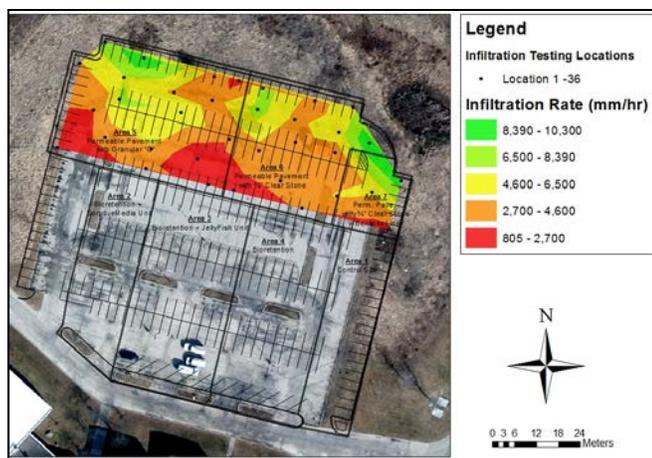
Figure 61: Infiltration rate contour map.
