# Belfountain Dam and Headpond Class Environmental Assessment

September 22, 2015

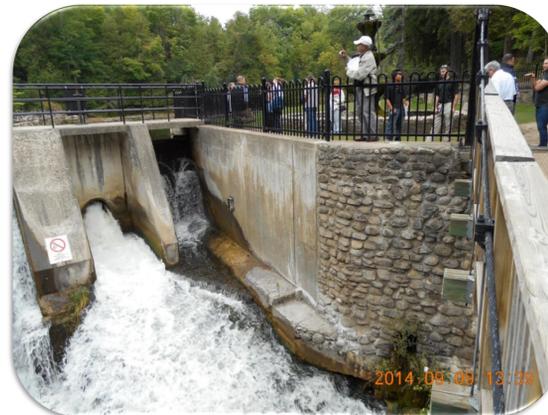
- Dam Stability: certain components of the dam do not meet Provincial factors of safety – a factor of safety is a measure to ensure the structural loads the dam can withstand are greater than those they are likely to experience
- Retaining Wall Stability: The north retaining wall is unstable during flood or flood-earthquake combined conditions. Mitigation will be required if the dam is proposed to remain.
- Dam/Retaining Wall Condition: the dam structure and retaining walls are in overall “good” condition with localized “poor” areas of concrete and undermined areas that will require rehabilitation

Dam outlet and north retaining wall

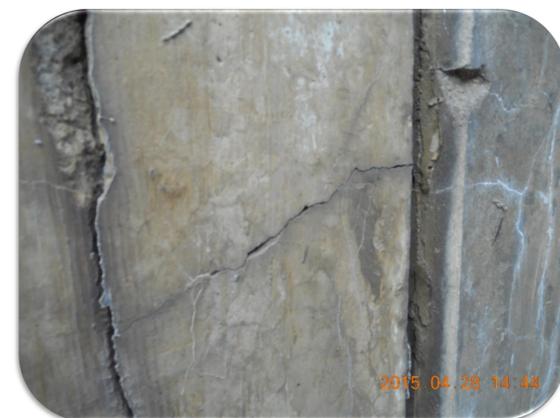
Concrete deterioration

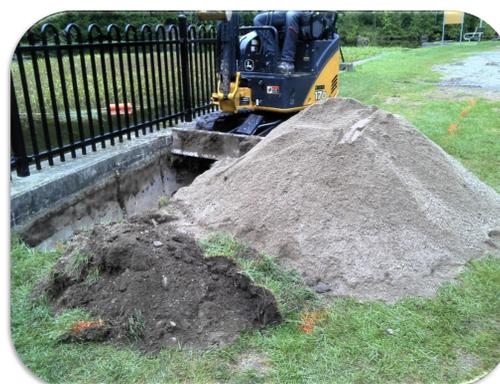
- The geotechnical investigation relates to area soils and slope stability:
  - Test pits have been completed to obtain information on the retaining wall backfill
  - A review of the south valley wall will be completed to determine slope stability

Test pitting behind north retaining wall

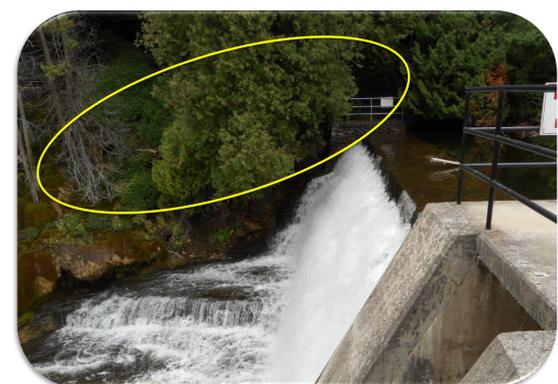
South valley slope

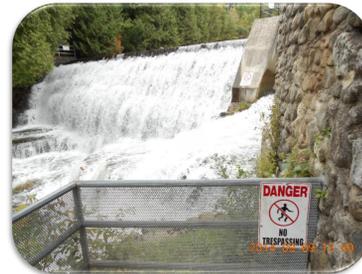
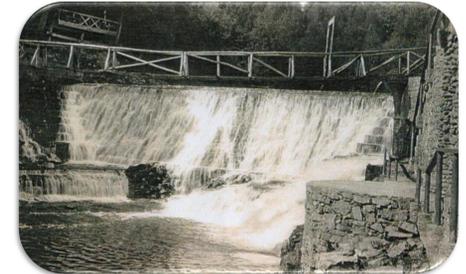
The dam could be repaired, replaced or lowered. It could look as it does today, or be restored to a condition more similar to the original

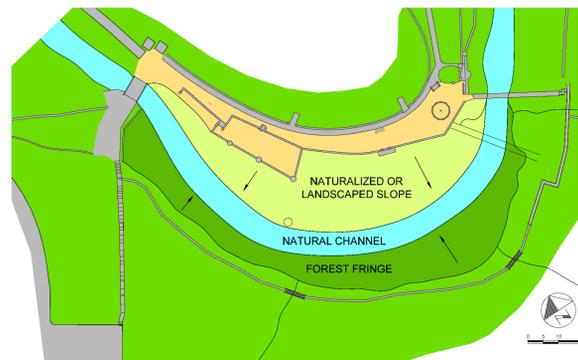
DECOMMISSION DAM, NATURALIZE RIVER

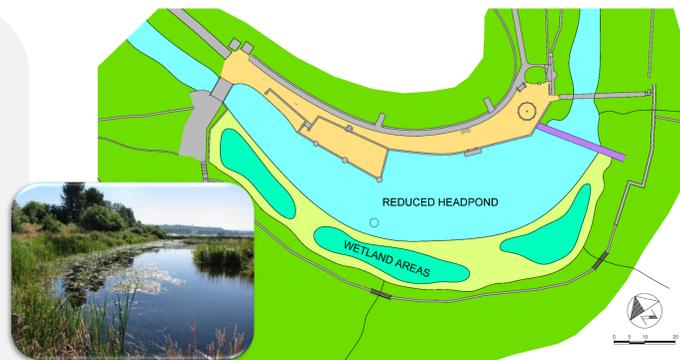
CONVERT PORTION OF HEADPOND TO WETLAND AREAS

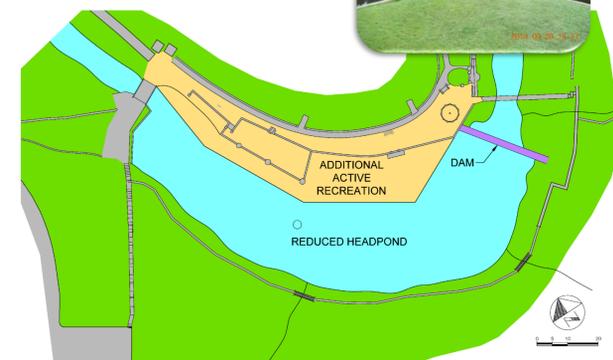
EXPAND TABLE LAND

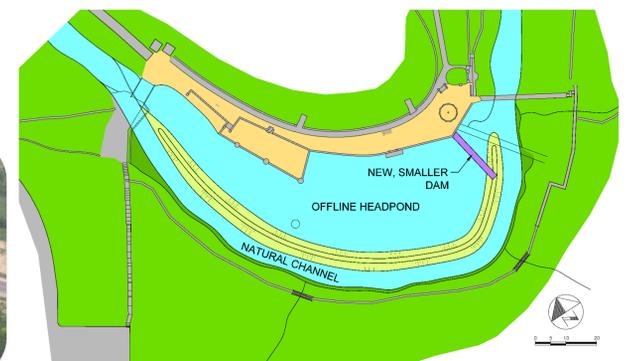
OFFLINE DAM, NATURAL CHANNEL
