Unitarian Congregation

Location: Mississauga
 Constructed: 2011

Project Overview

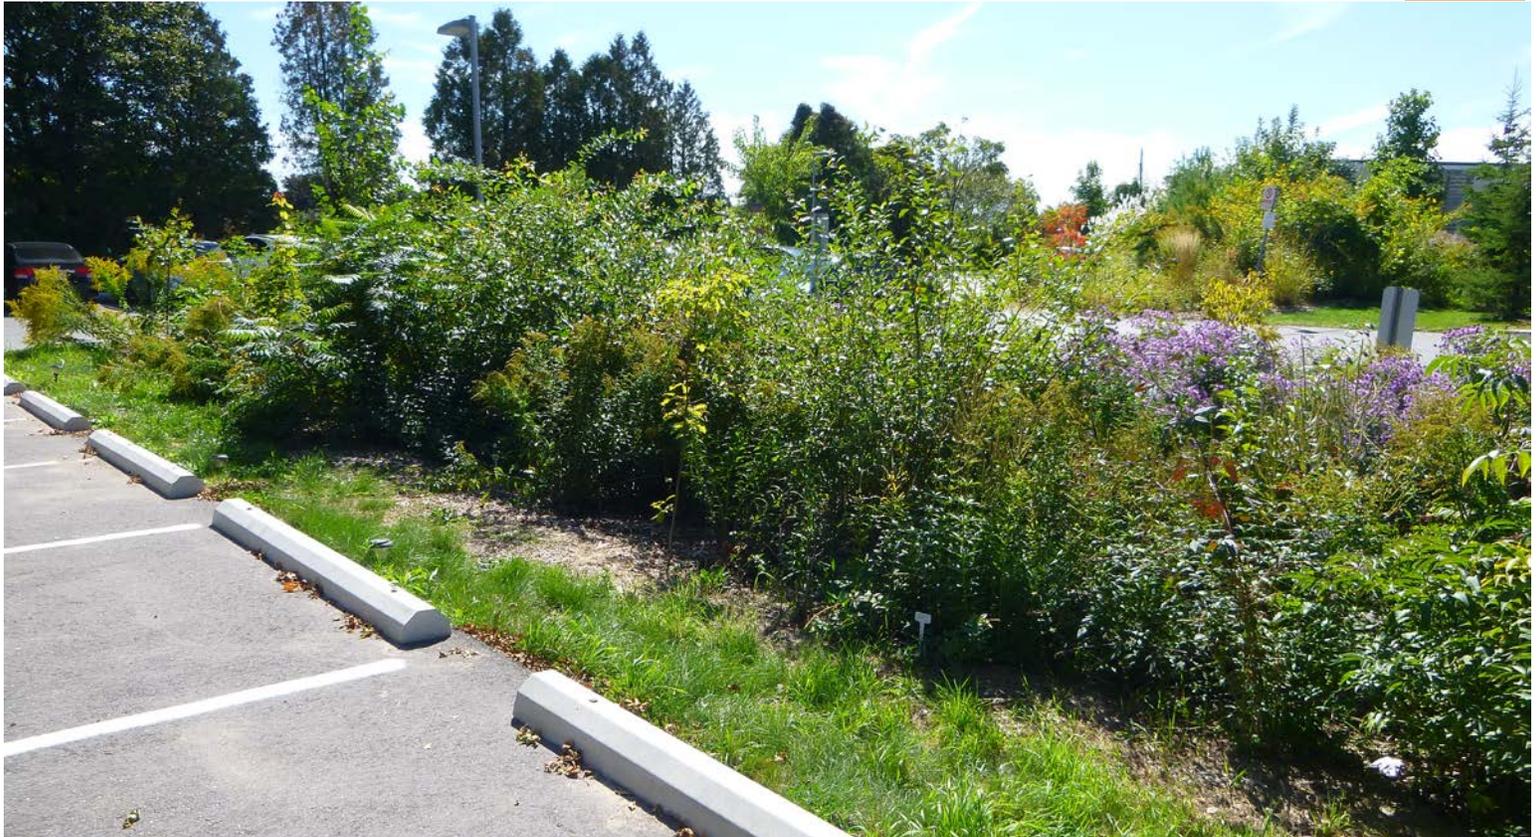
The Unitarian Congregation of Mississauga (UCM) features a bioswale (rain garden) which has been planted with all perennial native species to attract pollinators and birds. CVC, in partnership with the City of Mississauga, is evaluating the performance of the bioswale.

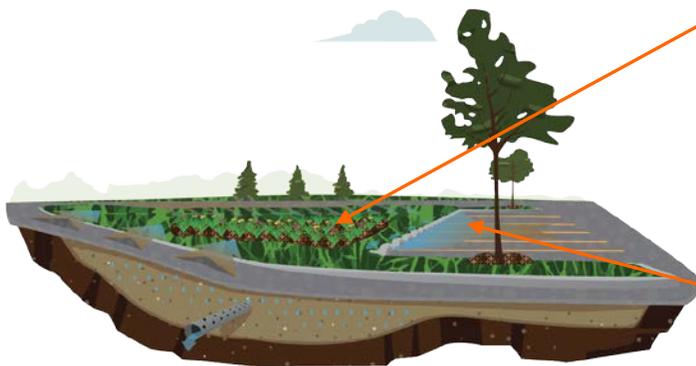
naturally clear water drains directly to the Credit River

The bioswale collects stormwater run-off from the parking lot and cleans the water through a compost amended native soil mixture and selected vegetation. In the bioswale, the interaction of plants, soil and natural microbes remove pollutants to improve the quality of water flowing back into Lake Ontario – our drinking water source.

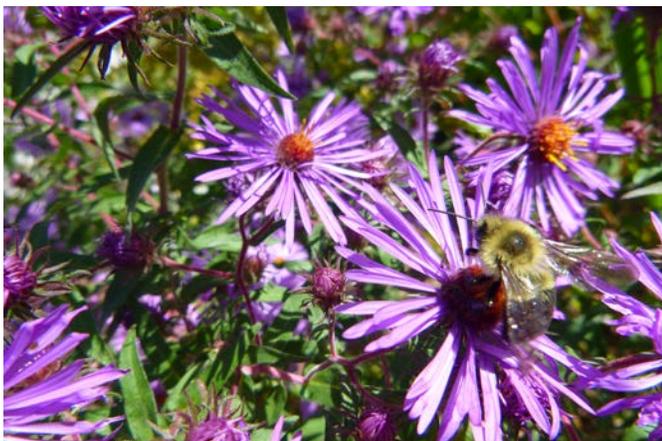
Infrastructure Assessment

As part of CVC's Infrastructure Performance and Risk Assessment Project, the performance of the UCM rain garden is being evaluated. This assessment will help to provide municipalities and property managers with the information and tools they need to ensure that LID practices on their property are working properly.

Landscaping – the bioswale landscaping consists of many different native shrubs, plants and trees. The plants have had four years to establish and have been found to thrive.

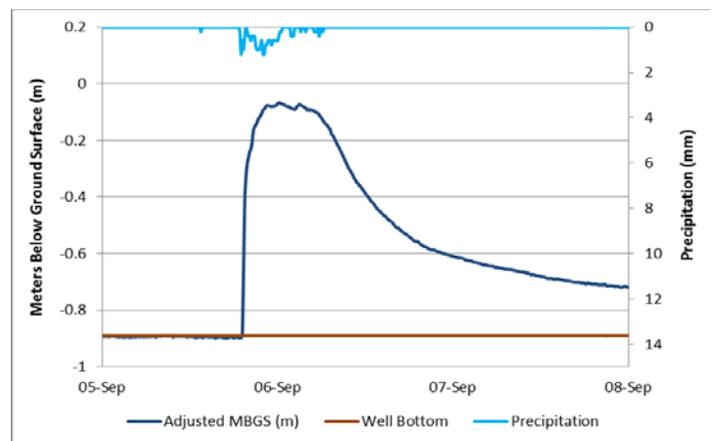
Performance – Analysis of water level data collected from 2013 to 2014 indicates that the bioswale is performing well and functions within the design parameters. Any ponding of water that occurs on the surface is able to soak into the bioswale within 24 hours. The figure below shows that stormwater was able to fully leave the bioswale and soak into the surrounding native soils in September 2014, as the monitoring well was dry. As precipitation fell during a storm, all of the stormwater was infiltrated into the system and there was no evidence of ponding, although the storm totaled 25 mm.

Precipitation event and measured water level in September 2014
