Showcasing Water Innovation
O'Connor Park
July 2013 Monitoring Update

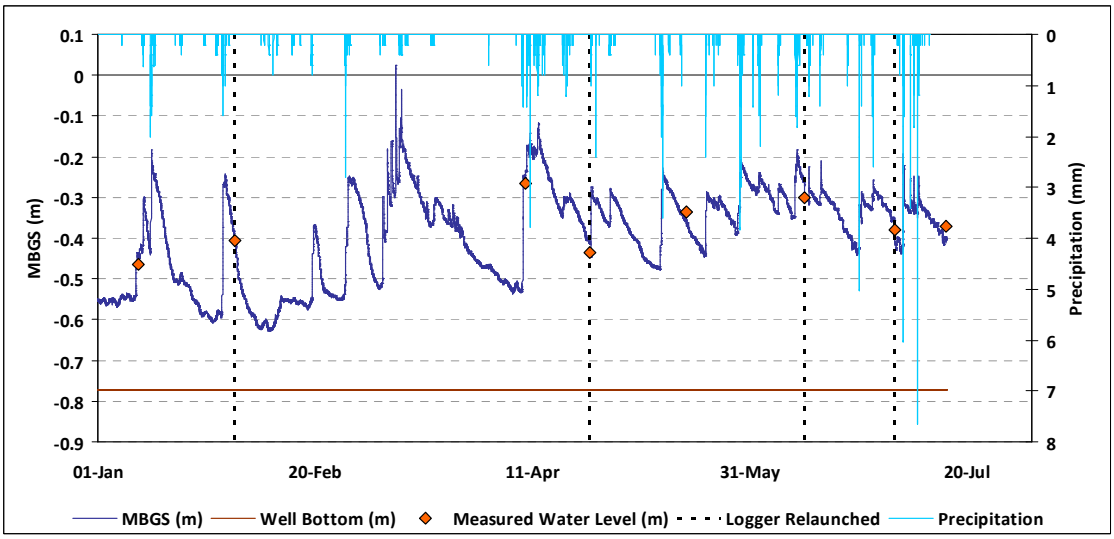
- **Water Levels -** Initial results have shown that the rain garden is functioning as designed. The garden is not designed to have surface ponding, but it may hold rainwater in the sandy soil until it has had time to soak into the silty clay or less porous native soil below.

Figure 1. Graph showing O'Connor Park's parking lot rain garden water levels and precipitation from January 2013 to early July.
