Terra Cotta Conservation Area Rain Garden

Location: Town of Caledon

Constructed: 2011

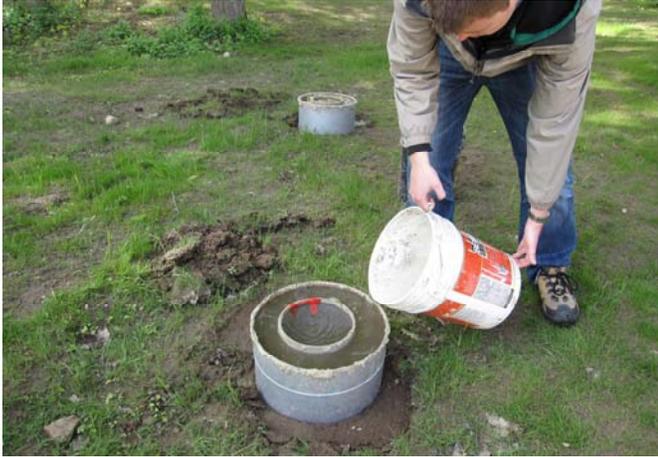
A closer evaluation of the preferred rain garden location was completed by the project team. They found shallow bedrock within 1-2 meters. The soil was found to be sandy clay loam/ clay loam. Sandy soils are ideal for well draining rain gardens while clay soils require significant amendments and must be sized larger. The soils at Terra Cotta are in between and would need some amendments of compost to function well. A double ring infiltration test was performed to determine an accurate infiltration rate (14 mm/hr) of the native soils.

CVC staff completes a double ring infiltrometer test

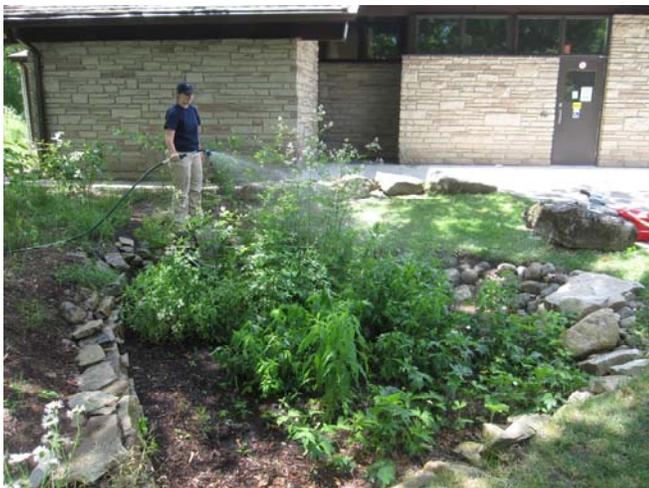
Conservation areas staff waters the rain garden at Terra Cotta

The rain garden at Terra Cotta is operating as expected. For the most part, plants are establishing well. The rain garden has experienced some die back, caused by shady site conditions. A large tree next to the rain garden affected growth more than was expected. In the summer of 2013, additional native shade-tolerant plants were added to the garden, including common elderberry, sensitive fern and heart-leaved aster. They were planted by CVC's Conservation Youth Corps, a volunteer environmental education program for high school students.

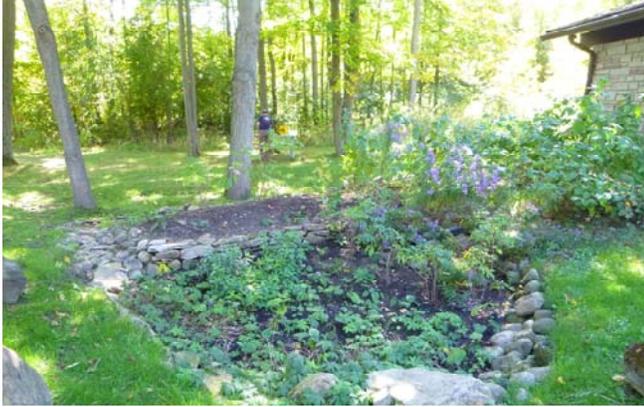
This LID Checklist Inspection photos is included in the photo log. It helps to track site progress and maintenance needs over time.
