# Appendix C

Case Studies

# Elm Drive

## Road Right-of-Way Retrofit

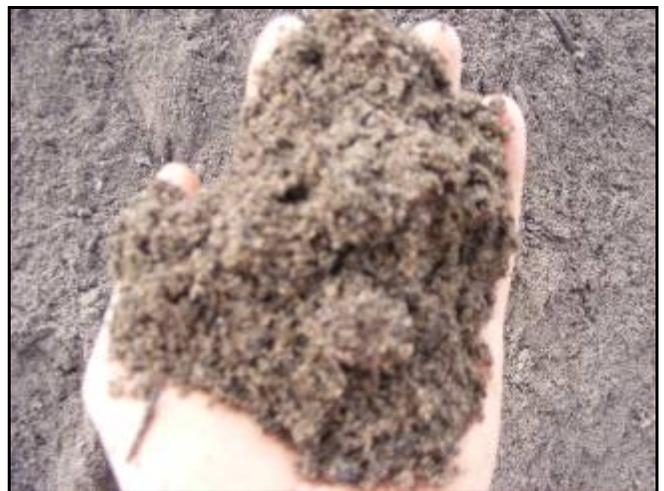
Figure 38: Bioretention soil media consisting primarily of sand and organic material.

A two-point hydrometer test determined the soil textures of the sampled bioretention soil media and categorized the sample into percentages of sand, silt and clay. The test has a minimum detection limited of 2% for each particle size analyzed. The first samples submitted demonstrated 12% clay material and <2% silts which bordered on failure. A second sample was requested to verify manufacturing consistency and determine if the percentage of fines can be reduced. It is preferable to have bioretention soil media samples that demonstrate fine percentages closer to the low end of the acceptable range. The processes of loading, transporting and handling bioretention soil media material can often result in an increase in percent fines by the time the bioretention soil media is installed. Soils high in fines can be easily clog and reduce drawdown times. Clogging will negatively impact the effectiveness of the LID practice.

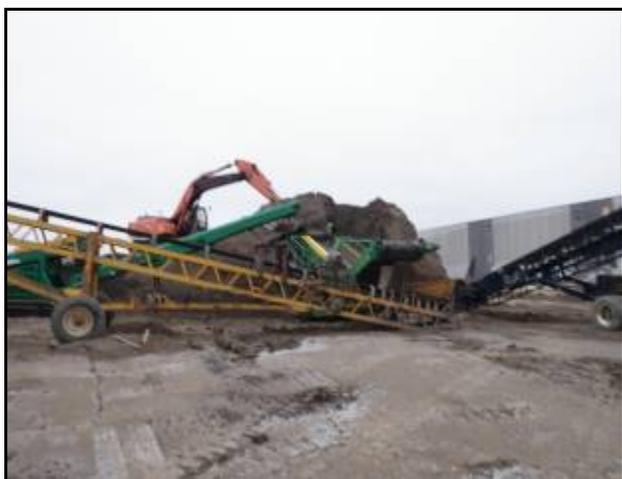
Figure 39: Mechanically mixing process for bioretention soil media manufacturing.

The second sample failed to meet specifications. This failure was the result of a miscommunication between the soil manufacturer and the personnel at the sourcing yard responsible for mixing the correction materials. To ensure the proper materials were used for the submission of the third sample, field engineers and soil manufacturer met at the mixing yard to verify the raw materials and to observe the mixing operations. Three samples were again collected during the mixing of the bioretention soil media and submitted for analysis. Although the bioretention soil media was marginally low in organics, the sample was accepted as fine percentages were optimal and natural process from landscape material would increase organic percentage over time.

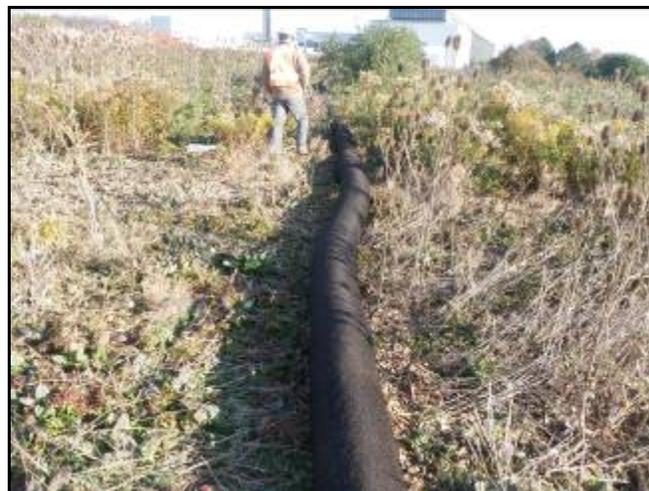
Figure 40: Filter sock installed to protect wetland.

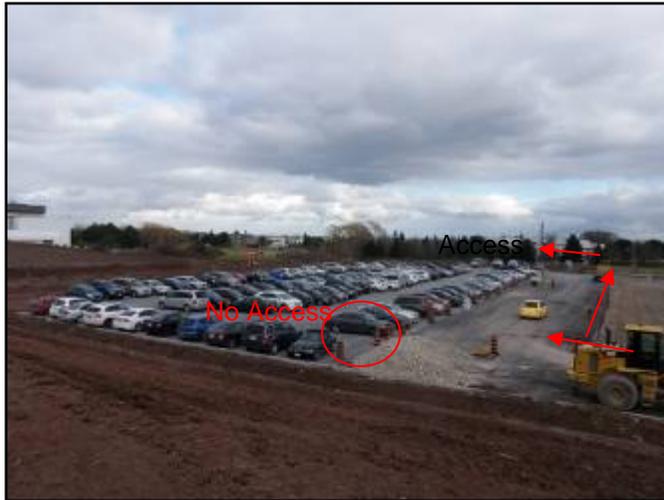
The most difficult ESC operation was controlling the amount of sediment deposited on the permeable pavers once they were designated as the primary parking area. During the construction of the asphalt areas, vehicular traffic had to travel over open aggregate to access the permeable pavers for parking. Through discussions between CVC, the contractor, and construction supervisor, it was decided vehicles would be diverted over washed clearstone and a temporary asphalt access strip prior to accessing the permeable pavers. Access to the permeable pavers was limited to a single

Figure 41: Access route to permeable pavement.

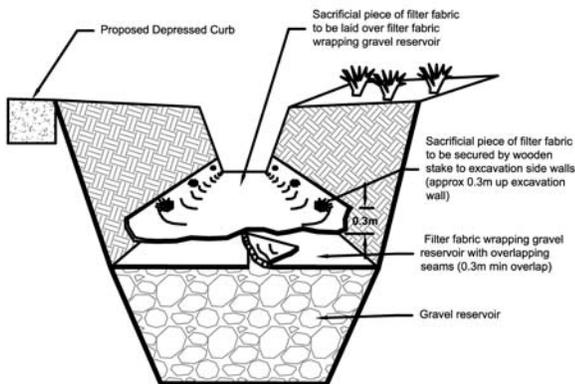
Prior to the installation of the bioretention soil media and paving of the asphalt parking areas, sediment socks and sacrificial pieces of filter cloth were installed to protect the bioswale infrastructure from contamination. Sacrificial pieces of filter cloth were installed over the cloth-wrapped clearstone reservoir of the bioswales. Prior to the installation of the bioretention soil media; this filter cloth was removed and included any captured contaminating fines. Figure 42 shows how the filter cloth was used.

Figure 42: Conceptual of the sacrificial piece of filter cloth used to protect bioswales.

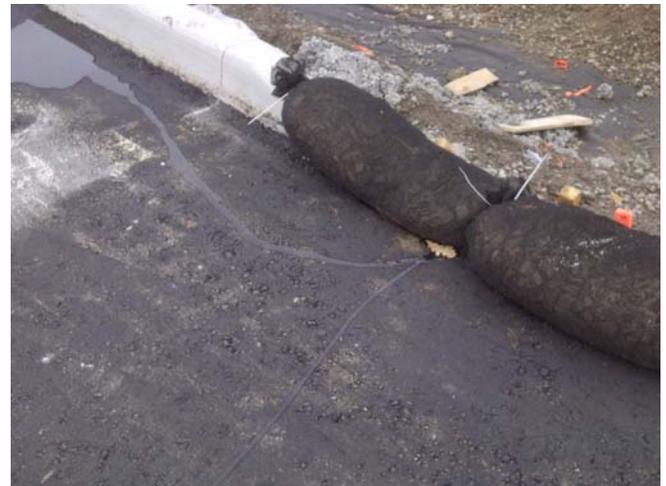
Filter socks were staked in place at the bioswale curb cut to prevent sediment laden runoff from entering the bioswales. These measures were removed once the bioretention soil media was installed and asphalt areas were stabilized.

Figure 43: Sediment socks installed at bioswale curb cuts.

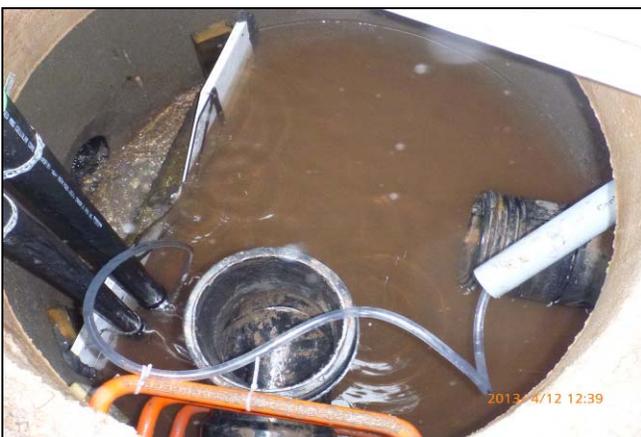
This criterion was met for all the monitoring stations except for the permeable pavement monitoring locations IX-5 and IX-6. In addition, being adjacent to the man-made wetland, concerns regarding the risk of backwatering and inundation of the monitoring equipment were considered.

Figure 59: IX-5 – weir structure.

To address this issue, the manholes were made as shallow as possible to avoid backwater affect from the wetland and accommodate the weir structure at the

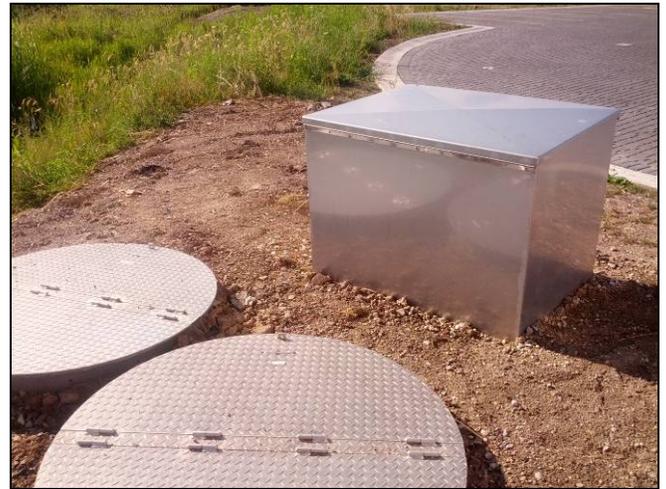
Figure 60: Steel box to accommodate Autosamplers.

same time (installations which include only the weir require a mere four feet of clearance). The Autosamplers were placed in an above ground steel box (Figure 60) in a low traffic landscaped area near the wetland posing no obstructions on the daily use of the parking lot.

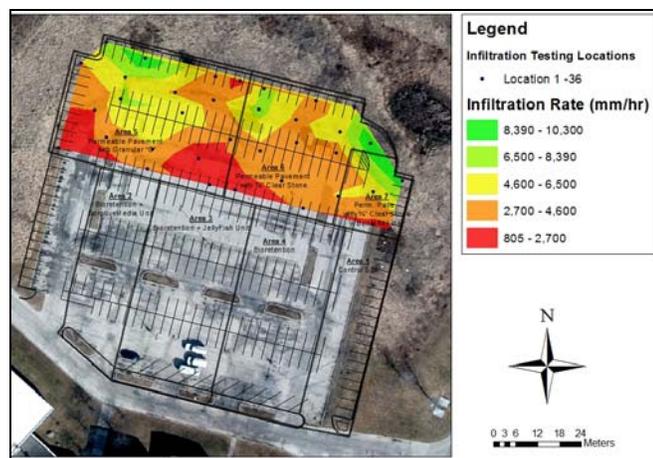
Figure 61: Infiltration rate contour map.

High-traffic areas within permeable pavement parking lots, such as laneways, typically have lower infiltration rates than low traffic areas, such as parking stalls. The highest average infiltration rate based on parking area location was found, as expected, within the centre of the parking stalls with an average of 5334.0 mm/hr. The lowest average infiltration rate based on parking area location, however, is located on the lines dividing parking spaces. The average infiltration rate in these areas is 3735.1 mm/hr. This is likely due to the build-up of sediment along the lines that washes off of vehicles within the parking spaces, as well as due to the accumulation of debris left in these areas by people entering or leaving their vehicles. The average infiltration rate for laneways fell between those for parking stalls and paints lines, with an average of 4499.1 mm/hr. Infiltration rates within laneways, however, varied significantly; both the lowest (804.5 mm/hr) and highest (10288.8 mm/hr) individual infiltration rates were found in laneways. The lower infiltration rates within the laneways are located in the entrances to the permeable pavement area as well as in the row closest to the entrance to the building. This
