# Green Glade Sr. Public School Rain Garden Retrofit

Location: Mississauga  
Constructed: 2011

### Project Objectives, Design & Performance

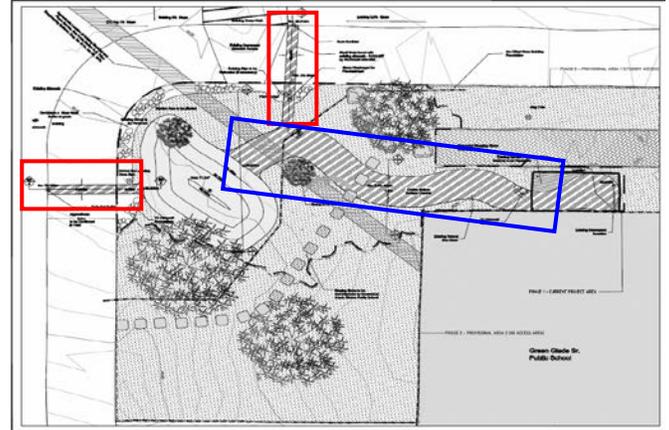
Rain garden site plan

To address the ponding issue along the front walkway the curb and walkway was cut in two locations to provide an inlet and an outlet (outlined in red in the figure below). The design of the inlet cannot address the ponding issue completely. However, when the school's parking lot is resurfaced, the grade of the lot can be modified to direct more of the water into the rain garden inlet to further reduce any ponding. In addition, the rain garden design accounted for the roof top drainage which was directed to a dry river bed which then flowed into the depression (outlined in blue in the figure below).

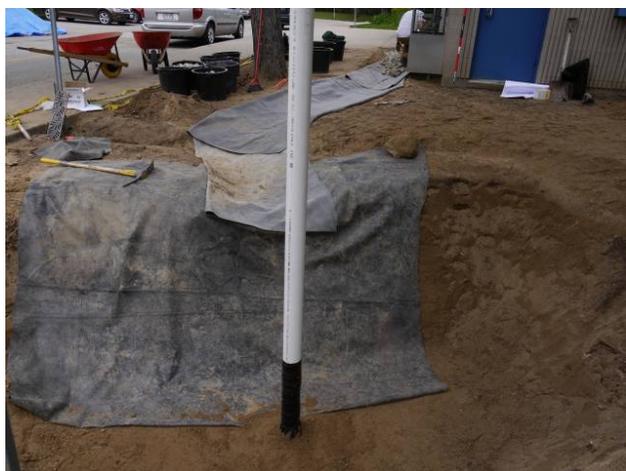
[Foreground]-observation well, [Background]-pond liner covering dry river bed and rear wall of the bioretention area
