Lakeside Park

Location: Mississauga
Constructed: 2012

Public Lands

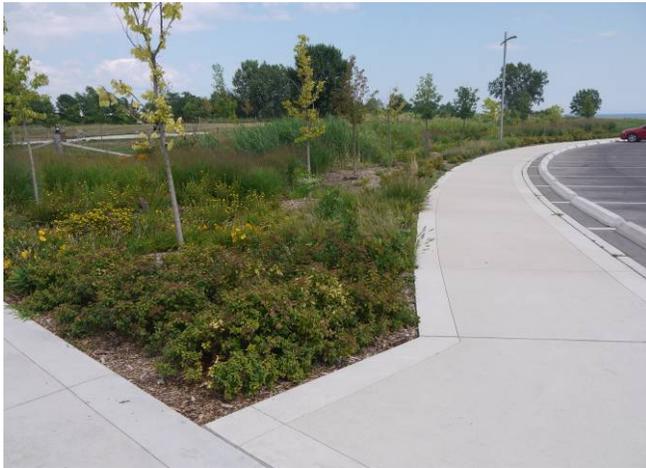
- Parking lot runoff flows over sidewalks to enter the bioswale which has resulted in some icy sidewalks in the winter requiring the use of de-icers. When designing LID practices, pedestrian and flow path conflicts should be considered.
- Implementation of LID helped preserve the natural environment while also adding aesthetic value to the park.
- Invasive species have been spotted within the bioswale and are suspected to be blowing in from neighbouring properties. Training maintenance staff to identify invasive species can help to prevent the spread of invasives plants.
- As the park included numerous innovative features, the City partnered closely with CVC and industry experts to ensure they were designed and constructed correctly.

Bioswale with adjacent sidewalk and parking lot

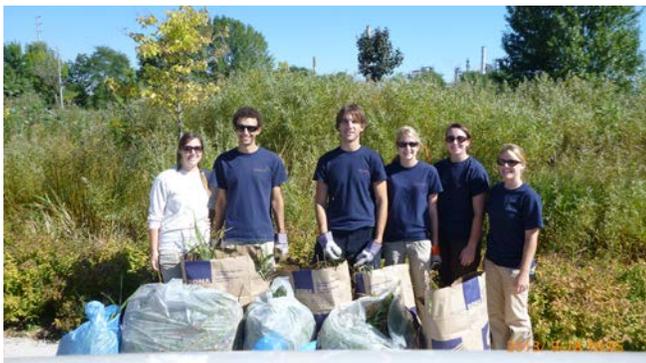
One issue that has been noted at Lakeside Park is the presence of two invasive species, European Reed Grass and Canada Thistle, within the bioswale. They are likely blowing in from the adjoining industrial sites. These invasive species pose a great risk to the establishment of native vegetation in the swale. CVC has assisted the City of Mississauga in identifying and removing these invasive species and replanting native species. Once the native plants in the bioswale are established, they should outcompete invasive species. Until then, CVC and the City of Mississauga must routinely monitor the bioswale for invasive species.

CVC monitoring crew after a day of weeding

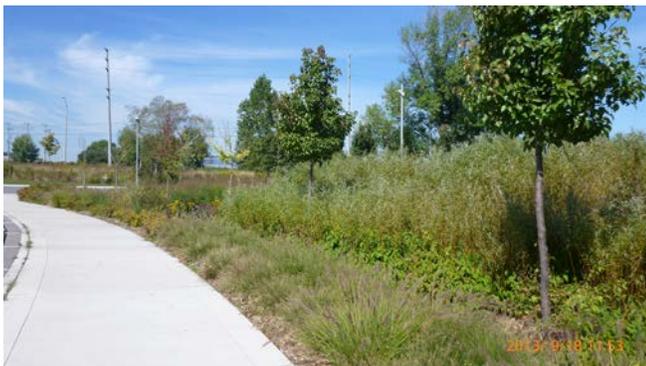
The plants are doing very well as they are now fully established. The plants have had three years to establish and are thriving. Most of the bioswale has filled in. The plants have no sign of salt damage despite the parking lot and sidewalks being heavily salted throughout the winter. Some adaptive landscaping is necessary. The upstream portion of the swale where most of the flow enters is often saturated. Several Hackberry trees are dying or stressed and scheduled to be replaced with more flood tolerant trees such as Red Maple. One planted species, Sandbar Willow, is a native species that is growing vigorously and is starting to take over the front of the bed and must be cut back periodically. As mentioned earlier, invasive species were taking over the landscape but about 95% of the European Reed Grass and Canada Thistle has been removed and their growth is being monitored. Overall, the bioswale landscaping has been well received by the general public.

Bioswale in September 2013

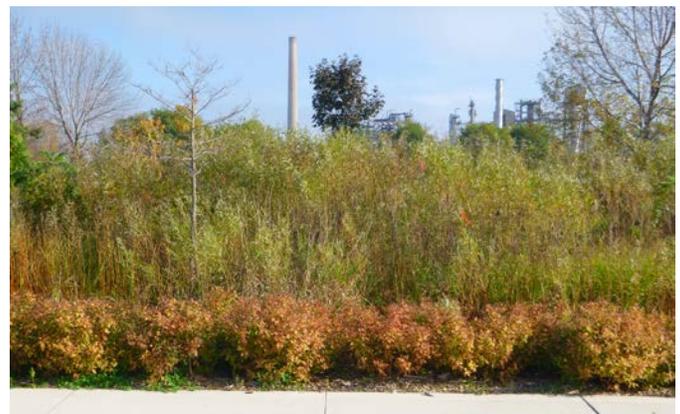
Assessment Item	Metric / Passing Threshold	Result	Pass / Fail
1. What percentage of the ground is covered?	80%	85%	Pass
2. What	5%	2%	Pass

percentage of plants is invasive/ undesirable?			
3. What percentage of planted species has died?	5%	3%	Pass
4. What percentage of the species is thriving?	80%	92%	Pass
5. Does the site meet aesthetic goals?	Yes	Yes	Pass

The landscaping assessments were conducted in September 2013 and overall, the site **passes** the vegetation survey protocol . The plants are thriving and are meeting the aesthetic goals as shown in the picture below

Bioswale showing fall colour towards the end of the growing season

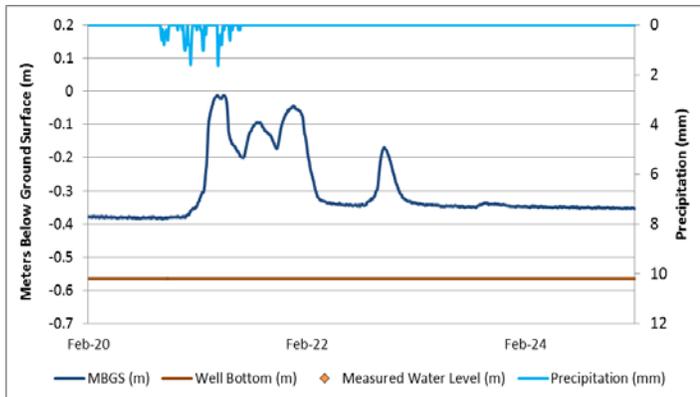
Assessment Item	Metric / Passing Threshold	Result	Pass / Fail
Average Drawdown time to Underdrain (hours)	24 hrs	8.6 hrs	Pass
Estimated Loss Rate at Surface	25 mm/hr	38.3 mm/hr	Pass

The following figure shows that the bioretention facility can still function in the winter when the ground is frozen. This event had a total of 24.2 mm of precipitation fall and the bioretention facility was able to infiltrate all the runoff received from the adjacent parking lot without ponding. Subsurface drawdown took place within the 48 hour threshold, demonstrating that bioretention facilities can still function in colder conditions.

Precipitation event and measured water level in February 2014
