Portico Community Church Parking Lot Retrofit

Location: Mississauga

Constructed: 2010-2012

Overview

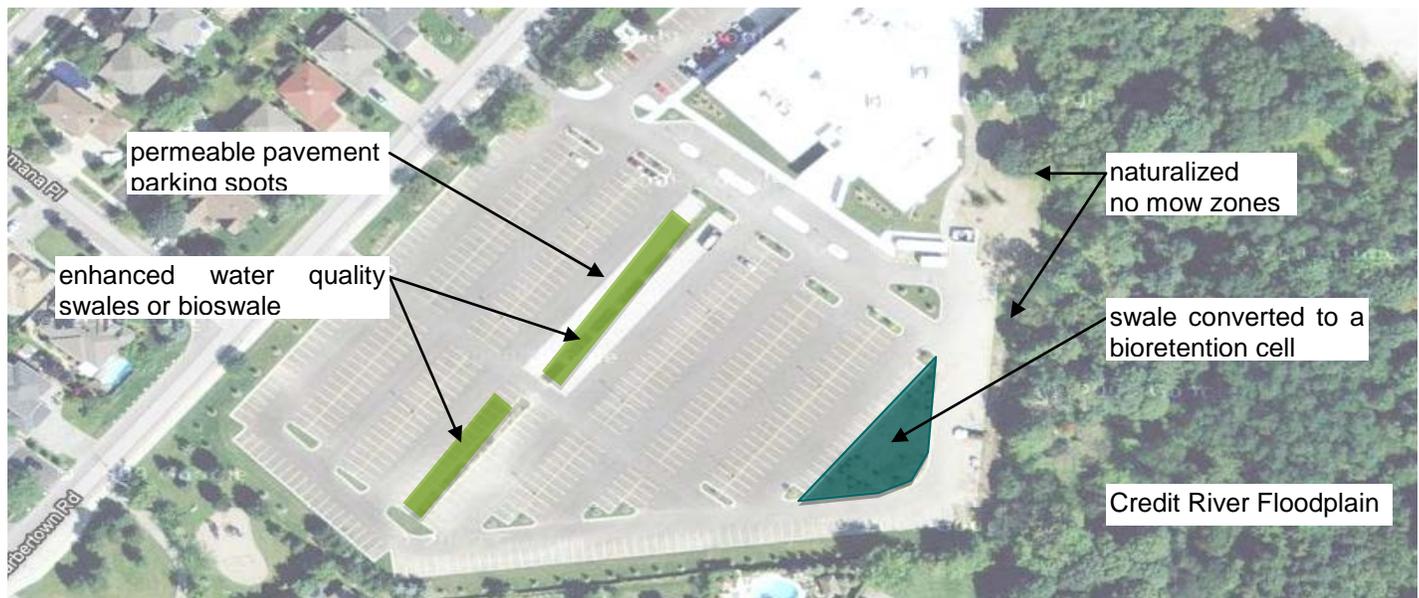
In June 2010 PORTICO contacted CVC to evaluate the swales and help to improve their appearance. The seed had not taken and the swales looked weedy and barren. The soil was also eroding and draining poorly.

The following year the native grasses did not come up as expected and weeds were taking over. CVC determined that likely causes were poor soils and runoff flows. The soils used were low in organic content and high in clay. The swale also had large runoff flows draining to it that could wash out seed before it had a chance to establish.

CVC worked with the site designer to find a solution that would re-landscape the swales and improve stormwater performance on site. The hard infrastructure, such as curb openings, catchbasins, and subdains, was functional and still useable. Only the plants and soils would need to be modified to make the practices work. The following actions were recommended by CVC and Dickinson & Hicks:

1. Replace soils and sod instead of seed in the long swales at the center of parking lot to make them **enhanced water quality swales or bioswales.**
2. Convert the swale in the triangular parking island to a **bioretention cell** through soil replacement, regrading and new landscaping.

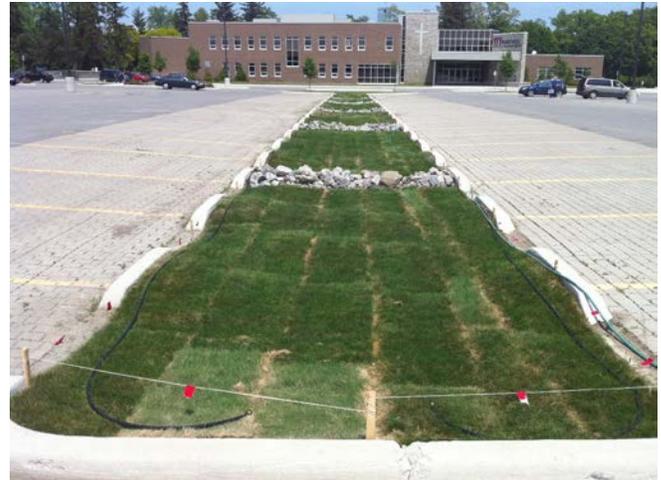
The above image shows the sod shortly after placement and the temporary soaker hoses used to water the sod during establishment.

Watering - The bioretention cell has an irrigation system around the edge that has consistently watered the cell during the establishment period. In 2013, the irrigation for the bioretention cell was turned off and will remain off except if the plants show drought stress. Temporary irrigation provided by perforated hoses was used to water the sod in the bioswale on a daily basis for the first two weeks and then periodically through the following hot, dry summer. Beyond that time, the deep-rooted sod has not needed watering.

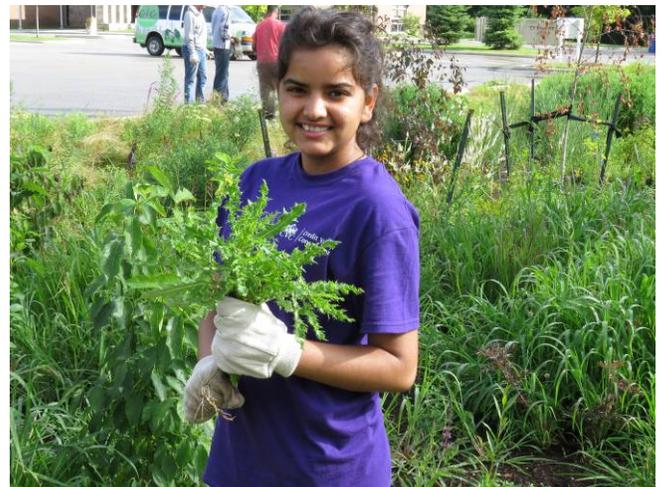
Weeding - The bioretention cell is large and it will take time for the desirable plants to fill in the space. In the meantime weeds, particularly lady's thumb and yellow nut sedge, continue to be a problem. Weeding is carried out about three to four times a season by CYC and PORTICO church volunteers.

Conservation Youth Corps volunteer removes weeds from PORTICO site in September 2012

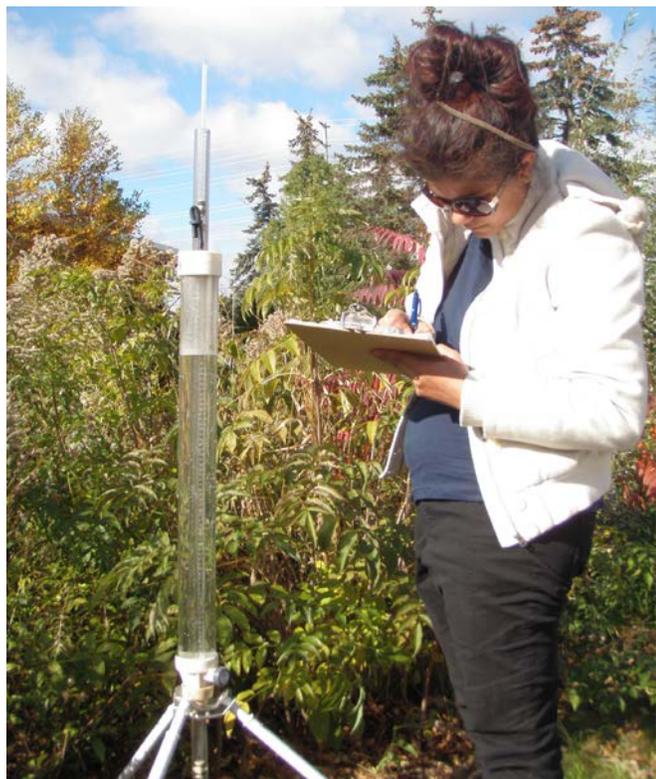
The tests were performed after a 24-hour dry period to ensure accurate results with no previous saturation. A total of three tests were performed on the bioretention soil bed. The infiltration rates were 118 mm/hr, 131 mm/hr and 158 mm/hr with an average of 122 mm/hr. The infiltration results coincide with the soil analysis results given larger sand particles and the higher

infiltration rate. The bioretention cell passes the infiltration test protocol.

The Guelph Permeameter apparatus is shown above. This test requires less water and takes less time than the double ring infiltrometer test.

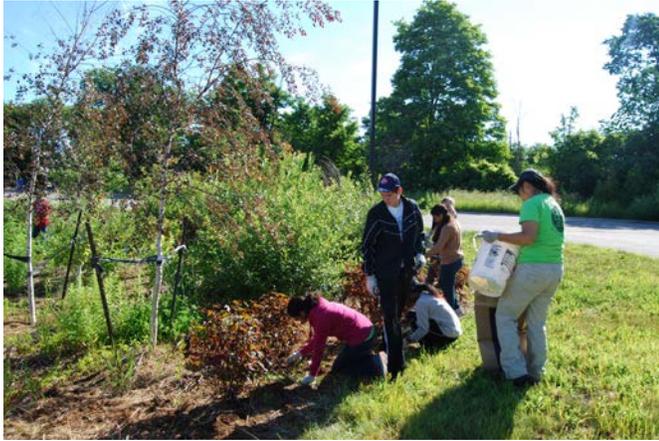
The Conservation Youth Corp volunteers help out with maintenance, including weeding and planting. Over two days in 2014 they were able to remove a significant amount of weeds and add additional plants where needed. A landscaping contractor was hired to perform the remaining tasks throughout the growing season, which includes plant maintenance and mulching, as well as removing any sediment from the inlets. This large parking lot seems to accumulate a fair amount of sediment and the inlets need to be cleared monthly to

The Conservation Youth Corp volunteers helping with weeding in July 2014
