Elm Drive

Road Right-of-Way Retrofit

Project Objectives, Design and Performance

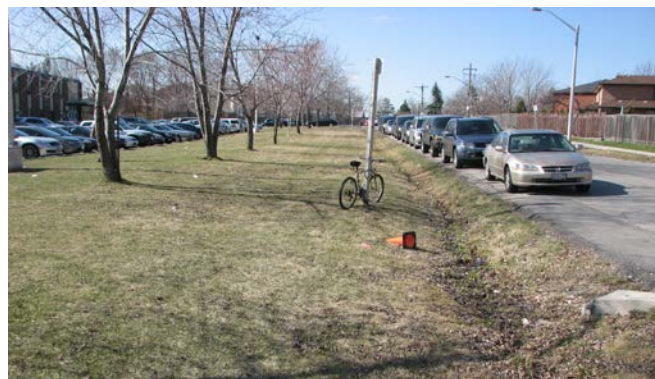
Elm Drive West pre-development

Prior to implementing the retrofit project, Elm Drive consisted of a roadway with soft shoulders and a grass drainage ditch.

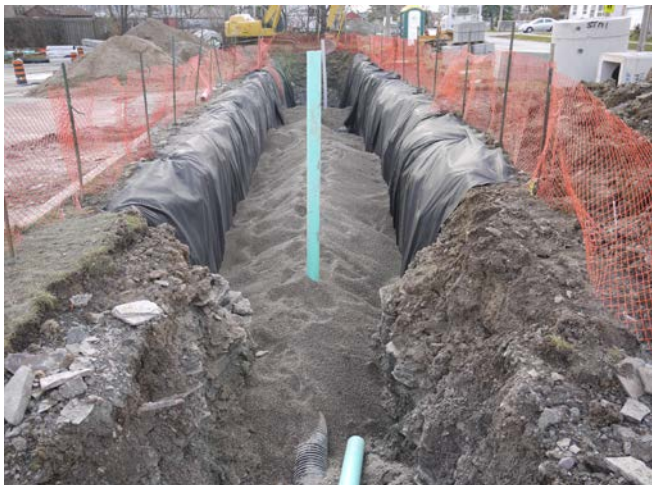
Perforated pipe covered in high performance bedding

Bioretention planters consist of layers of varying types of aggregate. The excavated trench is lined with non woven geotextile and the first layer of aggregate is high performance bedding. There is a 250mmØ HDPE perforated pipe that runs through each of the planters within the first layer of high performance bedding. The bedding is comprised of angular washed limestone free of dirt or small fines.

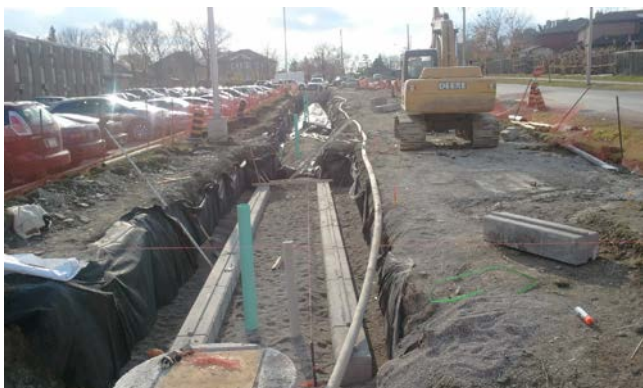
Bioretention planter with beginnings of retaining wall

Above the high performance bedding are retaining walls for bioretention planters. Non woven geotextile lines the first layer of the wall. A 150mm thick coarse concrete sand filter layer is then placed on top, followed by the 450mm filter media mix (sand and mixed organic compost, detailed in the Bioretention Soil Media table).

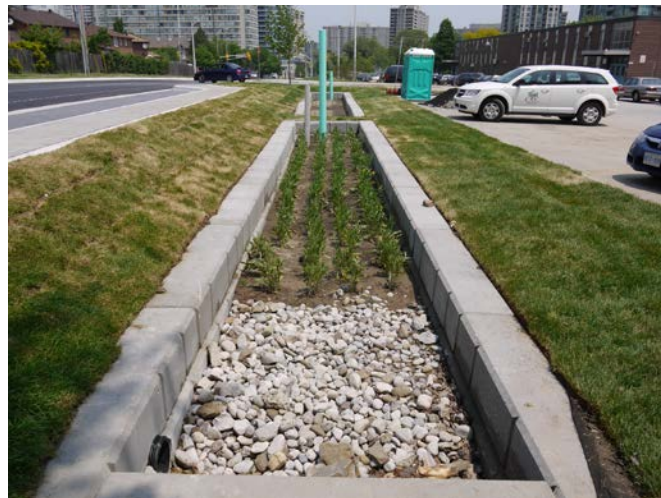
Completed bioretention planters, showing flow dissipater (foreground) and salt-tolerant native plants (background)

Each of the six planters has a catchbasin that empties into the planter through a 200mm corrugated HDPE pipe. Within the planter, there is a 300mm thick layer of 100-150mmØ river run stone on top of a 100mm thick 19mmØ clearstone bed. This layer is placed where stormwater flows into each planter and acts as the flow dissipator and spreader.

The design of the bioretention planters identified a need to incorporate use of a rock flow dissipater where runoff discharges into the planter (shown in the forefront of the *completed bioretention planter* figure). The intention of this dissipater was to slow the velocity of the incoming road runoff and to encourage sheet flow across the planter. However, this feature was placed directly over top of the high performance bedding, creating a path of least resistance directly to the granular material at the base of the planters and permitted runoff to bypass the bioretention soil media and the plants.

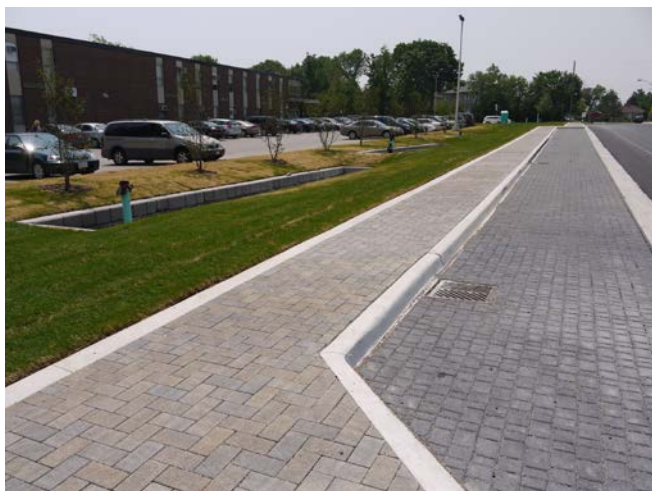
Completed permeable pavement lay by and sidewalk

The permeable pavement was installed in the lay-by as well as the sidewalk, totalling an area of 670 m². The subbase aggregate is lined in geotextile, contains a 150mmØ subdrain, with a 400mm layer of 50mmØ clear stone, followed by a 250mm layer of 19mmØ clear stone. The setting bed aggregate consists of a 50mm layer of 6mmØ high performance bedding.

The lay-by is a charcoal Unilock Eco-optiloc 26cmx26cm, with 2-5mmØ washed limestone gravel joint aggregate. The sidewalk is a Unilock Eco-priora 12x24cm in herringbone pattern, with 2-5mmØ washed limestone gravel joint aggregate.

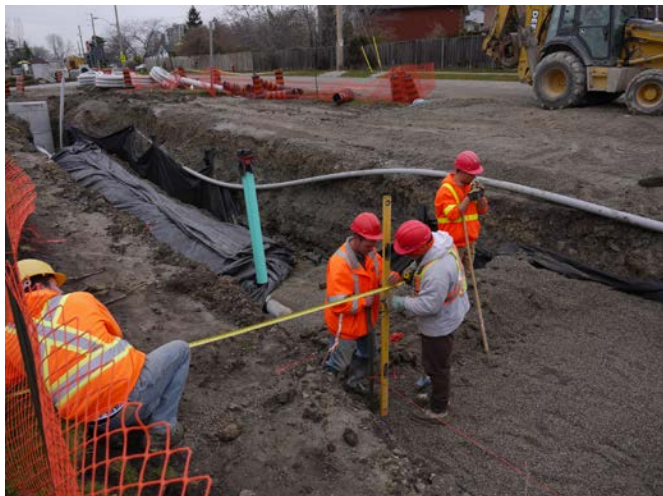
A curb was used as a benchmark, creating challenges, as the alignment skewed one of the bioretention planters before the oversight was noticed. Care should be given to ensure proper and accurate benchmarks are used.

To minimize errors and keep construction on track, a survey crew should be on site to assist in establishing and confirming elevations. At Elm Drive, surveyors verified the elevations of the inverts of buried pipes to ensure that the correct excavated depth was attained and storage volumes were met.

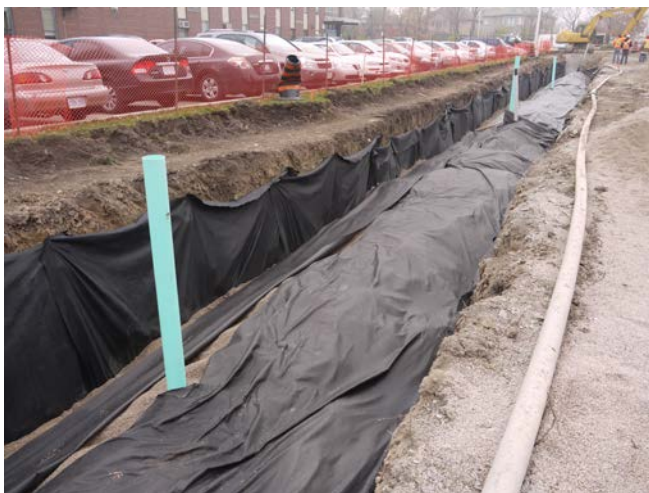
Temporary geotextile placed to prevent contamination

Steps were also taken to minimize the interaction of native clay soils with engineered media. Planters were lined with geotextile and a sacrificial geotextile layer was layered on top of the surface. When clay fell in to the high performance material after rain events, the contractor was required to remove them from the bioretention planter.

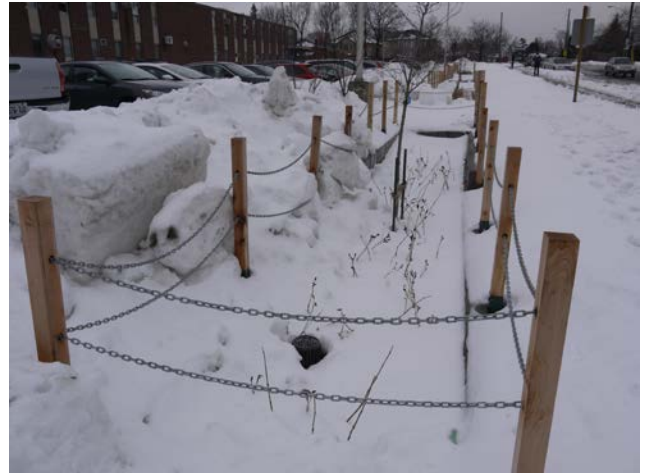
New fence around bioretention planters and revised plantings

Since safety concerns arose over the winter, trees were planted in the planters to give a better visual indicator of their depth during snow covered months. In addition to the new trees, a fence was erected around the perimeter of each planter for safety reasons. These unforeseen issues arose after the first winter and solutions were implemented immediately the following year.

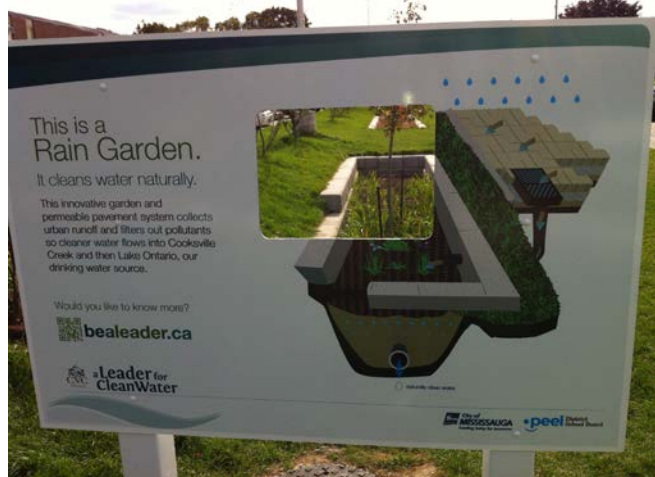
Signage depicts the bioretention planters (rain garden) and connection with the permeable pavers

CVC used a highly visual approach to give the public a view below the ground without cumbersome displays. Anyone walking by can read the simple text and look through the hole, aligning the real life bioretention planters with the display. They will have an immediate sense of what was engineered below the ground and how permeable pavement was linked to the bioretention planters. Easy-to-understand text was used to ensure that general public could understand it. The term rain garden was substituted for bioretention planters.
