# Lakeview Neighbourhood

Location: Mississauga  
 Constructed: August 2012

## Road Right-of-Way

### Project Objectives, Design and Performance

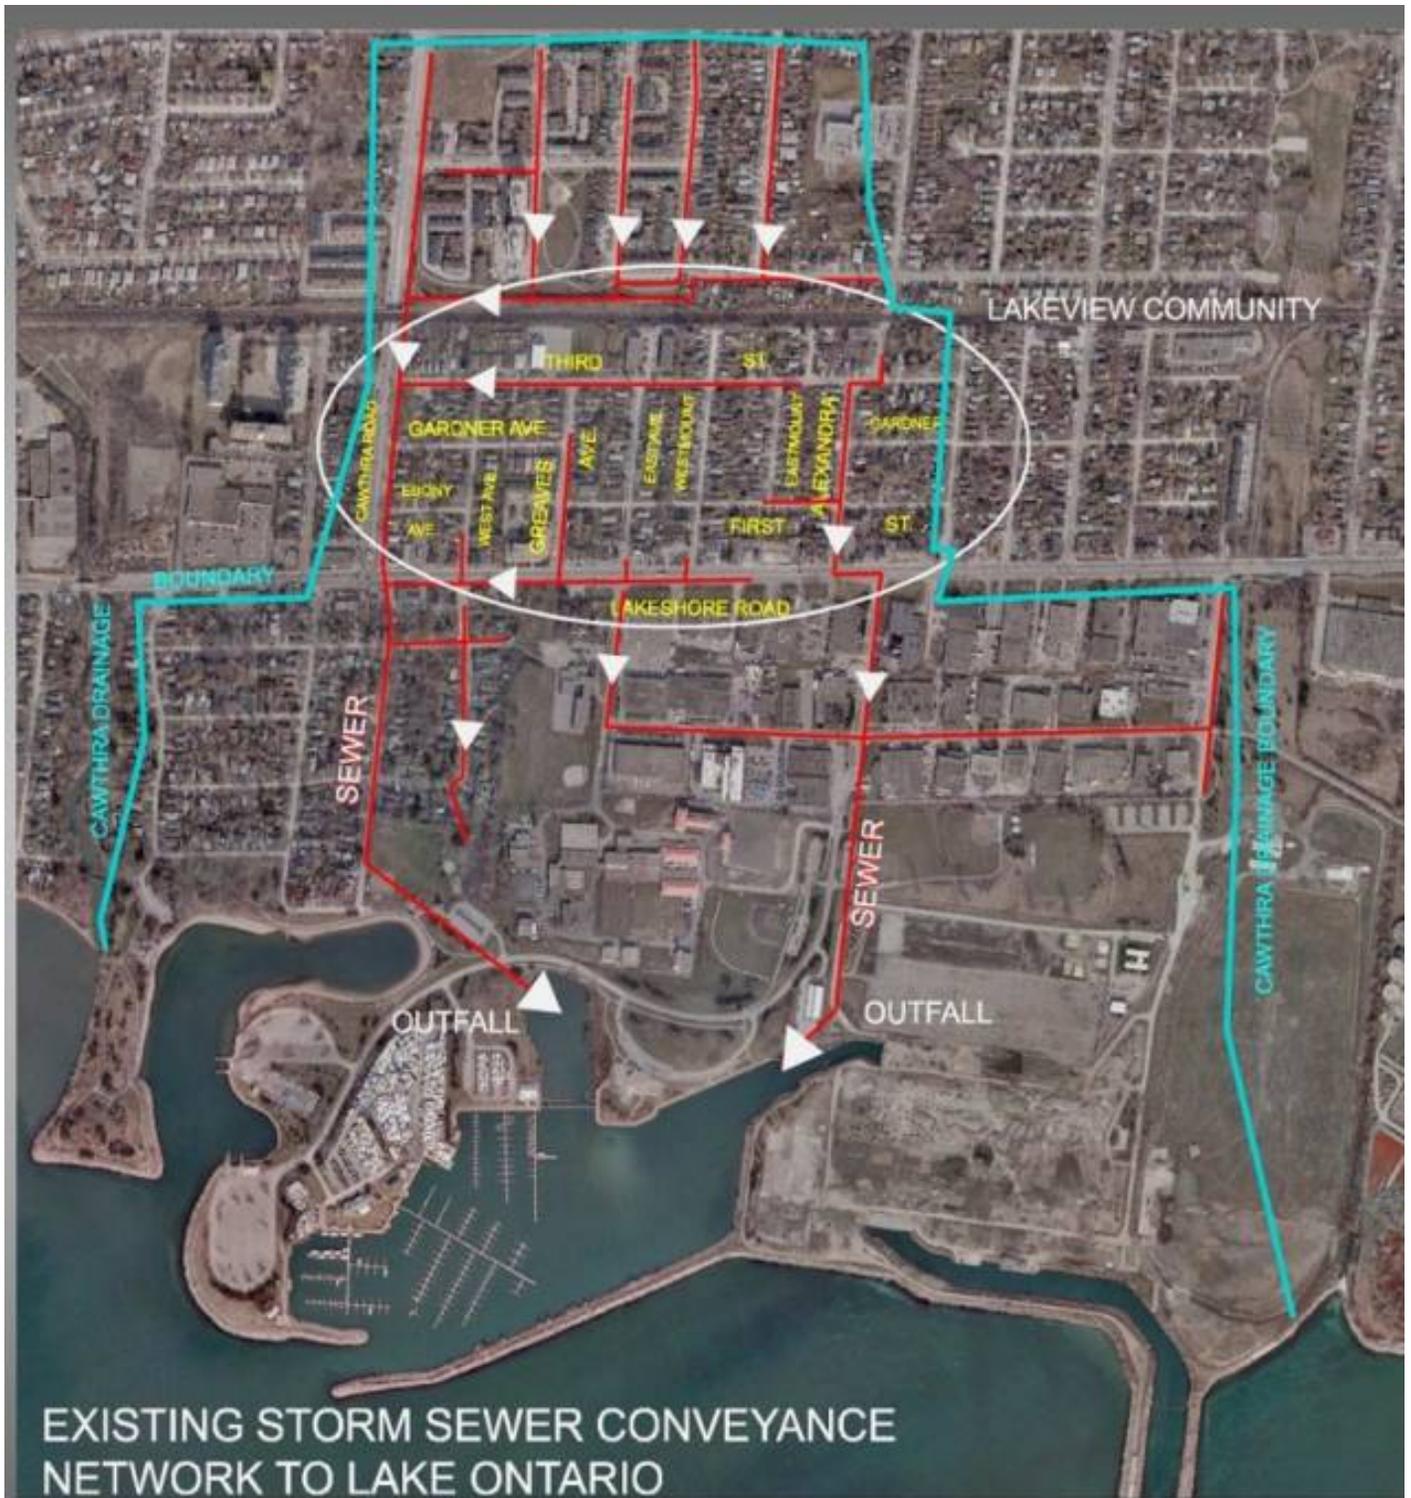
Figure 4 – Existing storm sewer conveyance network to Lake Ontario. Cawthra Drainage area is marked by blue and the sewer system is identified by red.

The Lakeview community drainage network consists of a combination of traditional catch basins and sewer networks and roadside ditch and culvert systems that discharge directly to Lake Ontario. **Figure 4** demonstrates the Cawthra drainage network which includes the Lakeview community.

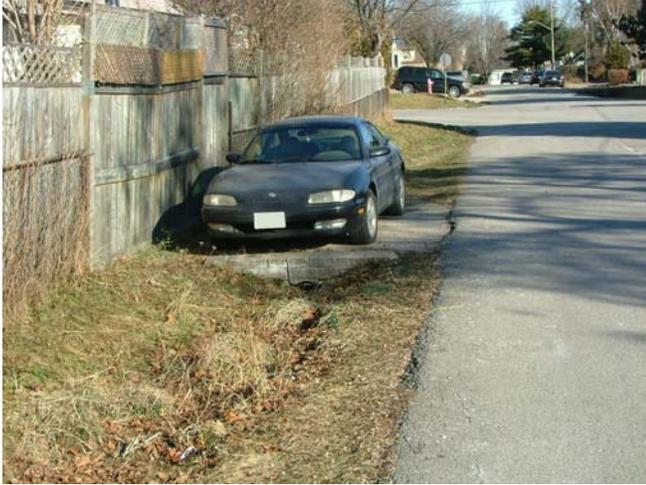
Figure 8: Fence line encroachment on First Street

Since the project was implementing LID practices within the municipal road ROW, areas adjacent to the road had to be available for design purposes. In many cases encroachments from private fences, parking areas, and other structures impacted the availability of space for LID implementation. **Figure 7** demonstrates the type of encroachment observed throughout the site area. A photograph of an encroachment is provided in **Figure 8**.

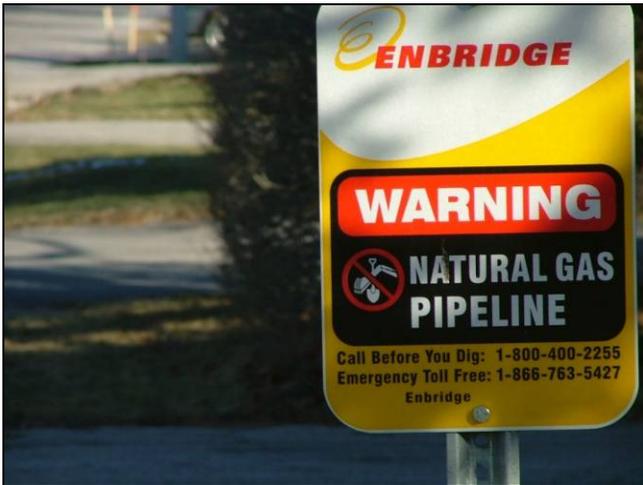
Figure 9: Many buried utilities were located along First Street and Third Street, posing a challenge for construction

Utilities both overhead and underground were located throughout the proposed locations for the LID practices. Locate information was surveyed during the completion of pre-design tasks and added to existing mapping to ensure as much utility information was available during the design phase.

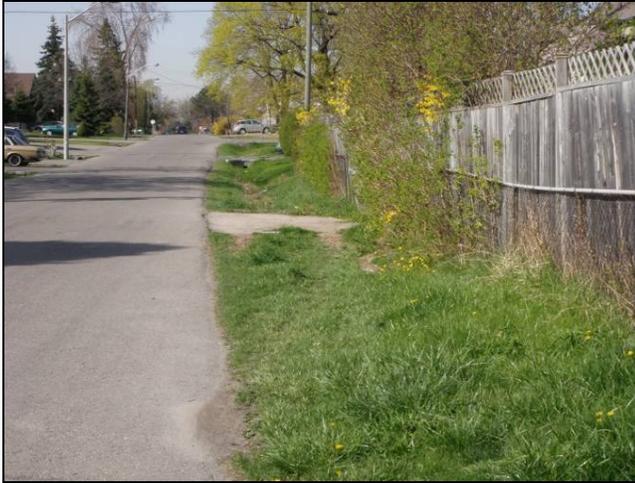
Figure 12: Ditches filled in for parking purposes

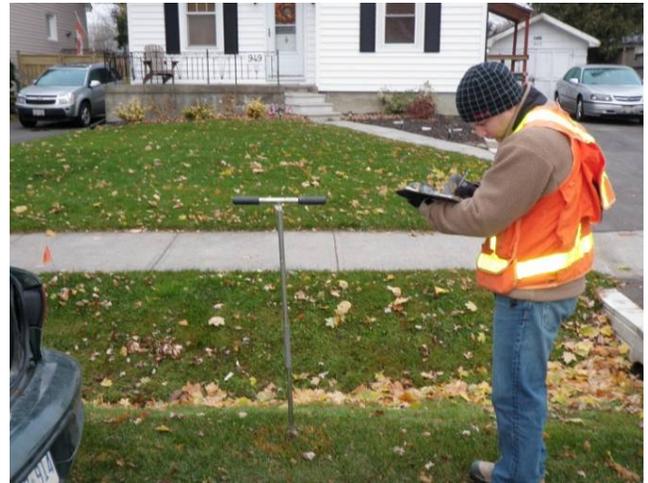
Figure 13: Infiltration testing conducted at Lakeview

Guelph Permeameter testing was performed in November 2010 to determine the saturated hydraulic conductivity (Kfs) of the in-situ soils. The experimentally determined Kfs was then converted to infiltration rate (mm/hr) and a factor of safety corresponding to the non-stratified soil conditions was applied as per Appendix C of the Low Impact Development Planning and Design Guide. The calculated design infiltration rates for were determined to range from 0.04 – 7.67 mm/hr across the site. The average design infiltration rate was determined to be 5.45 mm/hr for First and Third St and was used as the basis for design calculations for the LID practices.

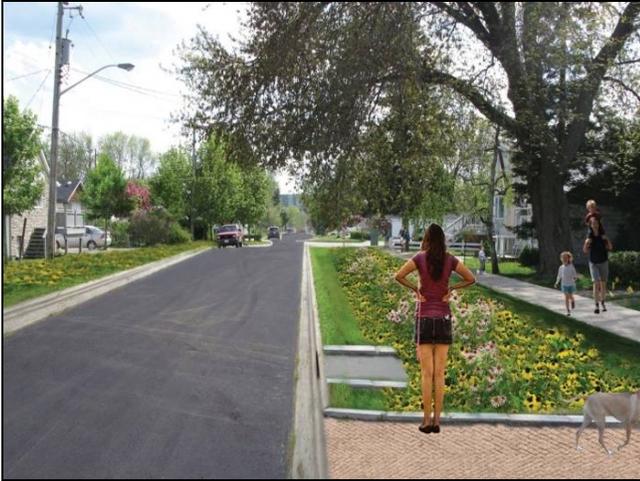
Figure 14 – Artist rendering presented by the landscape architect

The concept incorporated a combination of vegetated and grass bioretention units within the boulevard and permeable pavement at the end of driveways. The concept drawing was presented to the City in April 2010 at which time the project team discussed the overall usability of the street and other design considerations.

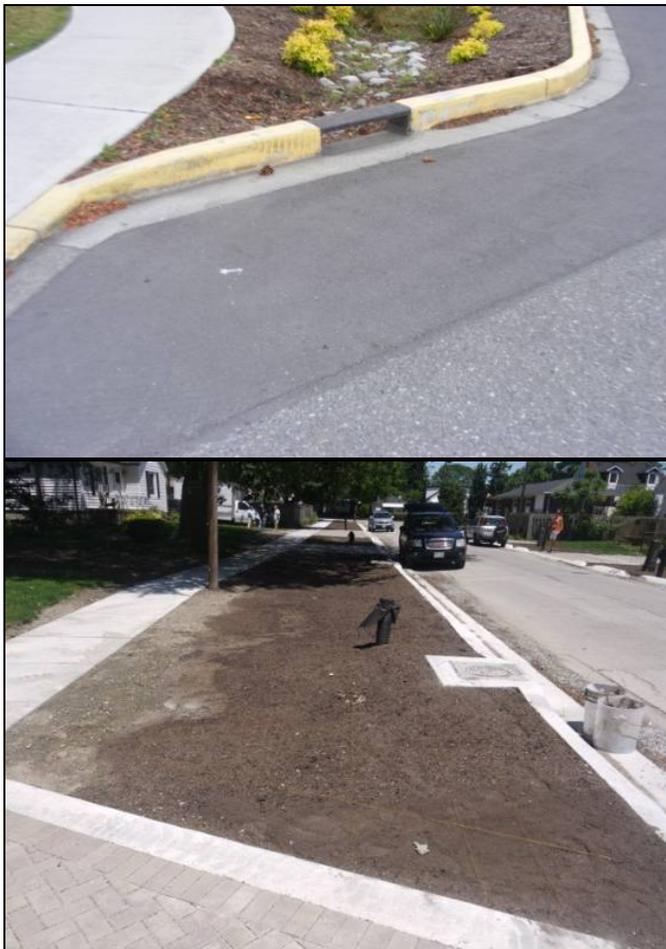
Figure 18 &19 – Covered inlet option (top) and side inlet catch basin (bottom)

Inlet types were also discussed. Many options for covered inlets or steel grated inlets were proposed. However, concerns regarding snow removal operations damaging the covers discouraged the alternatives.

A simple curb cut design was selected for the Lakeview project. However, for one of the bioretention units implemented on Third St., side inlet catch basins were used. This would allow the City to assess the difference in maintenance efforts and modifications

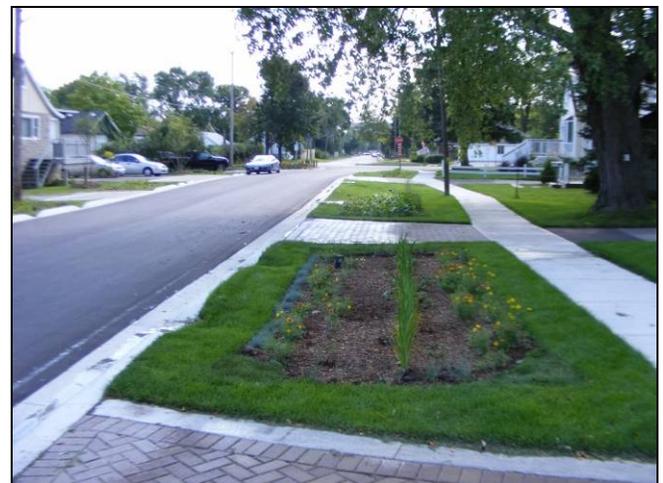
Figure 21 – Perennials planted within bioretention units

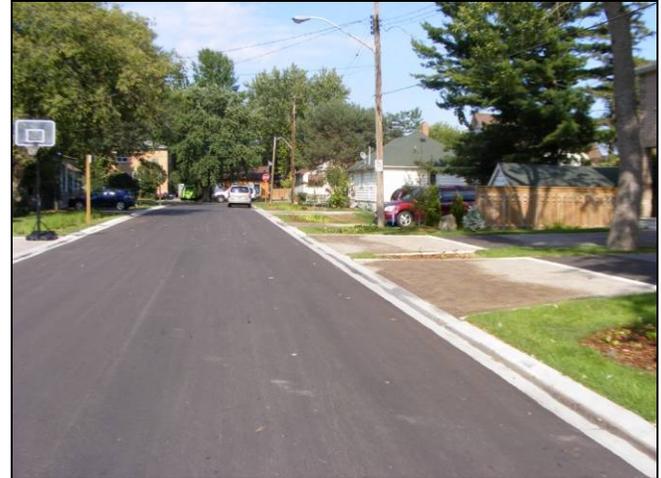
**Figure 23 – Permeable pavement driveways**

A different sub-base is used in the construction of asphalt driveways compared to permeable pavement. However permeable pavement and bioretention use the same base material, 20mm clearstone. Ensuring that the two types of base materials could be adequately separated to avoid fines contaminating the bioretention reservoirs was a concern. Phasing construction in order to properly incorporate the asphalt driveways would create additional costs and inconvenience to residents. This did not seem to outweigh the additional costs of the permeable pavers or the convenience of using only one type of base material. For these reasons and the fact that the residents highly accepted the aesthetics of the permeable pavement concept, the use of permeable pavement for the driveways was approved.

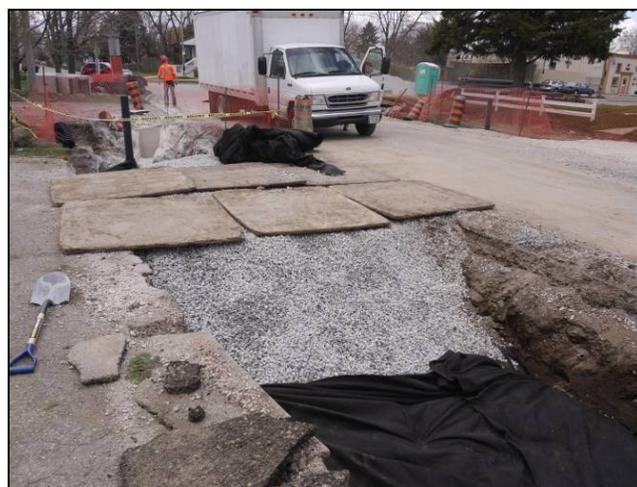
**Figure 31 – Preparation of permeable pavement driveways base material**

In preparation of the base material installation, a non-woven geotextile was placed directly on the prepared subgrade and up the sides of the excavated trench to prevent fines from the native subsoils from migrating into the clearstone base material. The geotextile was rolled out flat and tight with no folds. Adjacent rolls were overlapped and held in place by workers as base material was placed on top. Unlike the preparation of boulevard bioretention unit reservoirs, the top of the permeable pavement base layer was not wrapped with filter fabric.

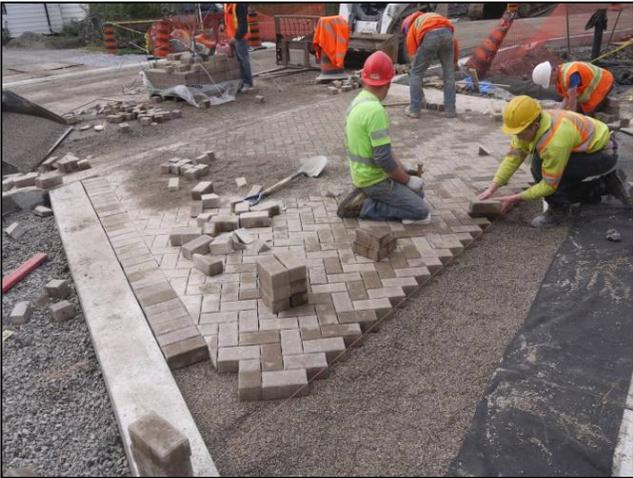
**Figure 32 – Installation of bedding material and permeable pavement**

Clearstone brought to grade was compacted and topped with the No.8 chip stone bedding layer. This layer was compacted prior to the placement of band curbing and permeable pavement.

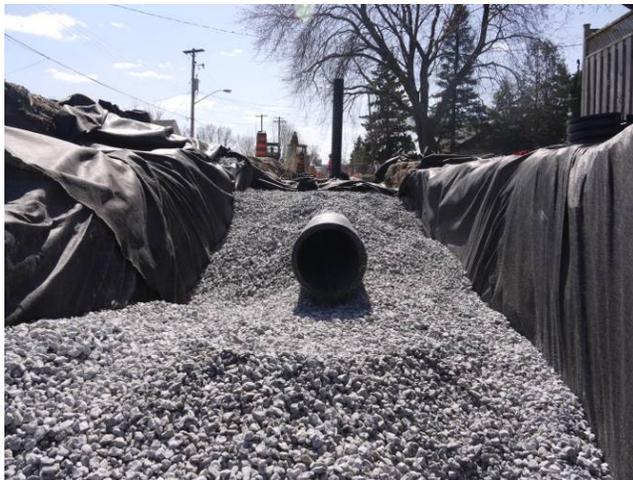
**Figure 33 - Bioretention unit with non-woven geotextile, 20mm diameter clearstone with an HDPE perforated pipe**

The bioretention unit underdrain systems consisted of an excavated trench lined with non woven geotextile and filled with an open void 20 mm diameter clearstone. 300 – 375 mm diameter HDPE perforated pipes situated within the clearstone bedding underdrain the entire length of the bioretention units and permeable pavement sections (see **Figure 33**). The 20 mm diameter clearstone bedding material is fully wrapped with non-woven geotextile so that it overlaps to cover the top of the clearstone bedding material.

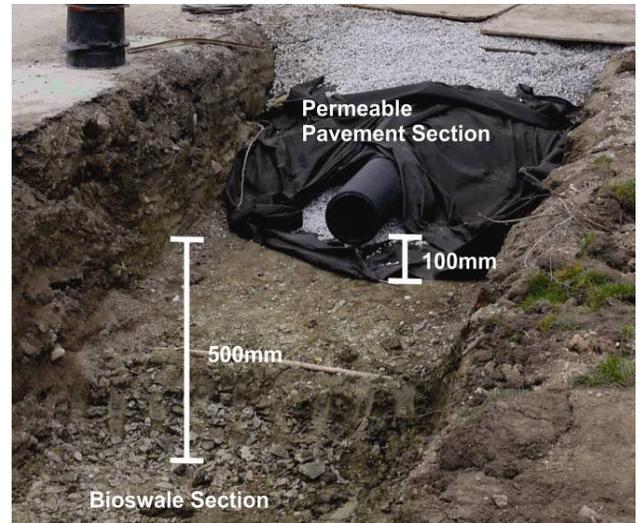
**Figure 34 - Varying excavation depths for the bioswale and permeable pavement sections**

**Figure 34** demonstrates the varying excavation depths of the permeable pavement and bioretention unit sections. The bioretention areas were excavated deeper to provide additional water quality storage whereas storage below the permeable pavement section was constructed such that pipe bedding material would be provided but prolonged periods of standing water would be minimized in order to protect the structural integrity of the subsoils.

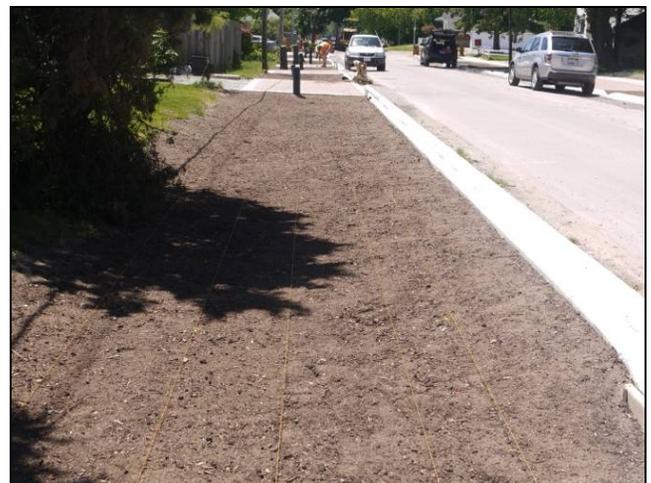
**Figure 35 - Bioretention soil media placed within bioretention units along Third St.**

A 450 mm – 600 mm thick layer of engineered filter media mix (see **Table 7**) was placed on top of the clearstone bedding material with geotextile separating the two materials. This was to avoid bioretention soil media from migrating into the clearstone and filling available void space within the clearstone. **Table 7** demonstrates the composition of the engineered bioretention soil media.

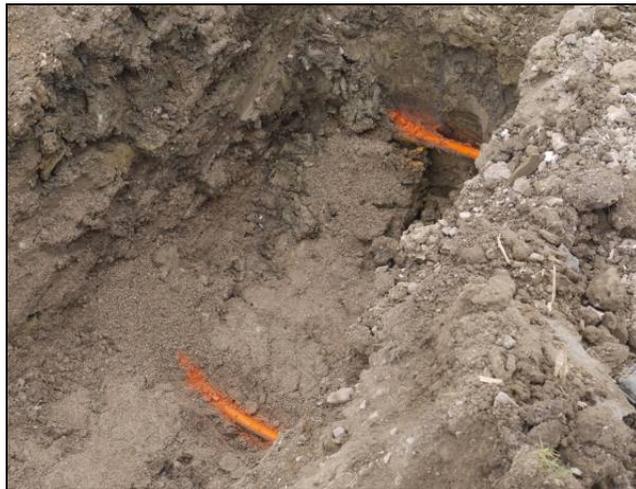
Figure 36 - Daylighting of Utilities

identified on the contractor's locate report. These utilities were generally not in service however in a few incidences, old utilities lines were used as conduits for new service lines. Such situations made identifying active utilities difficult and required caution during the construction process. To limit the potential damage to utilities, hand digging for daylighting purposes was used as a standard procedure during the construction.

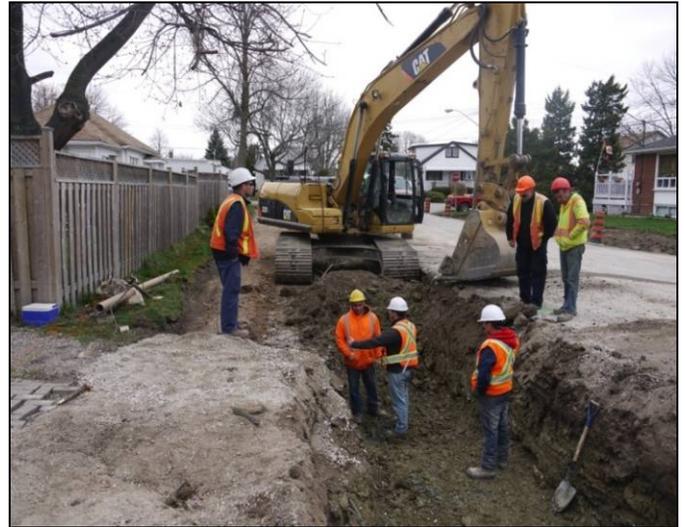
Figure 41 – Over-excavation of the bioretention unit trench by the contractor to avoid utilities

In order to avoid utilities and other obstacles, the contractor had to alter the extent of excavation either through narrowing, shallowing, deepening or widening the limits of excavation depending on the location of the obstruction. This was generally accepted as long as the final excavation would accommodate the necessary water quality storage volume specified for the design. This was accomplished by compensating for the change in excavation in subsequent sections. For example, if a section of the excavation was narrowed by 0.5 m for over a 10 m length in order to

avoid a utility, the subsequent 10 m was widened by 0.5 m to compensate.

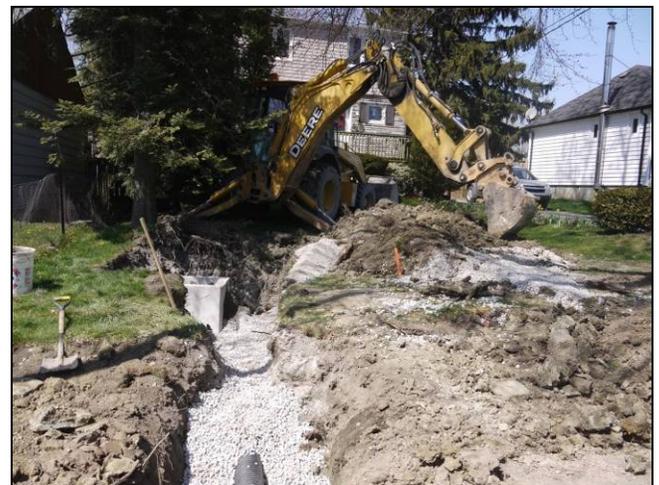
Figure 42 - Installation of provisional catch basin within resident front lawn

As part of the tender documents, provisional lot drainage was added for cases where surface drainage from resident's lots could not drain overland to the bioretention units. During the beginning of the construction, the project team and contractor identified lots which may have surface drainage issues. Following discussions and permission from the residents, surface inlets were installed on private property to collect local lot drainage and discharged to the bioretention unit underdrains.

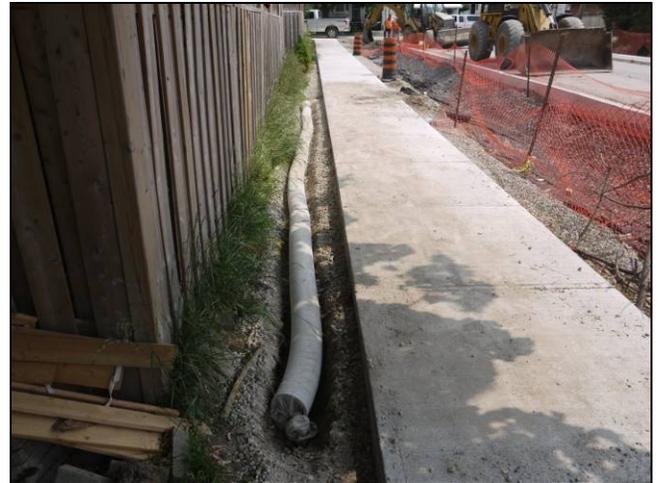
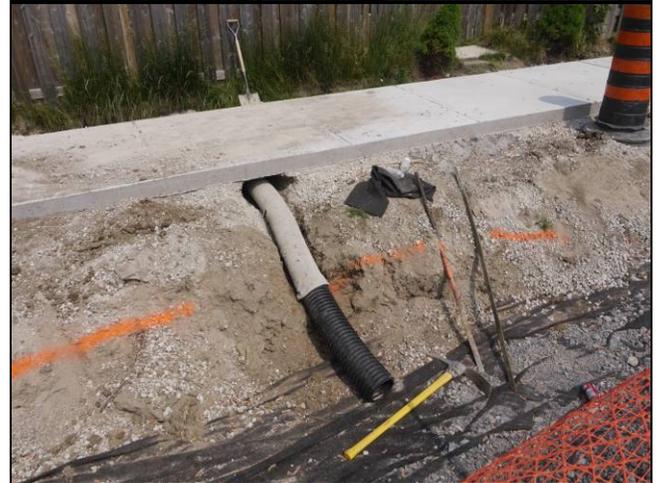
Figures 44 & 45 - Installation of subdrain adjacent to sidewalk (top) and subdrain outlet to bioretention unit (bottom)

As such a subdrain was installed along the lot side of the sidewalk to capture local drainage and discharge it to the bioretention unit.

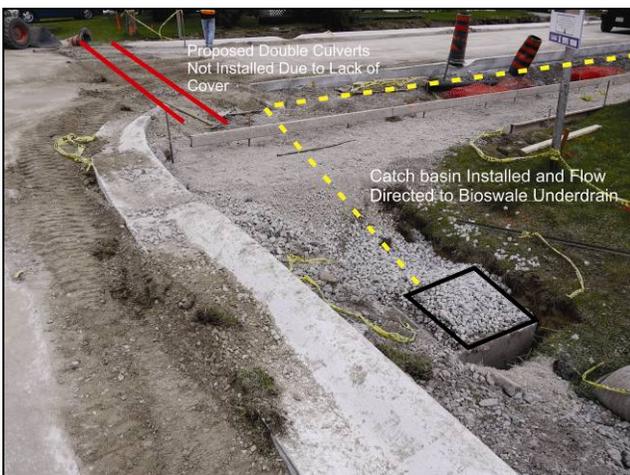
**Figure 47 – Installation of required catch basin**

A set of double culverts at the intersection of Meredith Ave. and Third St. were designed to convey drainage from the lots north of Third St. down Meredith Ave towards Lakeshore Blvd. During construction it was determined that an insufficient amount of cover would exist over the culverts should they be installed. Design calculations were revisited to determine if the underdrain system of the bioretention units had sufficient capacity to accept the addition drainage area from the north. With capacity available, a catch basin was installed at the end of the Meredith Ave drainage system to collect the addition drainage. The catch basin outlet pipe was connected directly to the bioretention underdrain.

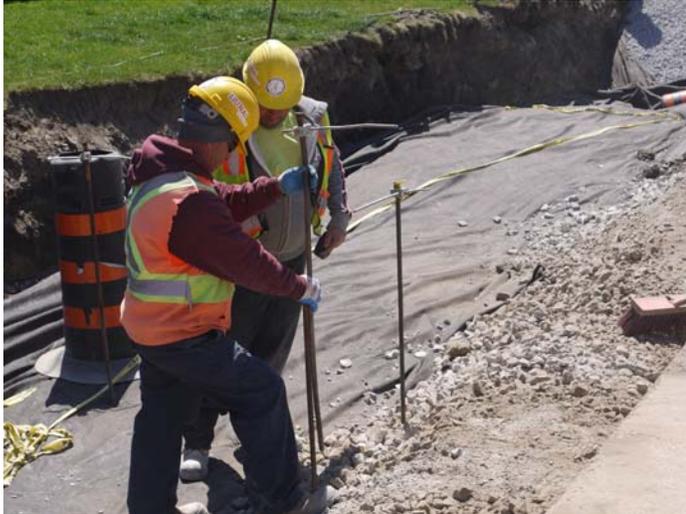
Figure 48 – Concrete subcontractor doubling up the stakes for the string line

Due to the unique sequencing aspects of LID construction, the concrete subcontractor did not expect to have a significant drop behind the curbs without any soil media. As a result, the contractor's stakes for the string line were too short and had to be doubled up in order for the string line to be at the correct height.

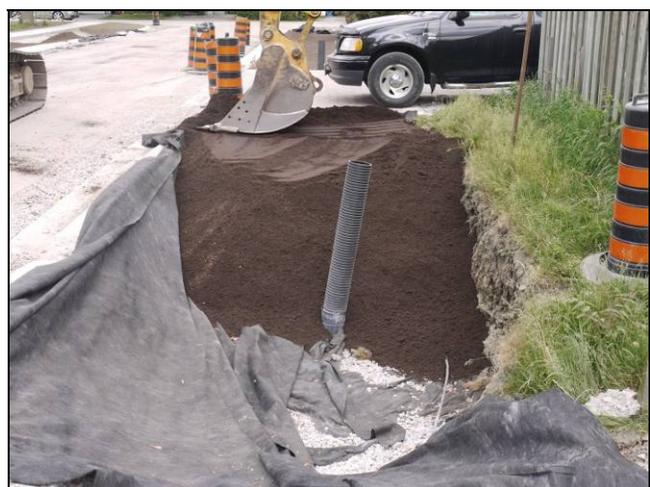
**Figure 53 – Installation of filter fabric to separate Granular "A" from the bioretention soil media**

Prior to placing bioretention soil media within the bioretention units, filter fabric was installed between the media and curb base aggregate to ensure that fines from the Granular "A" material did not contaminate the soil.

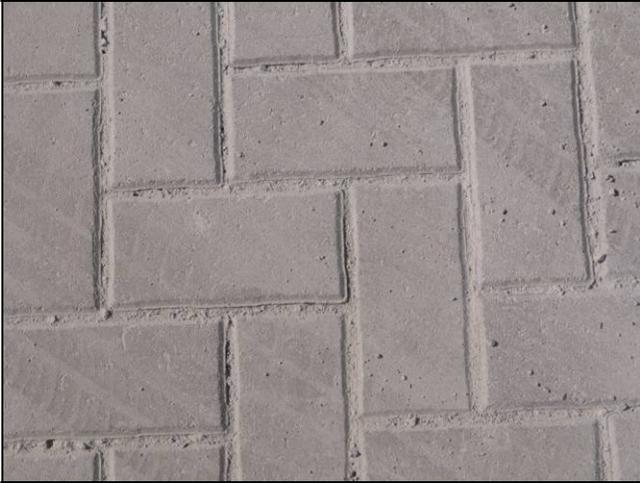
**Figure 54 – Gaps of permeable pavement filled with fines from tamping activities**

Per the contract documents and supplier installation guide, permeable pavement stones were to be tamped in place and bedding material (No. 8 stone) swept into the pavement gaps. During construction, bedding material was swept into the pavement gaps before tamping. Excess bedding material left on the permeable pavement was pulverized by the plate tamper, filling the gaps of the pavers with ultra-fine material.

To address this issue, the fine material was removed via a vacuum truck and disposed of. The gaps were subsequently filled with chip stone to ensure free drainage was provided.

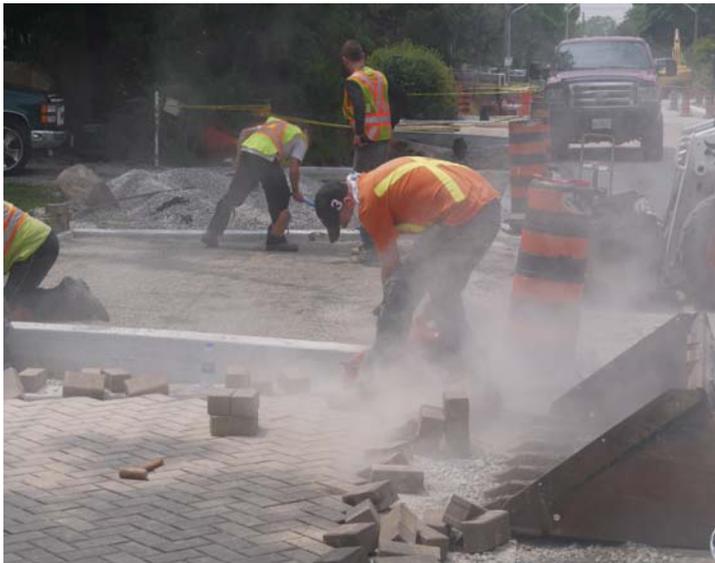
**Figure 55 – Fine dust during cutting of permeable pavers**

During placement of the permeable pavers, a significant amount of fine dust was created by the cutting process when the contractor was creating the soldier course. It was then requested that the contractor cut pavers away from the infiltration area or use a sacrificial piece of geotextile laid on the permeable pavers during cutting.

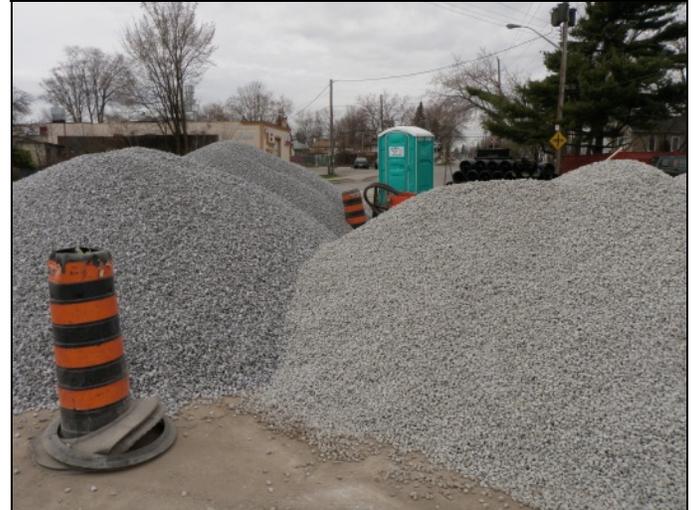
During construction, clearstone supplied to the site did not meet the specification detailed on the drawings which stated that double washed stone was to be provided. The first load supplied to the site consisted of single washed stone. Although seemingly a very minor detail to enforce during construction, the difference between the two types of material are quite distinguishable.

**Figure 56 – Double washed (left) vs. single washed (right) clear stone. Specs called for double washed**

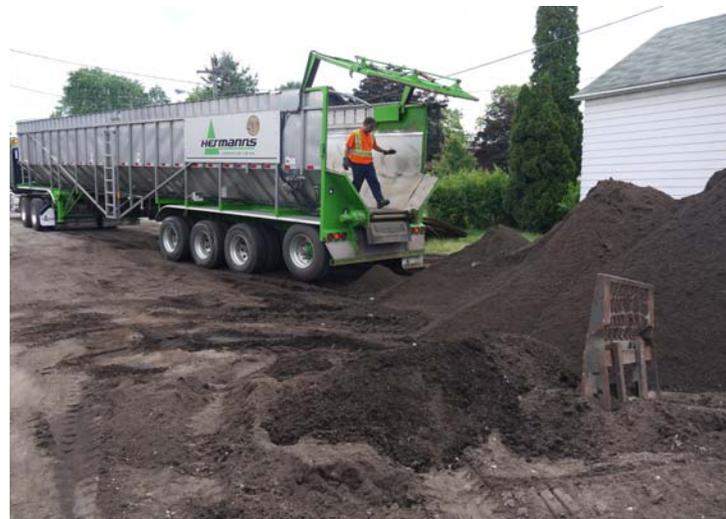
Sequencing and stockpiling material on site was also critical to successful construction. When storage areas are moved because materials are delivered with too much lead time, chances of contamination increase significantly. Materials were not moved as it was stressed how crucial it was to have infiltration areas free of contaminated materials.

**Figure 57 – Bioretention soil media delivered to one of the storage areas**

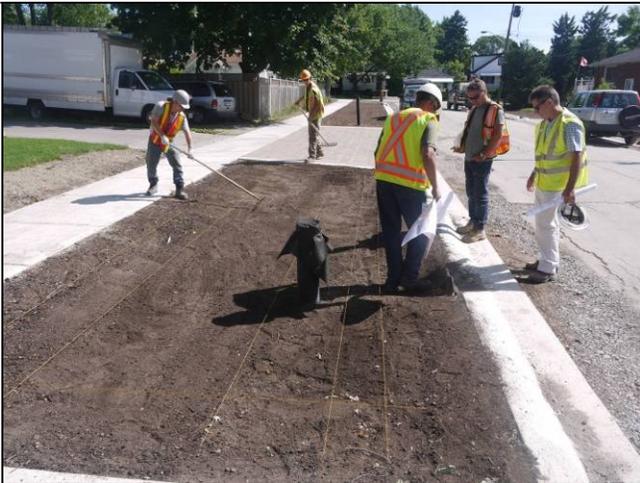
During the planting phase, staff from the landscape architect was on-site directing and supervising the planting installation and quality of the material delivered to the site. The month of June 2012 was an exceptionally hot month, which sustained a prolonged drought period following the installation of the plant material. It was prudent during the remainder of the summer that the contractor consistently watered the plant material to ensure survival.

Figure 58 – Installation of planting material

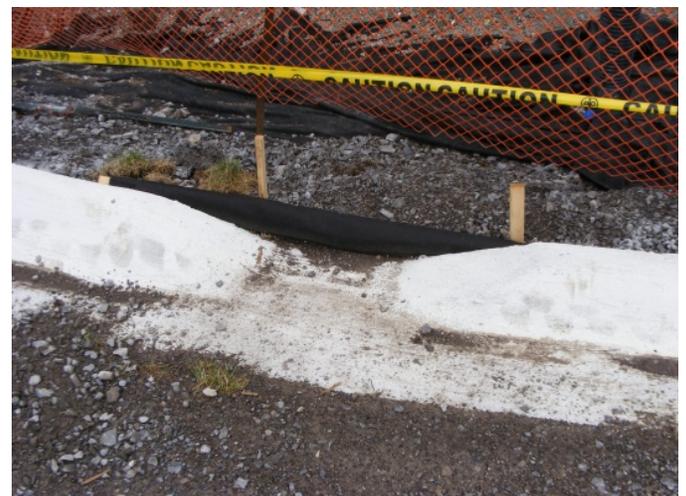
Figure 61 – Filter cloth wrapped wooden boards installed at bioretention unit curb cuts

Prior to the installation of the bioretention soil media and paving of the road surface, filter cloth wrapped wooden boards were staked behind curb cuts and sacrificial pieces of filter cloth were installed to protect the bioretention unit infrastructure from contamination. The sacrificial pieces of filter cloth were installed over the cloth wrapped clearstone reservoir of the bioretention unit. This filter cloth was removed prior to in the installation of the bioretention soil media including any contaminating fines which was captured (See Figure 60).

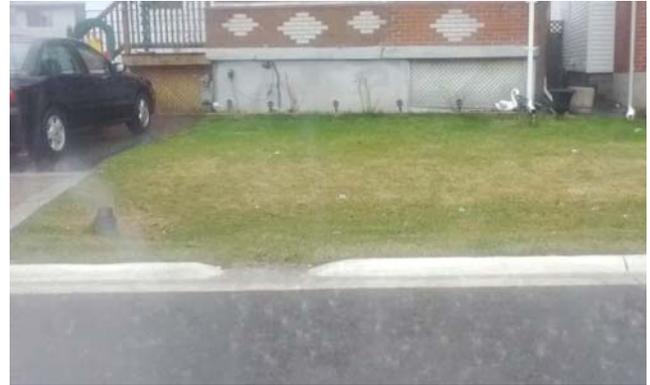
conducted during a precipitation event. The inspection revealed that several of the inlets were being bypassed. Because of this, insufficient stormwater runoff was able to enter the bioretention units at the curb cuts (shown in the following figure).

Figure 62 – Bypassing of bioretention units during a rainfall event

To better understand this issue, CVC had an as-built survey completed in the summer of 2013. The as-built survey confirmed that at some of the curb cut inlets and grade changes were insufficient to encourage the runoff to enter the bioretention unit. The as-built survey also revealed that grade changes didn't allow for positive drainage within some of the bioretention units, and that the ponding depths were not to that specified in the design.

Further investigation revealed that the primary issue with the inlets was that the sod located at the inlets was at too high an elevation, blocking flow into the bioretention cell. This was caused by bioretention soil media not settling as much as expected by the designer and contractor.

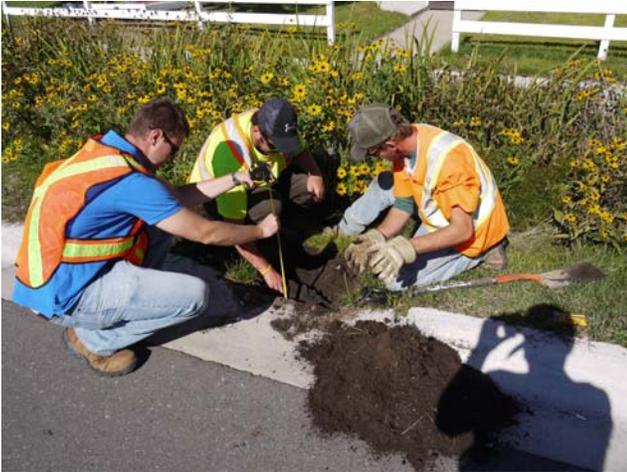
To address the issue, the sod was lowered by a minimum of 25 mm below the curb-cut invert to ensure positive drainage into the bioretention unit. Specific activities involved in adjusting the grade within the bioretention units included:

1. Temporary removal of plants
2. Media re-grading - grading, surveys, and string lining by the landscaper
3. Fine grading
4. Re-planting plants
5. Final survey of the start and stop of the planting beds

Figure 63 - Adjusting inlets by removing excess media

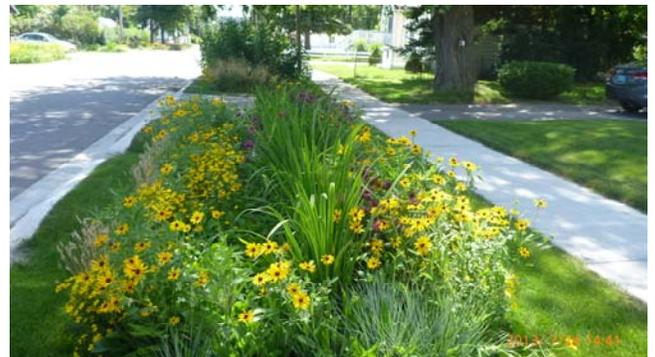
Figure 65 - Plants chosen to replace green headed coneflower based on this bioretention unit. Irises in the center, black-eyed Susans, and bee balm

In September 2013, contractors removed all the green headed coneflower and New England aster from many of the bioretention units and disposed of the material off-site. Unattractive grasses were also removed. The contractor replaced them with butterfly weed, black-eyed Susan, bee balm, obedient plant, and blue flag iris. These plants were chosen because they were already planted in the gardens, residents liked them, and they had established well. The bioretention units were then mulched and watered. For more information about regular landscaping maintenance that took place during the first two growing seasons see the *Operations and Maintenance* section.

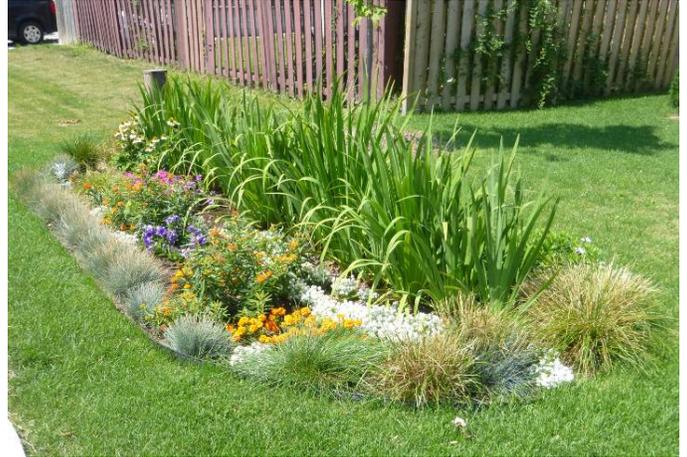
Feedback from PICs indicated that local residents were willing to undertake 2-4 hours of maintenance per month. However in reality, the level of maintenance done by each homeowner varied. Residents were encouraged to undertake maintenance activities such as weeding, pruning and general clean up. Some residents were renters or away for most of the summer so they maintained their bioretention units and permeable pavement less frequently. The amount of maintenance needed also increased if the landscaped option was chosen instead of turf for the bioretention unit.

**Figure 66 - Example of a boulevard bioretention feature that is being well-maintained by the homeowner**

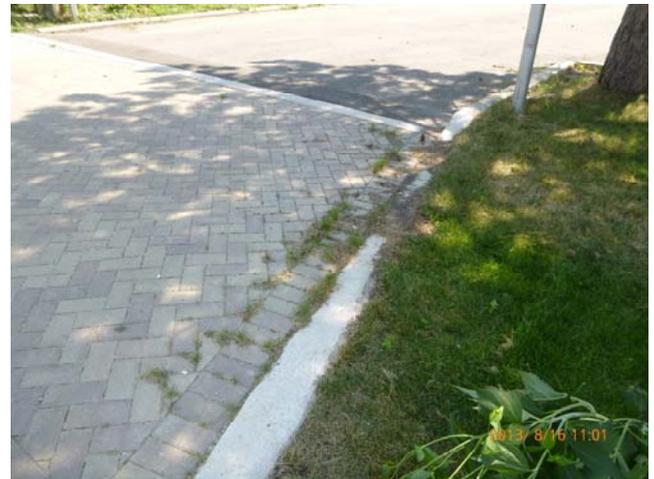
**Figure 68 - Sediment build-up and subsequent weed growth in between permeable pavers**

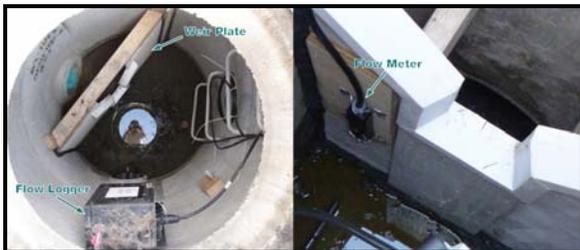
Outflow from the underdrains of the bioretention units and permeable pavement driveways are measured using a stage-based method with weirs and water level loggers.

A compound weir plate has been installed and calibrated by a consultant at all four performance assessment stations. An ISCO 4150 or Hach FL900 flow meter was installed in each manhole with the probe secured to the weir to make certain that accurate water level measurements are recorded. The flow meters are set to record water levels at 10-minute intervals.

Figure 70 - Flow monitoring equipment and compound weir

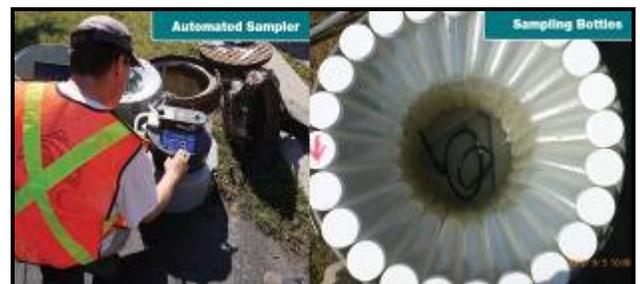
A minimum of ten precipitation events will be sampled per year from three of the performance assessment locations (LV-1, LV-2, & LV-4) with an ISCO 6712 Automatic sampler. The samplers are connected to the water flow loggers and triggered when a predetermined water level is recorded by the flow logger. The monitoring program will continue until a minimum of thirty precipitation events have been collected.

Figure 71 - Water quality sampling

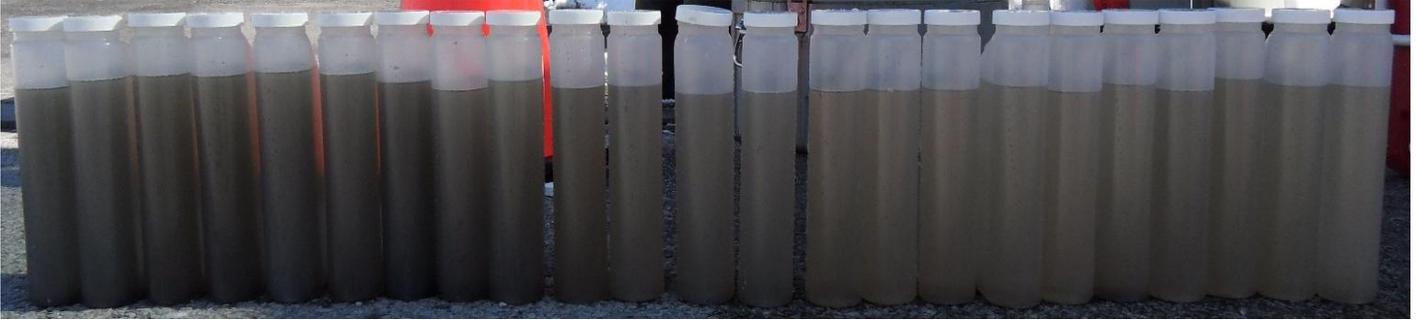
Figure 72 - Sampling bottles depicting the first flush, first six bottles from left and composite samples

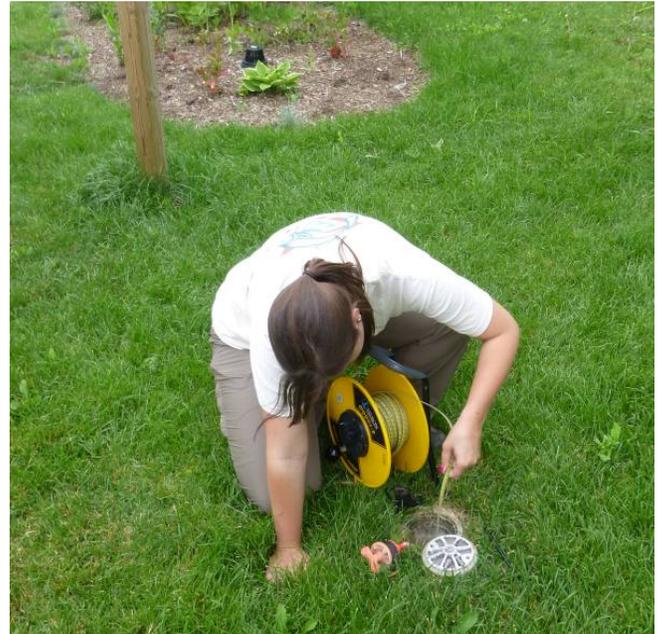
To assess surface water infiltration, two piezometers were installed within the First Street bioretention units during construction. The piezometers are located near monitoring stations LV-3 and LV-4. HOBO U20 continuous water level loggers were placed in the piezometers to measure variations in water level throughout the profile of the bioretention units. Level readings are then compared to rainfall amounts to calculate surface water infiltration in the cells and determine the drawdown time required for stormwater to fully infiltrate through the bioretention units.

An additional logger is located at Green Glade Sr. Public School (approximately nine kilometres from the site) to record barometric pressure. These measurements are used to normalize the water level measurements for barometric pressure. All loggers recorded water level readings in 10 minute intervals.

Figure 73 - Manual level measurements are taken to verify the accuracy of readings and level logger is calibrated as needed
