Belfountain Dam & Headpond

Class Environmental Assessment

Technical Report 1 – Baseline Inventory

Project No. TP114113

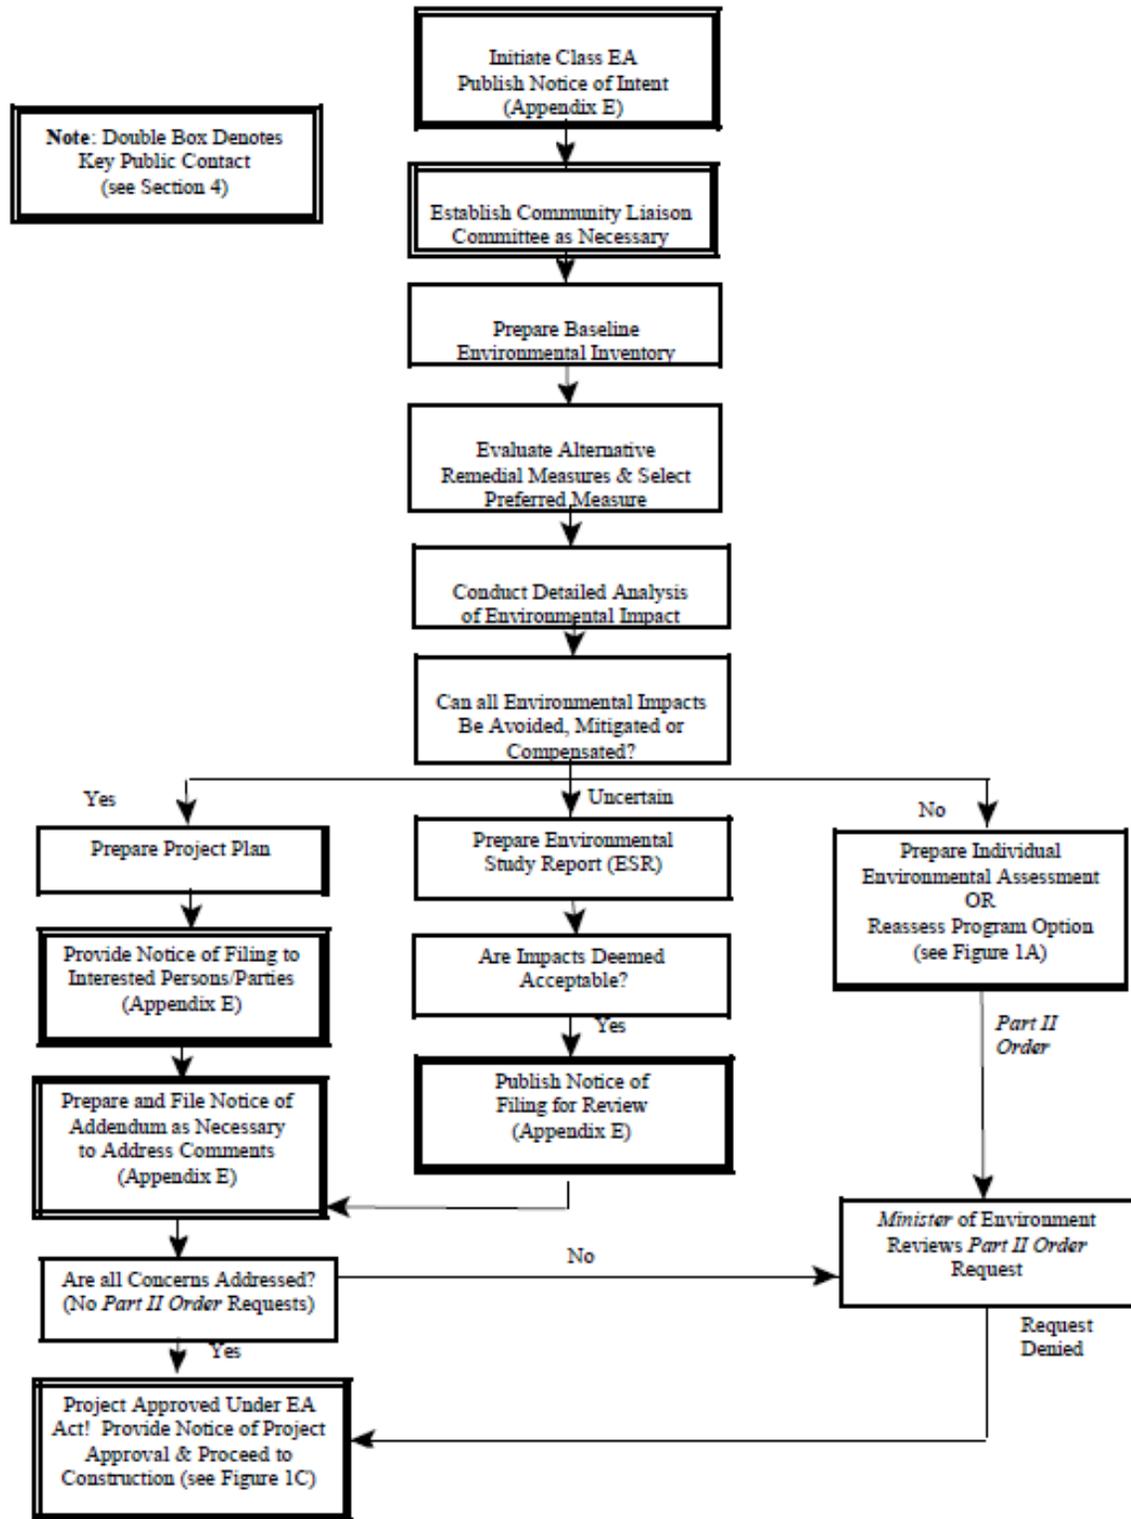
Figure 2.2.1: Conservation Ontario Class Environmental Assessment for Remedial Flood and Erosion Control Projects (June 2002, Amended June 2013).

The Planning and Design process as shown in Figure 2.2.1 outlines the step required to be undertaken by the proponent including how the Class EA process is initiated and the environmental planning and design principles that are to be employed in this process.

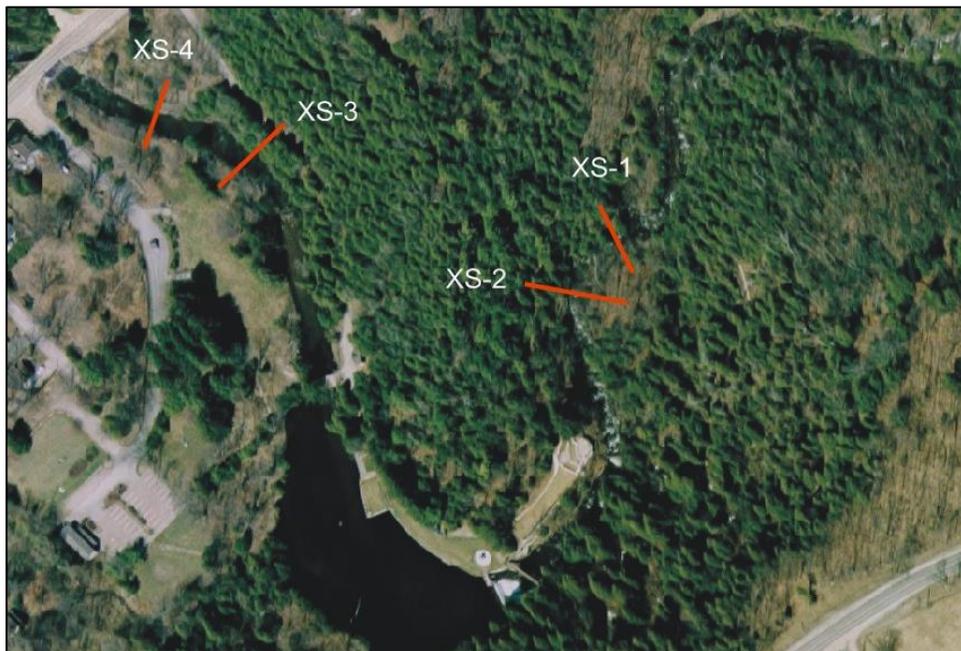
Figure 3.4.1: Cross-Section Locations for Geomorphic Channel Survey of the West Credit River at Belfountain Dam.

Four (4) monitoring cross-sections (two upstream and two downstream of Belfountain Dam) were established to provide the opportunity to build upon baseline information and create a temporal dataset to allow for long-term understanding of the function and stability of the West Credit River (Figure 3.4.1). To establish a monitoring cross-section two pins are placed on each side of the channel on its respective top of bank. A survey is conducted between the two bank pins with approximately 40-50 individual recordings that are easily repeatable for future monitoring. Downstream of the dam both monitoring cross-sections were established in a transitional zone between a riffle and pool, while upstream of the dam the monitoring cross-sections are located in a transitional bedform type and a riffle.

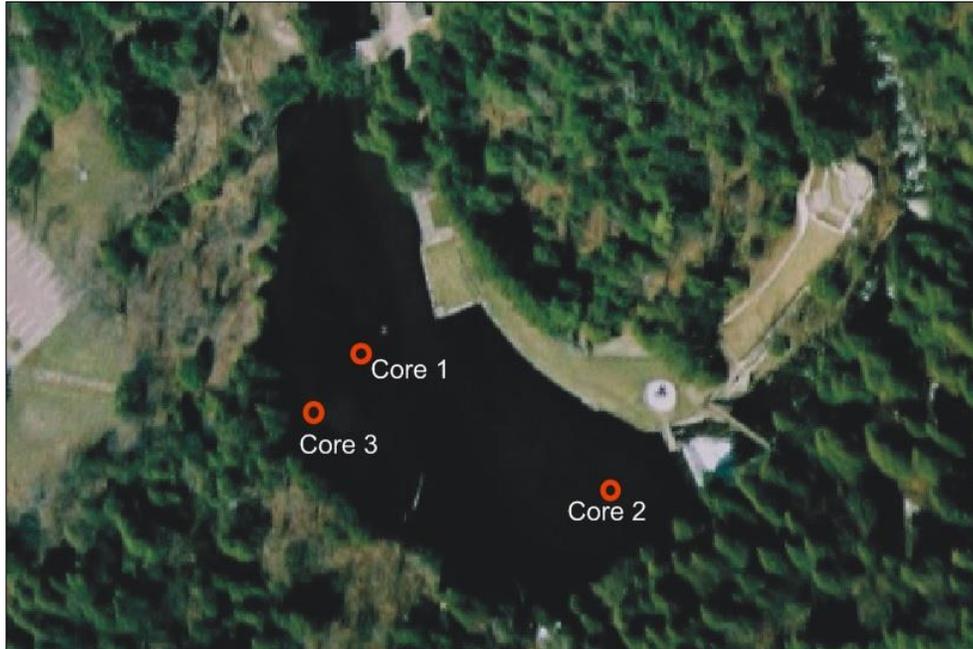
Figure 3.4.2: Location of Sediment Cores taken from Belfountain Dam Headpond.

Three (3) sediment cores were retrieved from the pond, Figure 3.4.2 illustrates the locations. The sediment cores were analyzed for grain size distributions and organic composition. Two (2) additional samples were collected from areas of thickest sediment accumulation within the headpond and provided to an accredited laboratory for chemical analyses. Given the rural nature of the Study Area, no PAH's or heavy metals were tested.

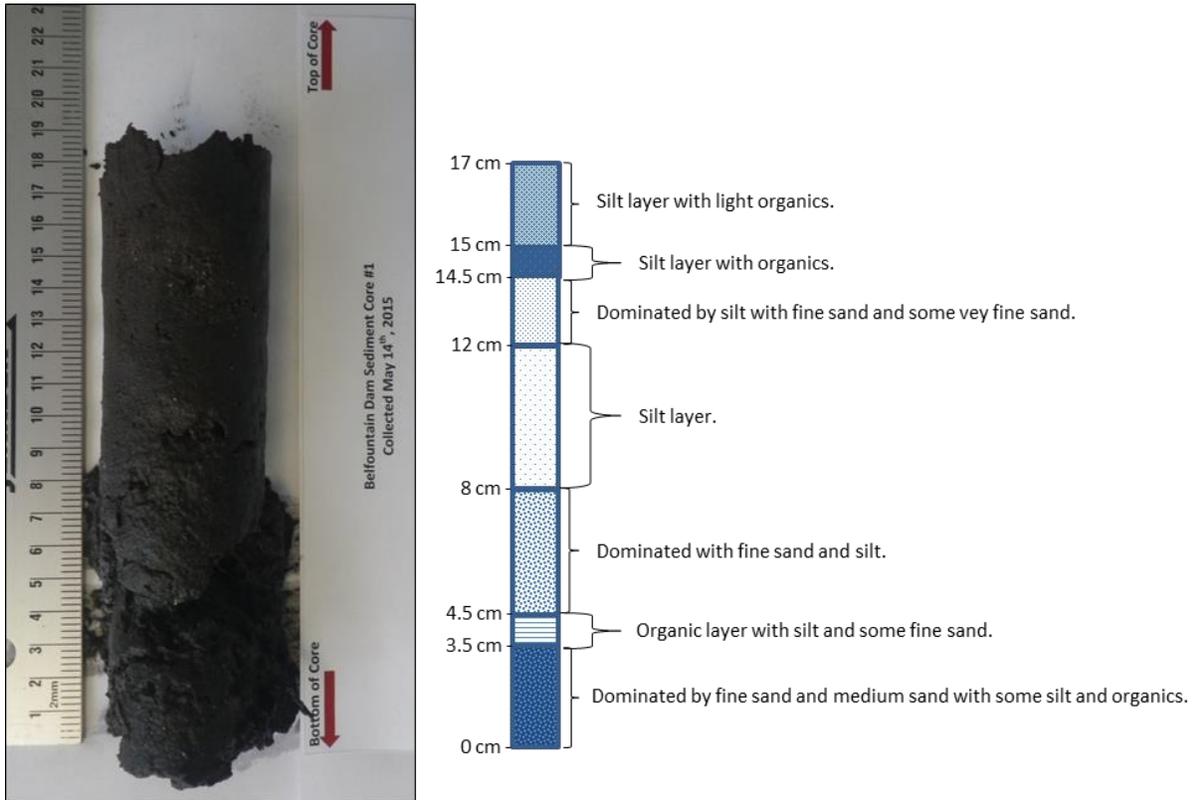
Figure 3.4.3: Belfountain Dam Headpond Sediment Core #1 Stratigraphic Sequence.

Sediment core samples ranges in depth from 0.6 m to 1.5 m and generally showed intermittent layers of silt, fine sand and organic material, with isolated layers of medium and very fine sand. Figure 3.4.3 provides an example of the core stratigraphy. Refer to Appendix F for a detailed discussion and additional figures.

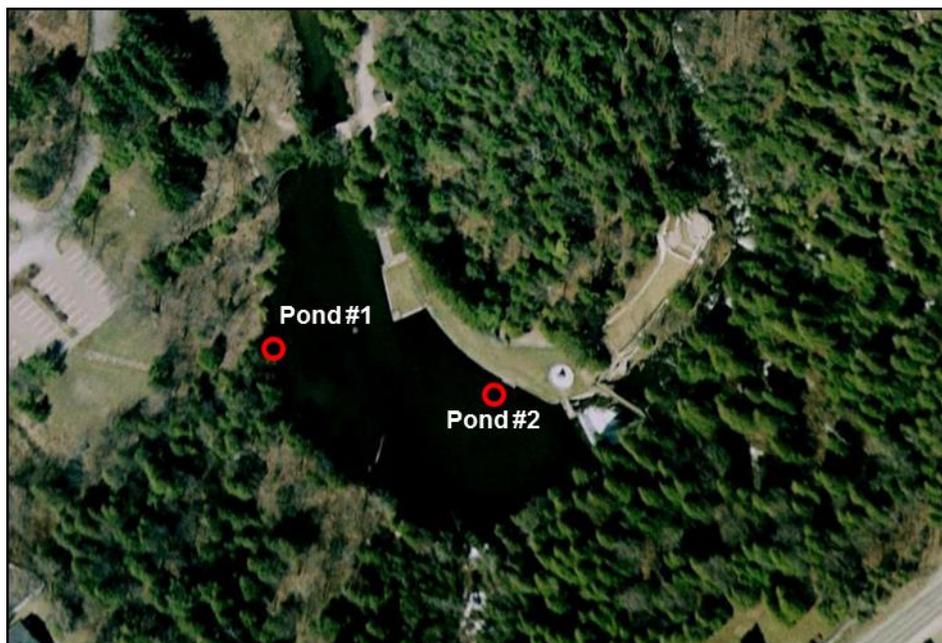
Figure 3.4.4: Location of Sediment Samples Taken from Belfountain Dam Headpond.

Two (2) additional sediment samples were taken from the Belfountain Dam Headpond to evaluate sediment quality at the locations shown in Figure 3.4.4.

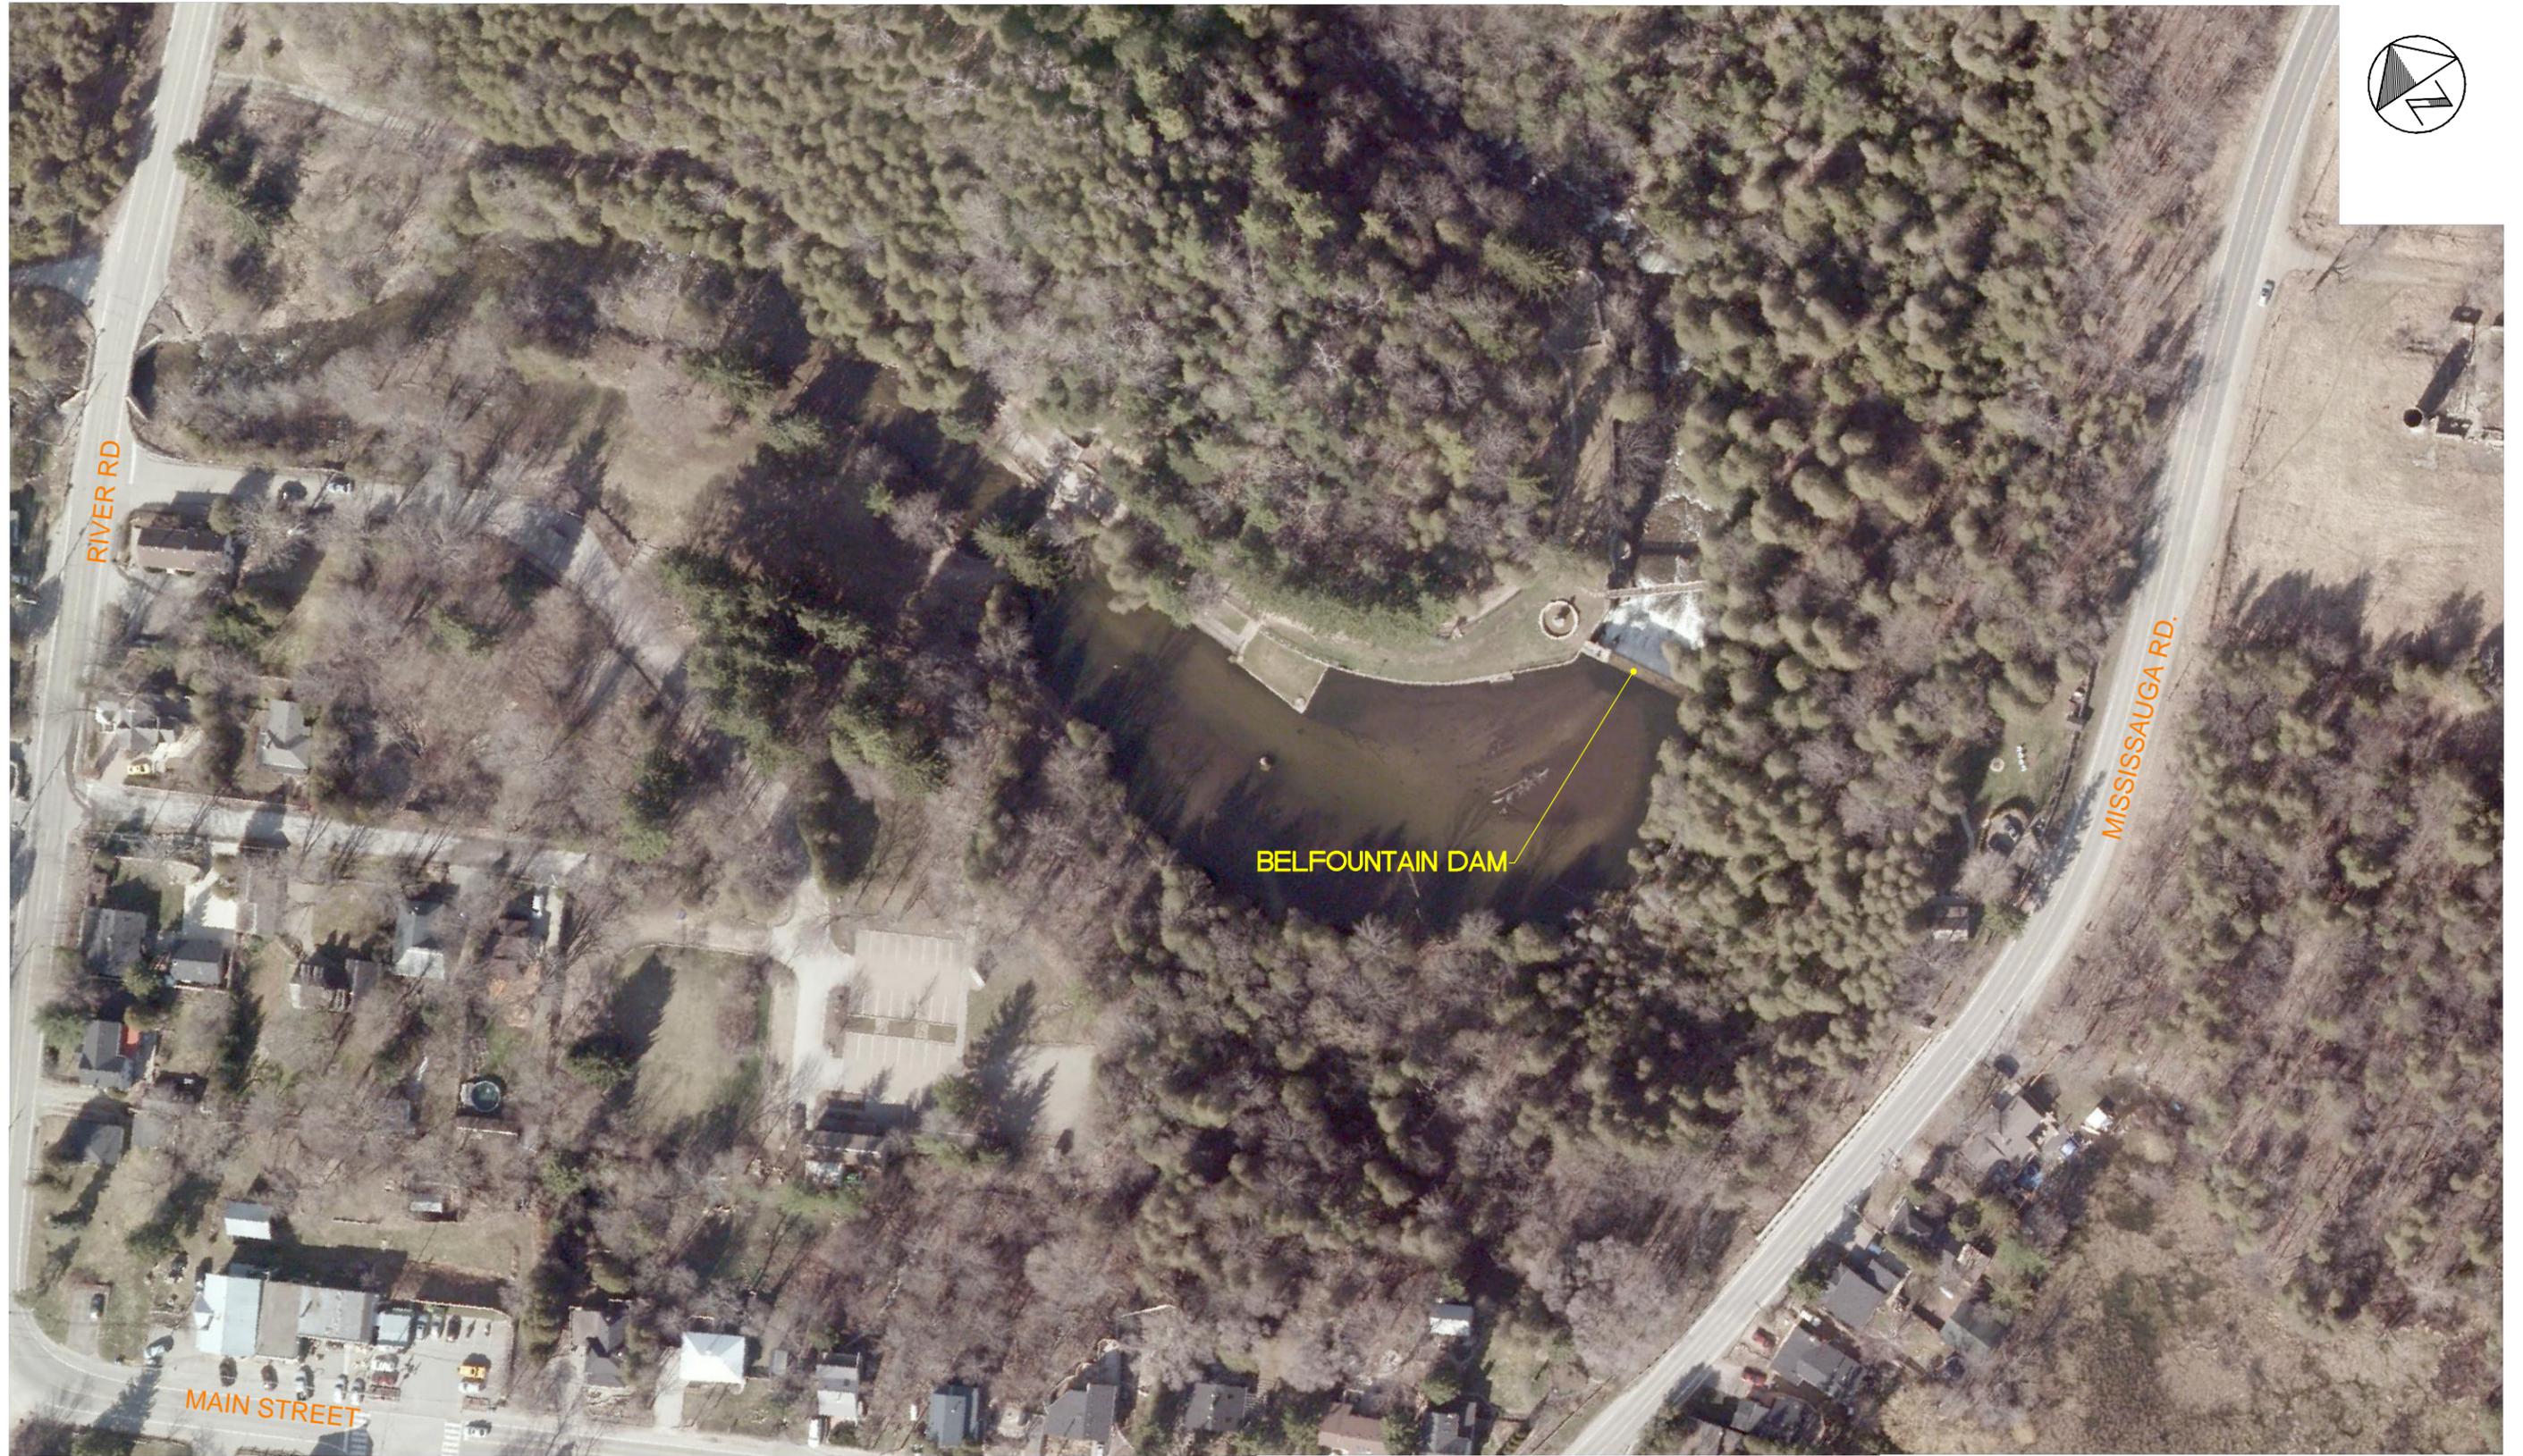
STUDY AREA

BELFOUNTAIN DAM AND
HEADPOND
CREDIT VALLEY CONSERVATION

The formal Study Area is comprised of the Belfountain Dam and Headpond and the immediate surrounding area that may be impacted by implementation of management alternatives (ref. Figure 1 and 2). The Study Area contains several anthropogenic and natural features including the Belfountain Dam and Headpond, other historic structures including the 'Yellowstone Cave', retaining walls and building foundations, a pedestrian bridge over the dam, a large terrace recreational area, the West Credit River and significant mature forest land. Appendix B provides a photographic catalogue depicting the Study Area in its current and historic states.
