LOW IMPACT DEVELOPMENT CERTIFICATION PROTOCOLS:
BIORETENTION PRACTICES

Version 1.0
2015

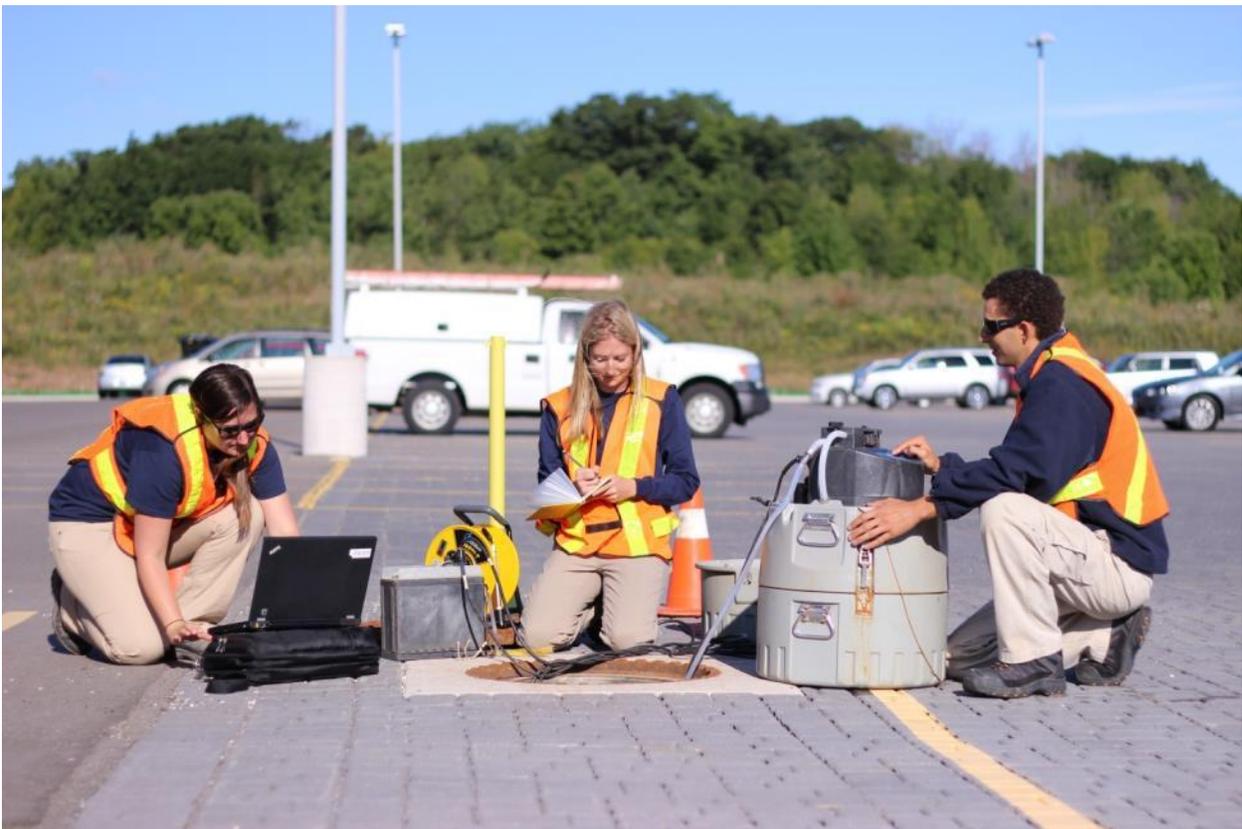
Example stormwater monitoring station (Source: CVC).

To assess runoff volume and pollutant load reduction, peak flow reduction, or both by monitoring a stormwater treatment practice, the inflow(s) and outflow(s) must be measured or estimated as in conducting a water budget. The summation of the inflows can then be compared to the summation of the outflows to determine the runoff volume reduction, peak flow reduction, or both. typical urban runoff events are flashy (rapid response) and require continuous flow measurement (or estimation). Pollutant loading changes will require state-of-the-art automated sampling devices to obtain flow-pace or time-weighted sampling that coupled with continuous flows allow estimation of loads.

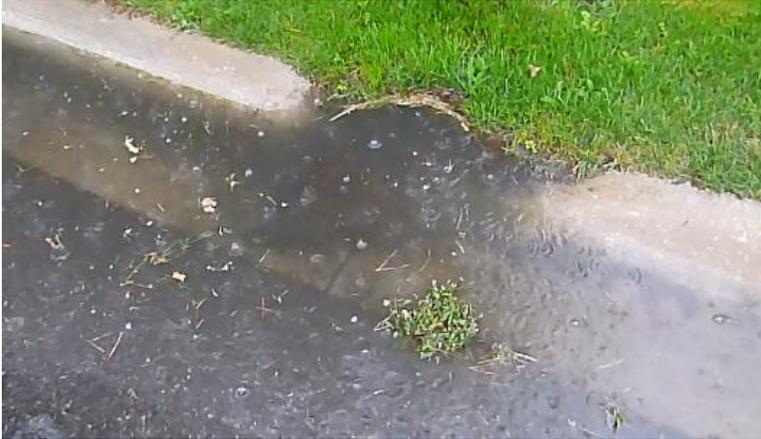
Bypassing of bioretention units during a rainfall event

Level 4 High-Intensity monitoring can be a key factor in identifying site deficiencies not caught by visual inspection. By examining the performance of the LID practices throughout multiple precipitation events, high-intensity monitoring identified an issue with the flow of stormwater through the bioretention units. While flow was being observed through the LID practices on the south side of the street, little to no flow was observed from those on the north side. From the data gathered, it was determined that the inlet design was not efficient at accepting water so the inlets should be replaced with a more efficient design.

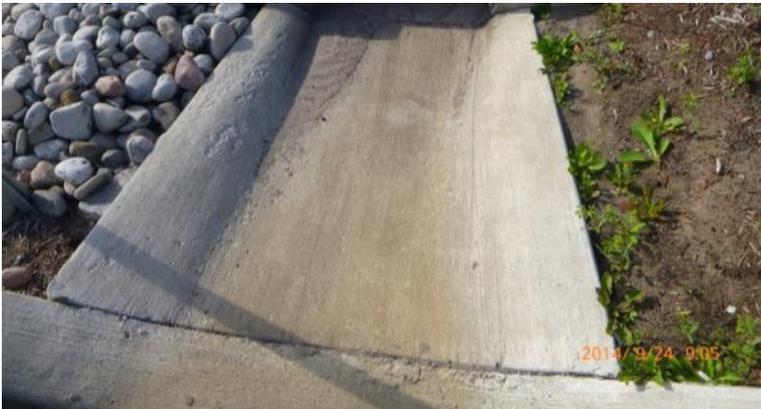
Example of inlet design that is more efficient to replace original inlet design.

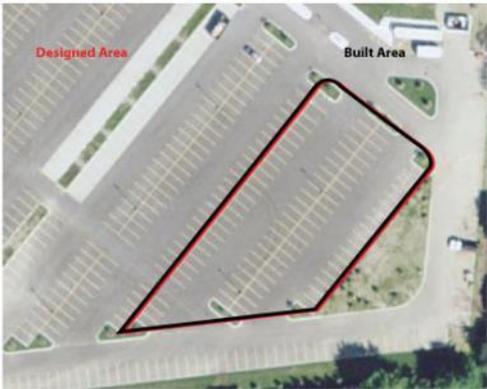
<p>PASS</p>

<p><i>Contributing drainage area matches design drawings.</i></p>	<p><i>Contributing drainage area is 5-10% different from design.</i></p>
<p>MODERATE</p>

Description: This indicator determines whether the contributing drainage area matches the original design. Bioretention facilities that are undersized can lead to the need for more frequent maintenance and repairs. Estimate drainage area during a rain event using a video camera to record runoff flow, then compare to design drainage area.

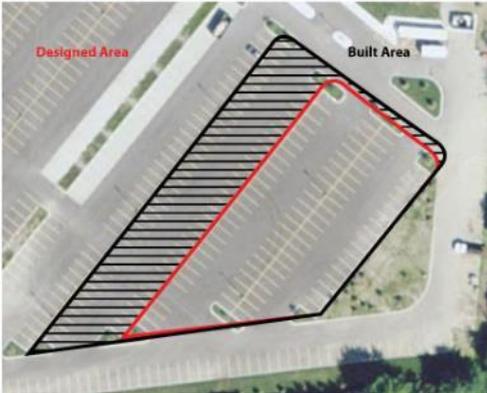
<p><i>Contributing drainage area is 10-25% different from design.</i></p>	<p><i>Contributing drainage area is >25% different from design.</i></p>

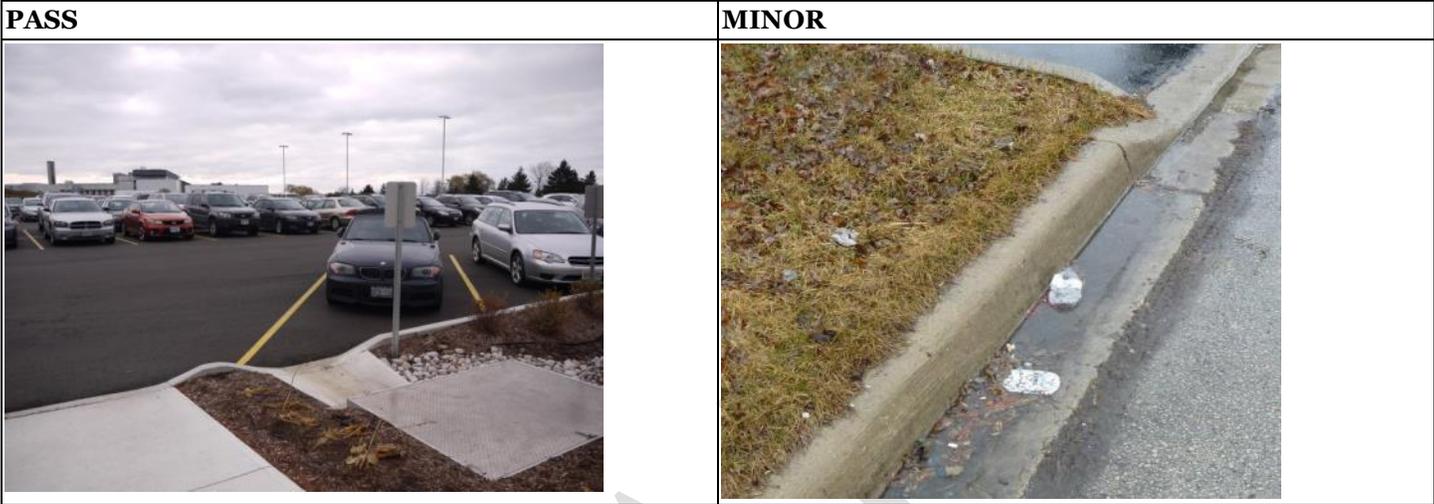
Description: This indicator determines if the contributing drainage area is littered with trash and organic debris. Trash and debris can block important parts of the bioretention like the inlets and outlets as well as take up valuable storage area.

<i>No evidence of trash and debris</i>	<i>Few pieces of trash and some organic debris</i>
--	--

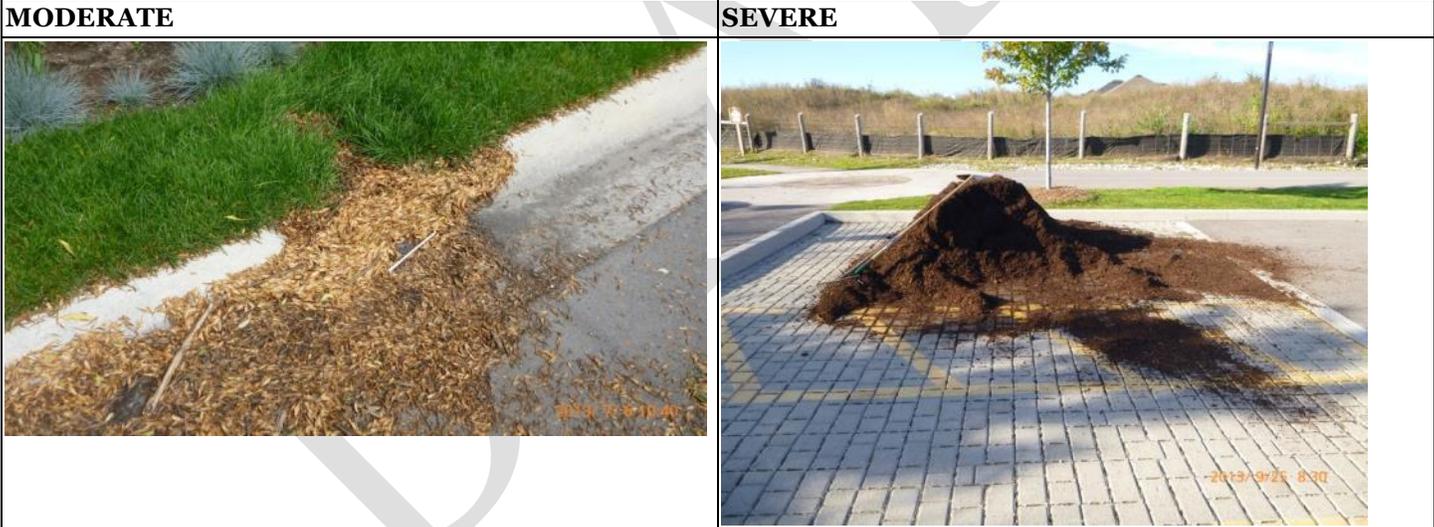
<i>Noticeable trash and debris accumulation</i>	<i>High trash and debris load is impacting bioretention area.</i>
---	---

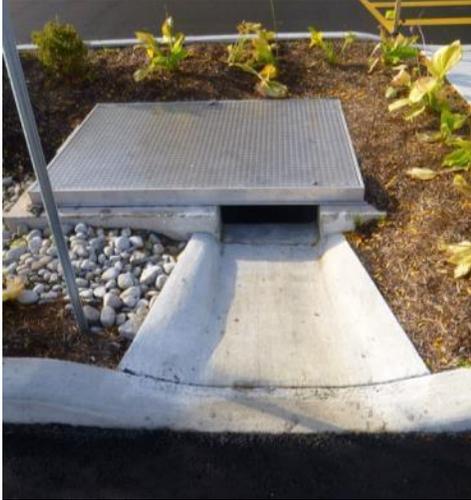
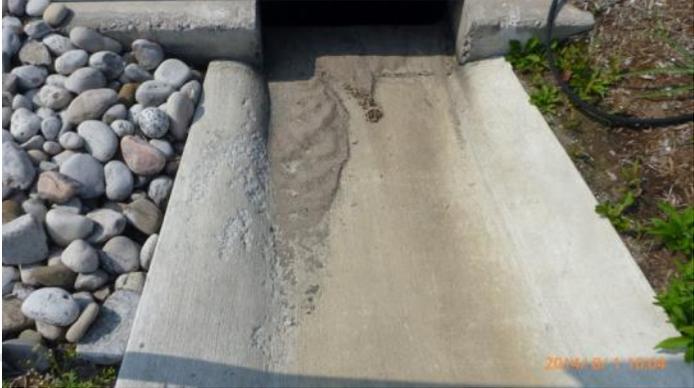
Description: Investigate the inlet for sediment, debris or turf that obstructs runoff from getting into the bioretention area, as well as proper grading that matches the design.

<i>This inlet is clean and in good condition.</i>	<i>There is a minor amount of sediment and/or debris build up at the inlet.</i>
MODERATE	SEVERE

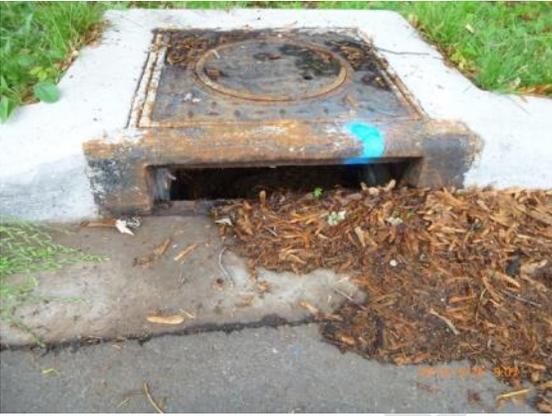
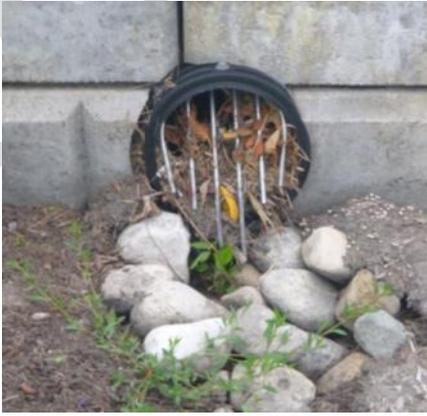
<i>The moderate amount of sediment accumulation and weed growth indicates an entry problem that could lead to a risk of blockage.</i>	<i>Sediment build-up or staining indicates that water is ponding and a significant amount of runoff is not getting into the facility.</i>

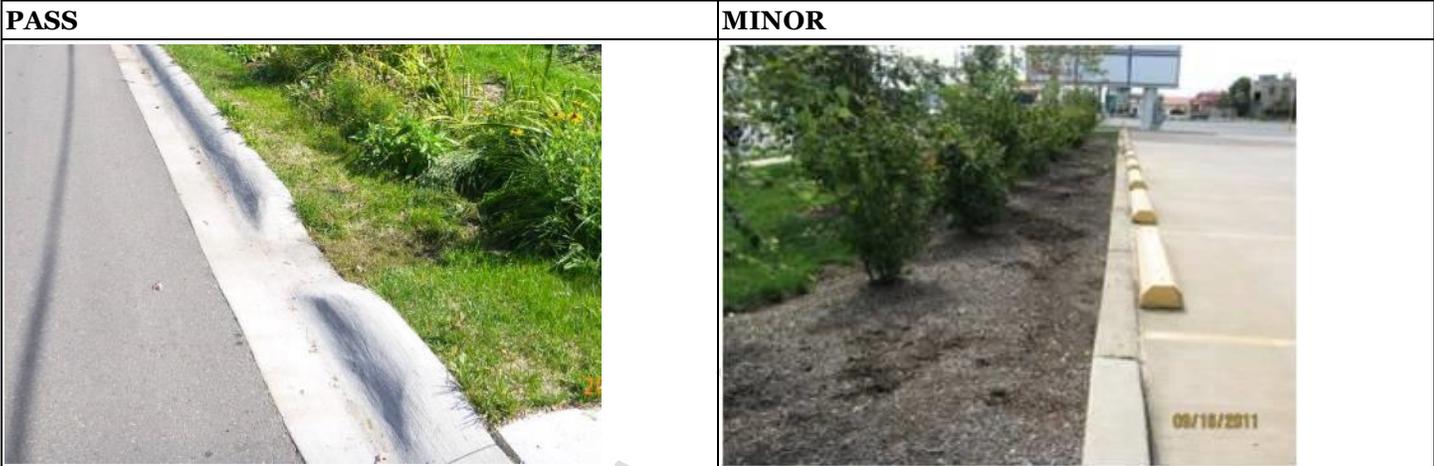
Description: Investigate the inlet for evidence of channelized erosion or scour. This indicates improper elevations or a preferential flow path within the facility.

Inlet is in good condition, no evidence of erosion.

Surface runoff from parking lot is causing minor erosion of mulch at inlet.

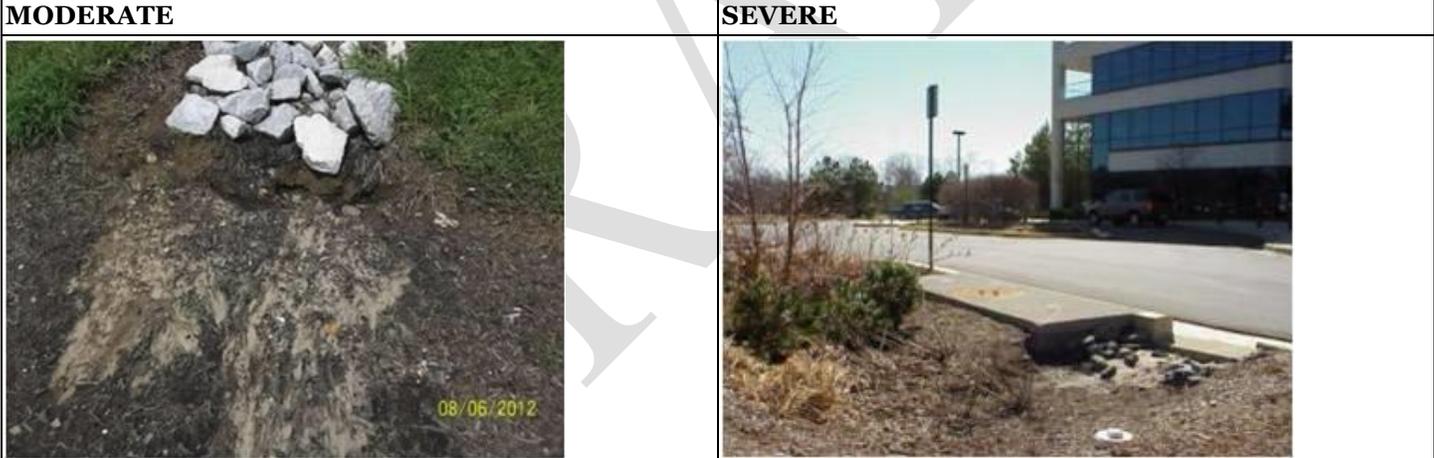
Concentrated flow results in moderate erosion at inlet. Investigation into cause is necessary as could result in more severe condition.

Scour is occurring at the inlet indicates a possible design flaw.

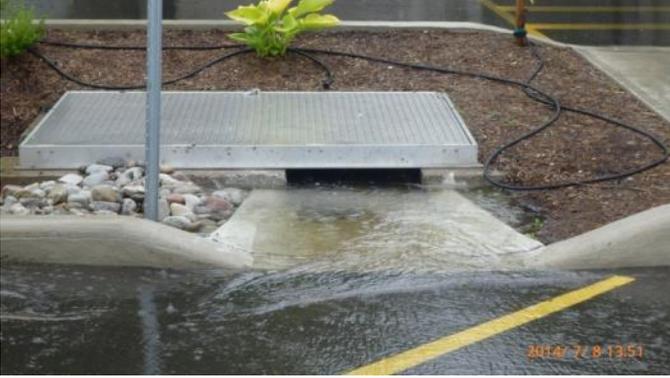
Description: During a rain event, this indicator evaluates whether water is flowing adequately into the bioretention cell.

<p><i>Water easily enters.</i></p>	<p>MINOR</p>

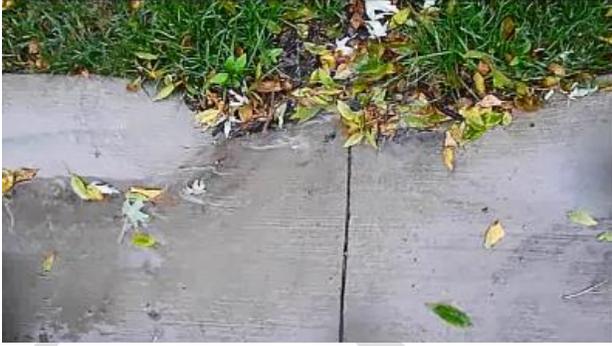
<p><i>Some bypass</i></p>
<p>MODERATE</p>

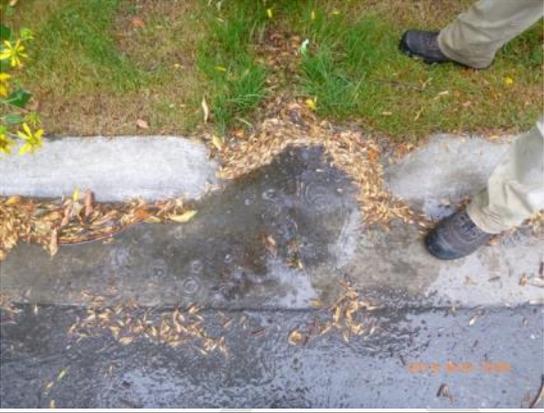
<p><i>Most of water is bypassing.</i></p>	<p>SEVERE</p>

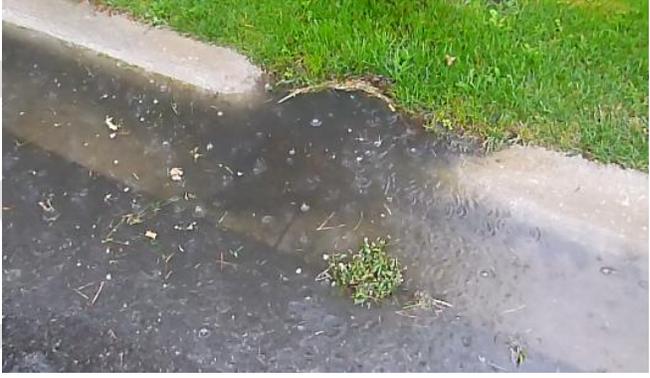
<p><i>Water is completely bypassing the bioretention cell</i></p>

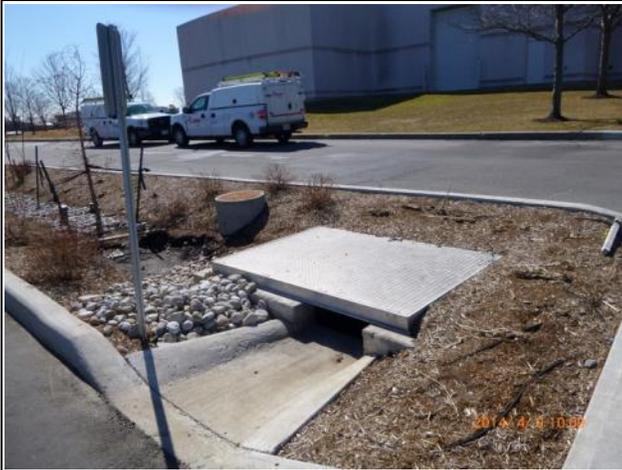
Description: This indicator evaluates whether pre-treatment exists at the facility and whether it needs to be cleaned out. Pre-treatment is necessary to trap sediment and debris before it reaches and clogs the filter bed. Pre-treatment methods vary by bioretention design but the visual indicators approach would be similar for all.

This pretreatment measure is free and clear of sediment/debris.

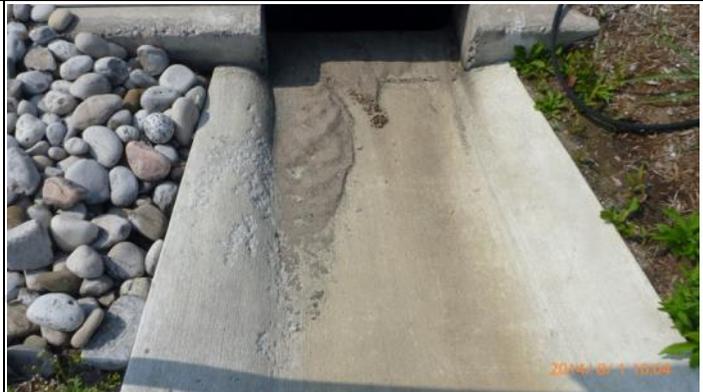
Slight accumulation of sediment in the pretreatment cell.

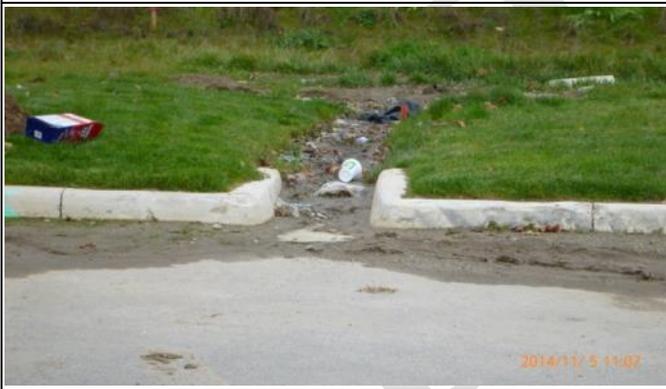
Pretreatment measures needed at this facility. Sediment deposition has almost entirely clogged the inlet.

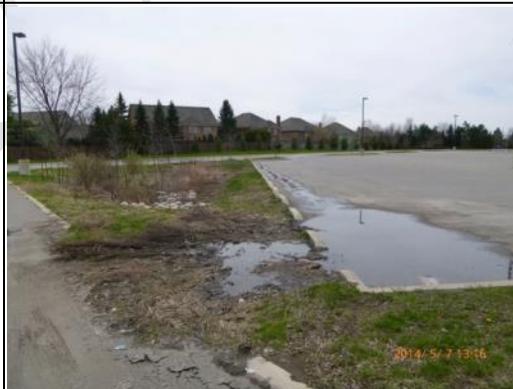
Lack of pretreatment or inadequate pretreatment has led to facility failure.

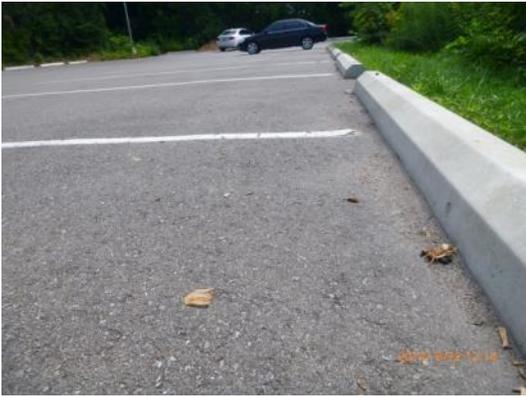
Description: This indicator assesses whether the facility is causing damage to adjacent pavement and curbs. Flows, scour or water seepage are usually the cause of the damage.

Surrounding curbs and pavement are in good condition.

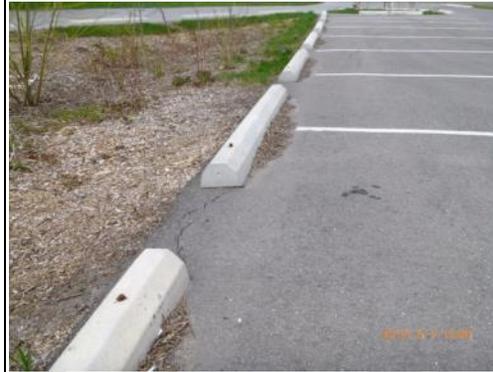
Some pavement cracking occurring in surrounding pavement.

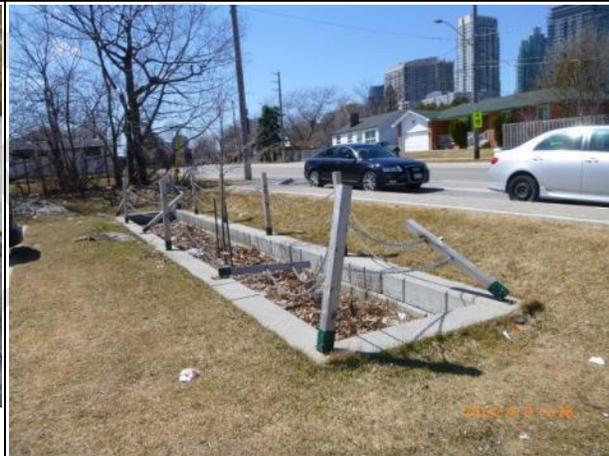
Major problems with adjacent curbs and/or pavement. Design repair needed.

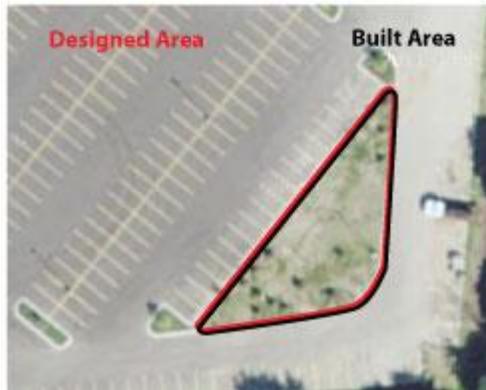
Description: This indicator determines whether the bioretention facility matches the original surface area of the design. Bioretention facilities that are undersized can lead to the need for more frequent maintenance and repairs. Use a measuring tape to estimate the facility area and compare to design area.

Constructed bioretention surface area matches design.

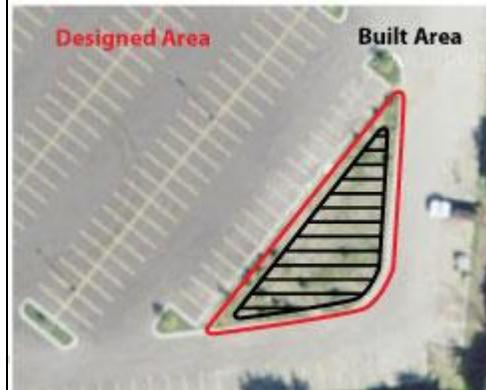
Constructed bioretention surface area is 5-10% different than design (outline).

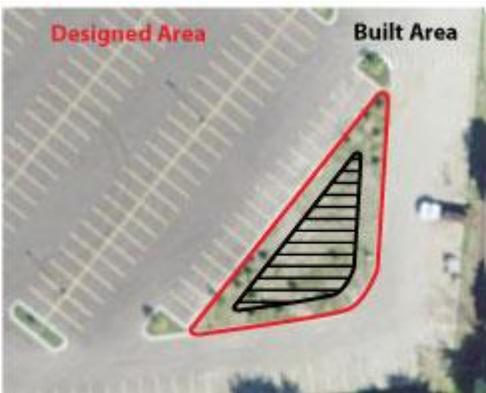
Constructed bioretention surface area is 10-25% different than design (outline).

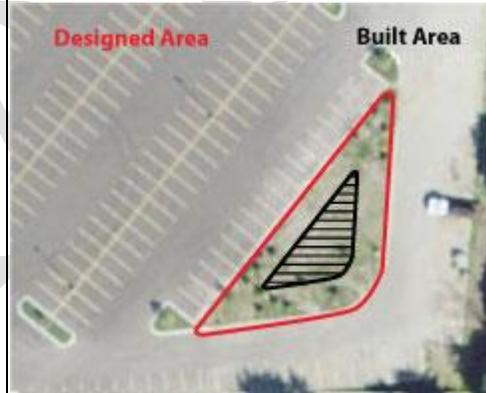
Constructed bioretention surface area is over 25% different than design (outline).

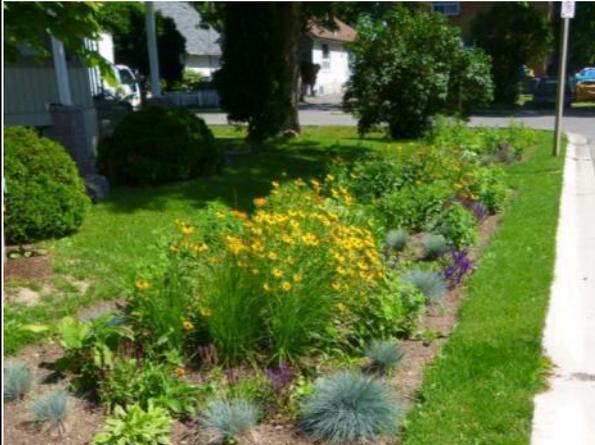
Description: This indicator evaluates the stability of the side slopes of the bioretention area which should be 3:1 or flatter. Erosion of the side slopes can indicate a problem with grading or incoming runoff velocities and may require better inflow protection measures.

There is no evidence of side slope erosion occurring in this bioretention.

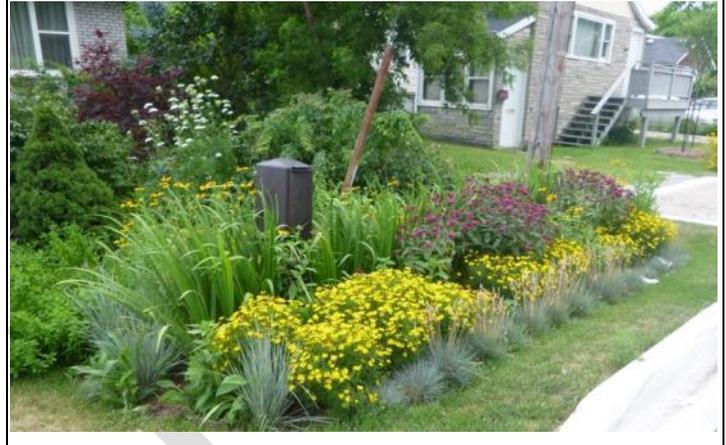
There is minor side slope erosion occurring as a result of overland flow of water into the bioretention facility.

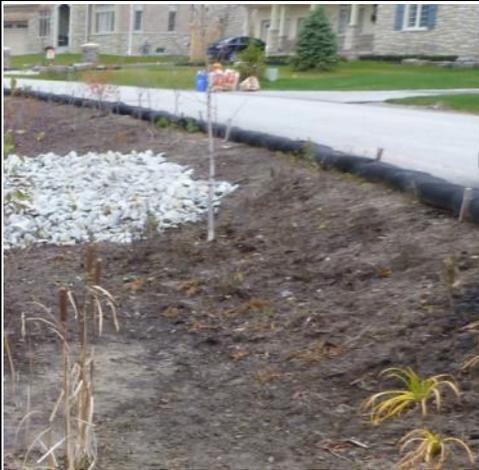
The side slopes in this bioretention are too steep which is causing moderate erosion.

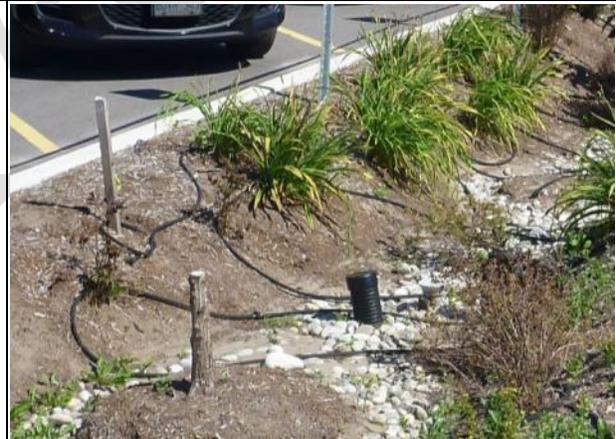
Severe side slope erosion is occurring.

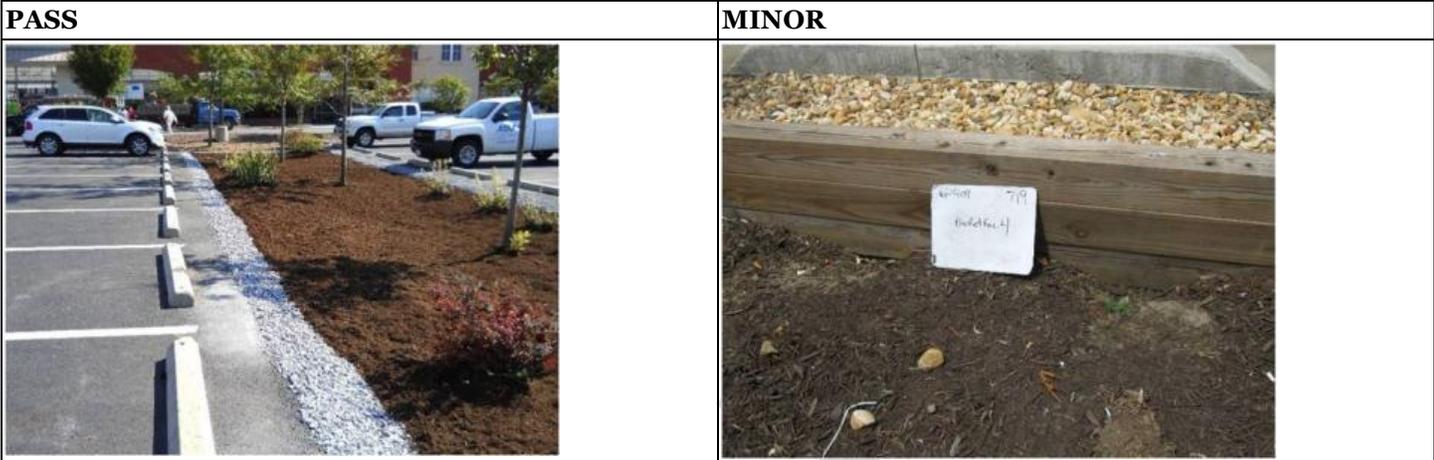
Description: This indicator determines whether any localized depressions or sink holes are present within the bed of the bioretention facility. This could indicate potential underground problems with the soil media, filter cloth, the stone layer and/or underdrain.

Even, flat bed, with no evidence of sinking

Minor, localized sinking occurring, likely cause is settling of the bioretention soil.

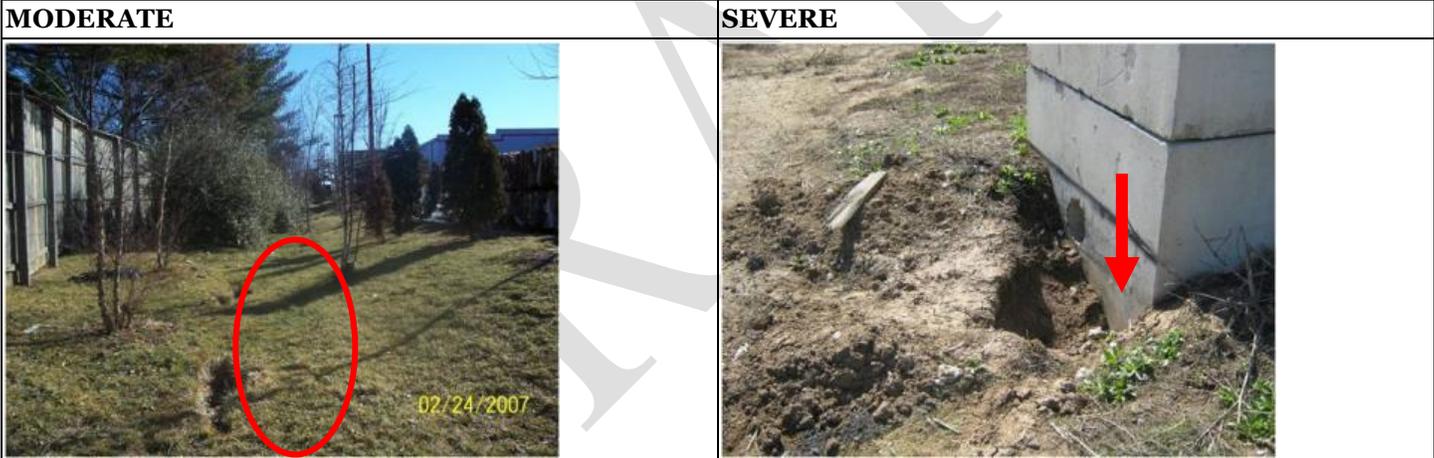
Moderate, localized sinking occurring

Severe sinking occurring at overflow structure.

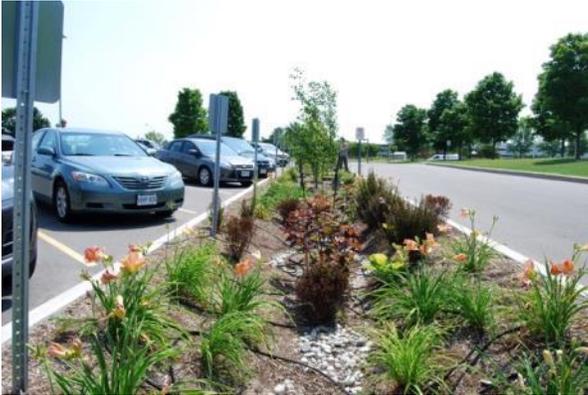
Description: This indicator determines if sediment caking or deposits exist in the bed that could impair the performance of the facility. This could indicate a source of sediment in the contributing drainage area or problems with the pre-treatment measures.

Bioretention in good condition. Free of sediment and caking.

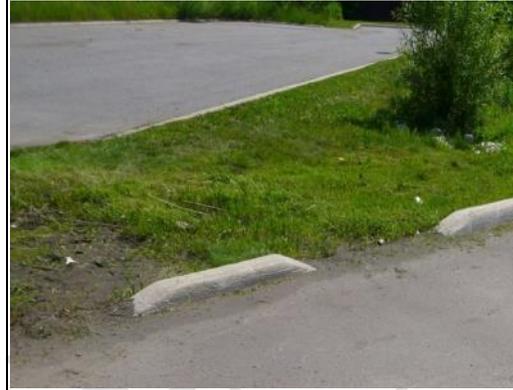
Thin and isolated areas of sedimentation caking.

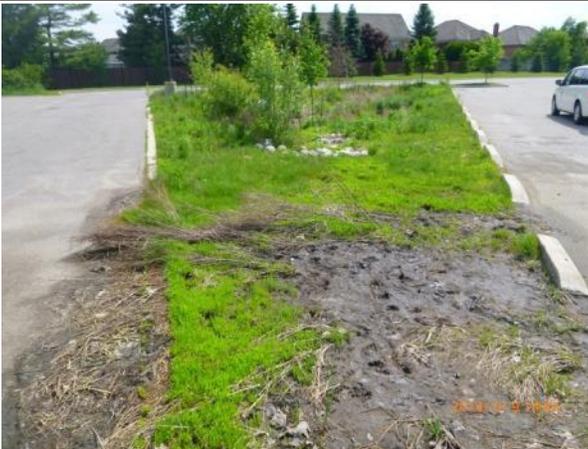
Thin but widespread sedimentation occurring.

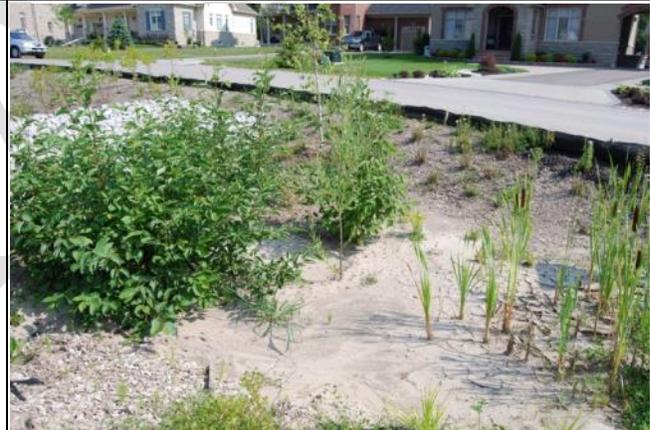
Severe sedimentation occurring; bioretention most likely clogged.

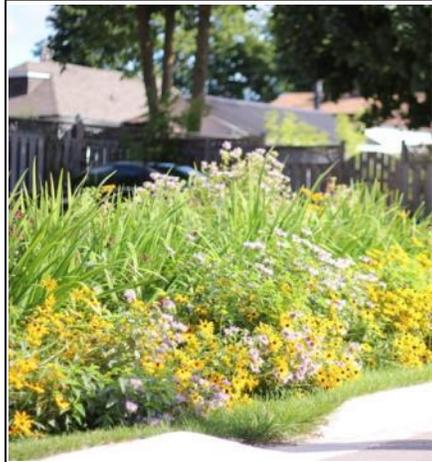
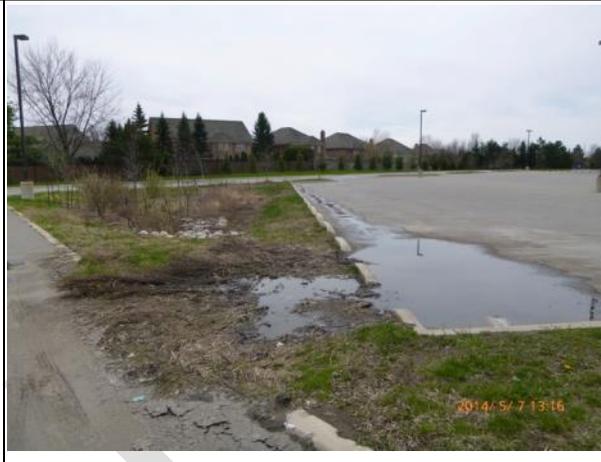
#12	STANDING WATER	24HR
<p><i>Description:</i> This indicator determines if the bioretention facility is functioning properly. Bioretention facilities are designed to be free of standing water 24 hours after the end of a storm event. Standing water or evidence thereof indicates a problem within the facility.</p>

<p><i>Bioretention in good condition, no evidence of standing water.</i></p>	<p><i>Saturated soils indicate presence of standing water.</i></p>
MODERATE	SEVERE

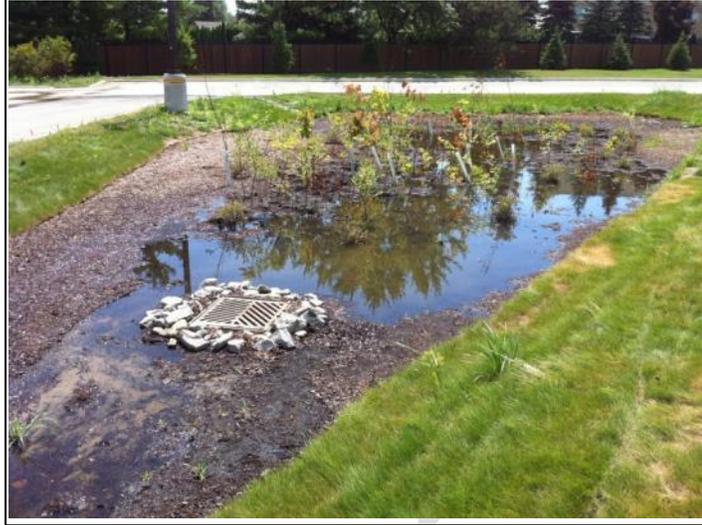
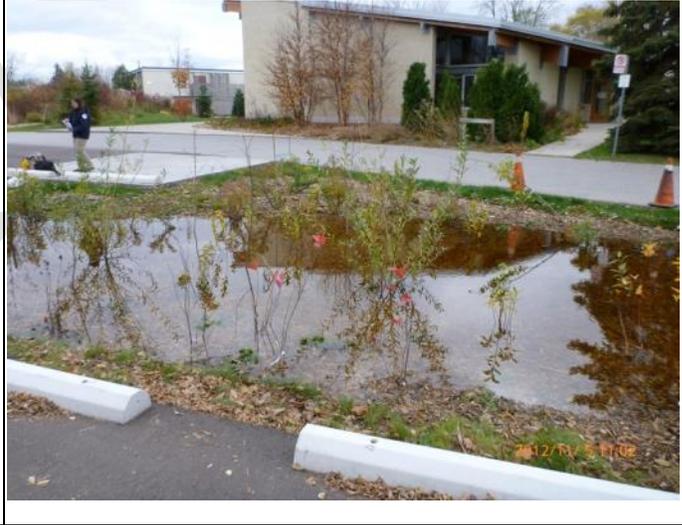
<p><i>Isolated areas of shallow standing water 24 hours after the end of an event.</i></p>	<p><i>Widespread standing water for more than 24 hours after the end of an event indicates facility failure.</i></p>

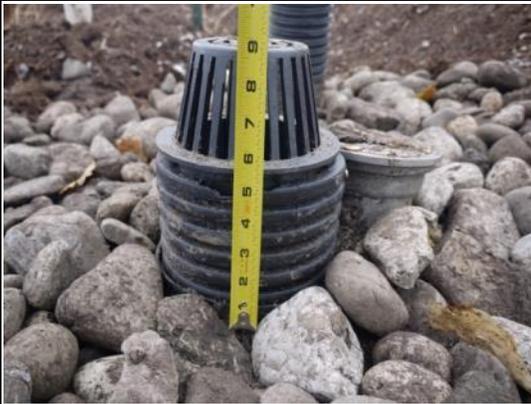
Description: This indicator determines whether the current ponding volume of the bioretention facility matches the design. Ponding areas that are too shallow are an indication that the bioretention does not provide the correct amount of storage whereas ponding areas that are too deep cause a safety and performance problem. If there is no overflow pipe, run string line from outfall and measure to base of swale.

Ponding depth should be measured and compared to the original design. 150-300mm is standard for most bioretention facilities.

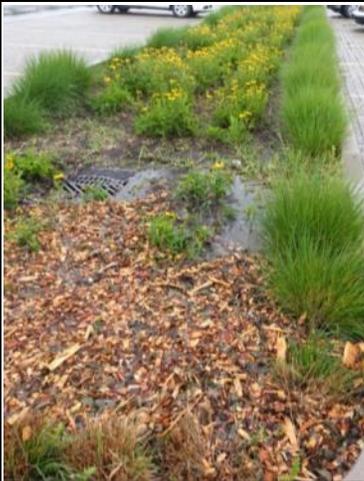
MODERATE

The ponding depth of this facility is significantly shallower than originally designed.

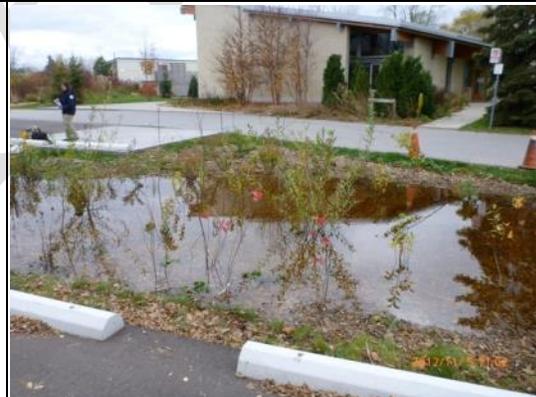
**SEVERE**

The ponding depth of this facility is significantly deeper than originally designed.

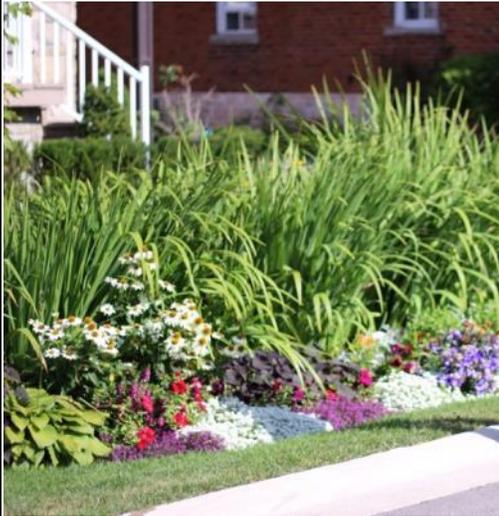
PASS

Bioretention in good condition. Good mulch depth and/or ground cover.

Description: This indicator assesses the mulch depth and condition in the bioretention area which should be 50-75mm deep unless the bed has significant ground cover (>75%). This visual indicator also assesses that there is not too much mulch in the facility which could lead to nutrient leaching, the loss of ponding depth, or smothering plant roots.

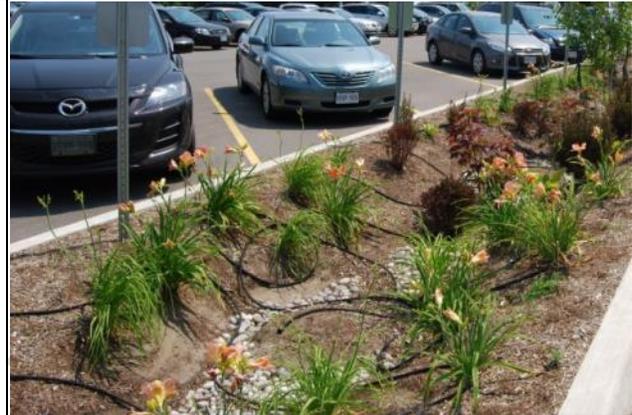
MINOR

Slight displacement occurring. Add mulch and/or ground cover.

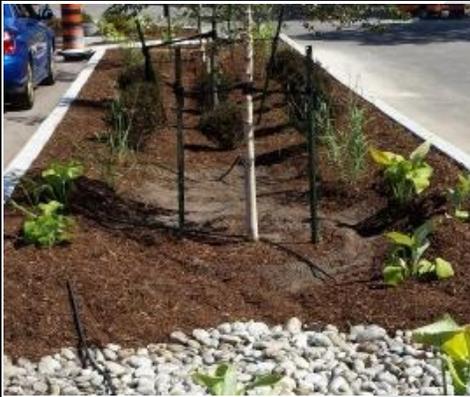
MODERATE

Level of mulch is blocking curb inlet.

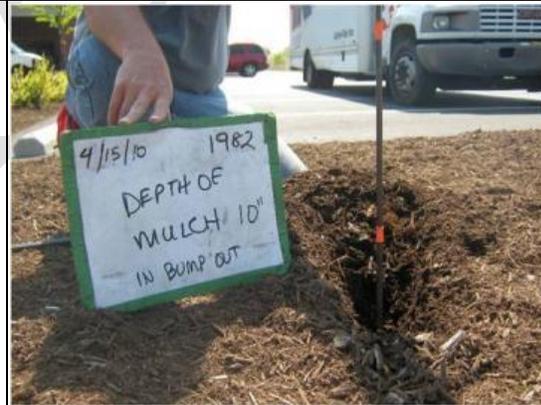
SEVERE

10" of mulch indicates maintenance crew not aware of function of facility.

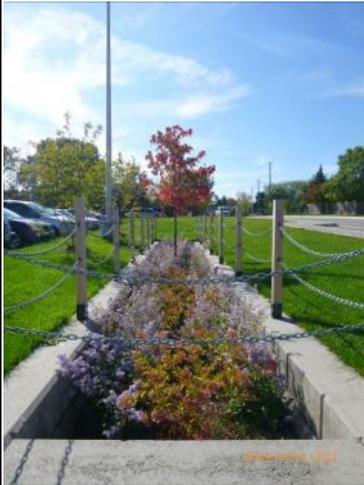
PASS

No trash in bed area

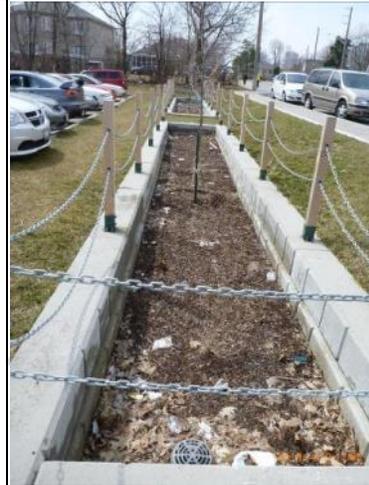
MINOR

Some trash and organic debris in bed area

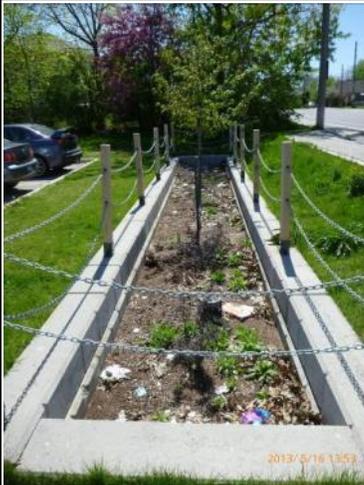
MODERATE

Significant trash and organic debris in bed area

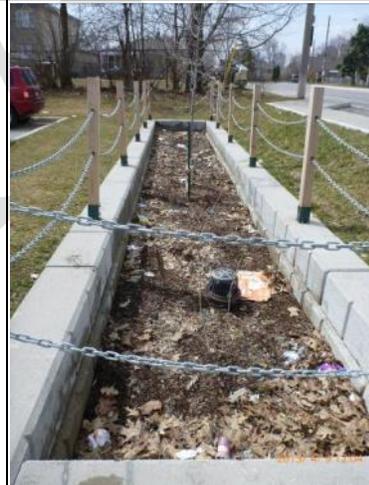
SEVERE

Significant trash and organic debris in bed area negatively is affecting performance.

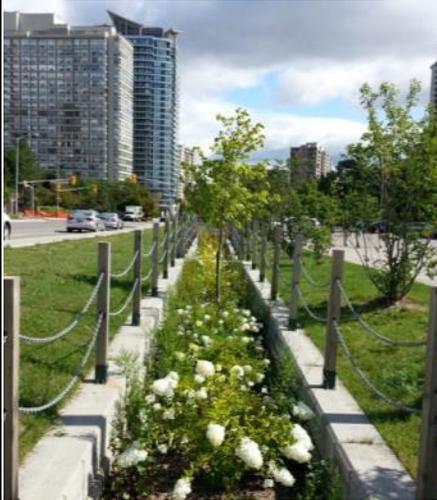
PASS

Bioretention is in good condition – no bed erosion occurring.

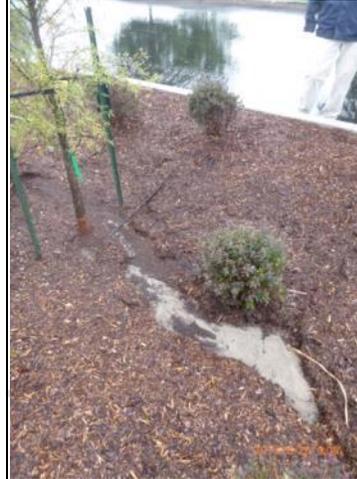
MINOR

Minor bed erosion or displacement is occurring as a result of a larger storm event.

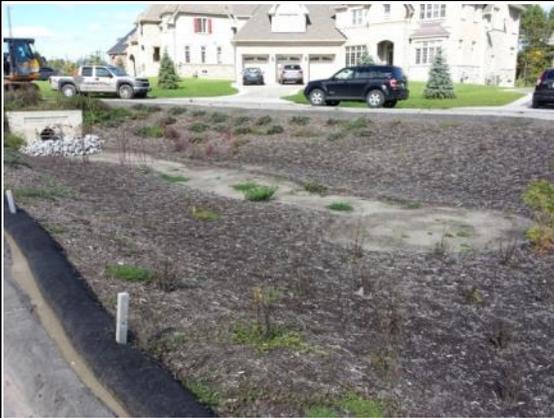
MODERATE

Significant bed erosion is occurring leading to a preferential flow path.

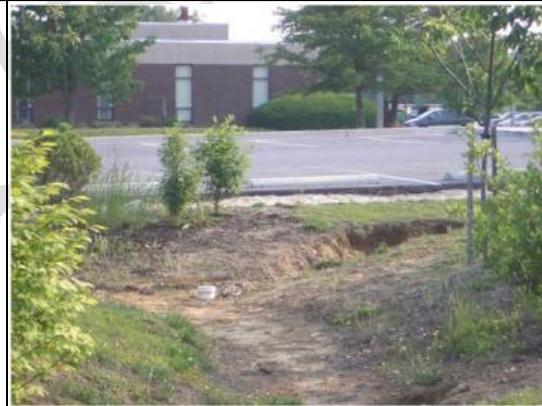
SEVERE

Severe bed erosion demonstrates that the bioretention may be undersized for the volume of runoff it is receiving or inadequate flow spreading throughout the facility.

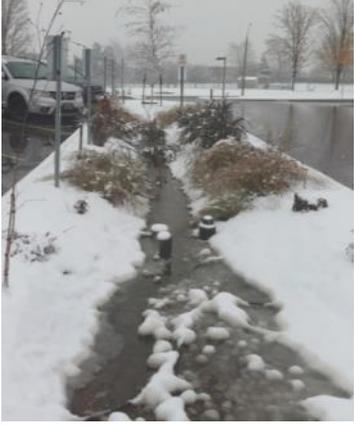
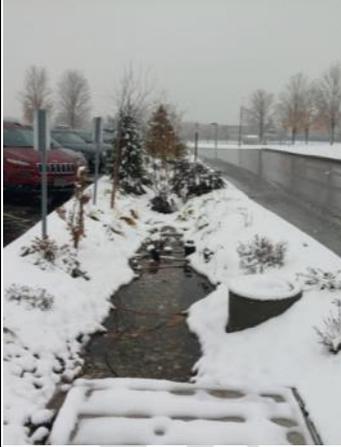
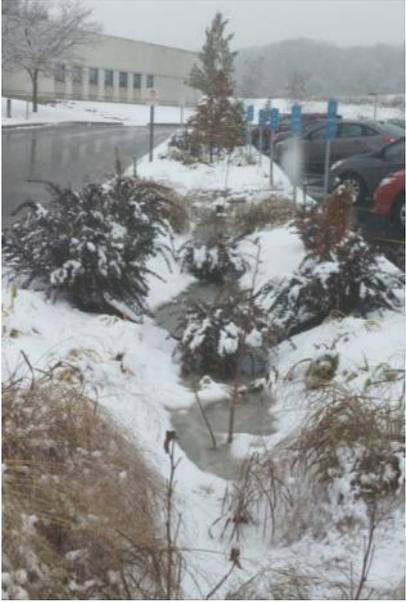
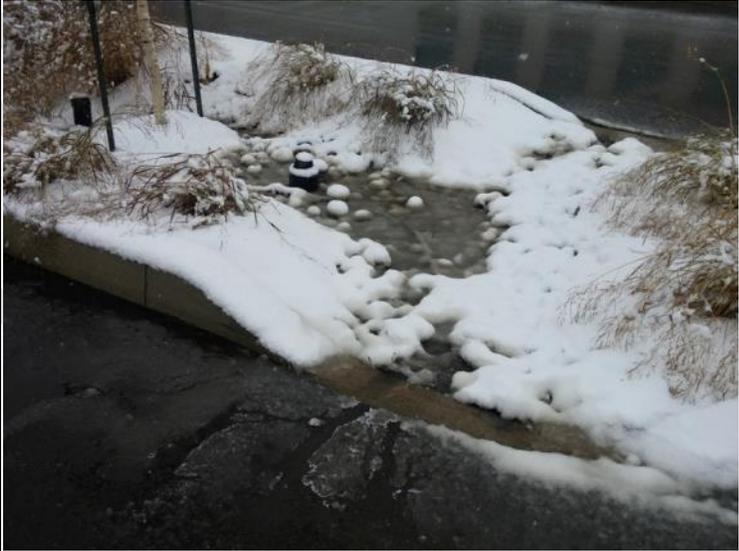
<i>Water is evenly distributed throughout bioretention cell.</i>	
MODERATE	SEVERE

CORRECTION TRIGGER	RECOMMENDED ACTION
PASS	Water is evenly distributed throughout bioretention cell.	None.
MINOR	Water is distributed at least half of the bioretention cell	Fine grade bioretention media and mulch to allow for positive drainage
MODERATE	Most of the water is concentrated at one end of the bioretention cell	Regrade bioretention cell to allow for positive drainage
SEVERE	Water is not being distributed to parts of the bioretention cell.	Regrade bioretention cell to allow for positive drainage

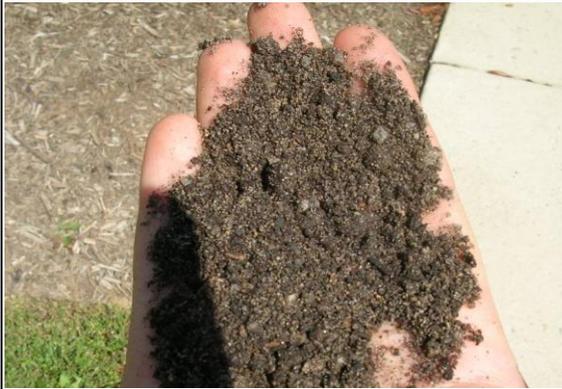
PASS

Soil has a high sand content to allow for quick infiltration of water.

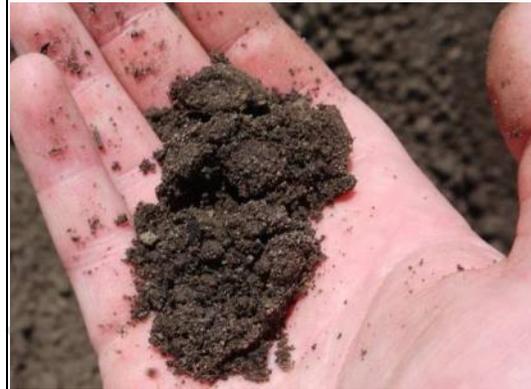
MINOR

Soil is sandy but has clumps. Some clumps may be organic matter, but others could contain clay.

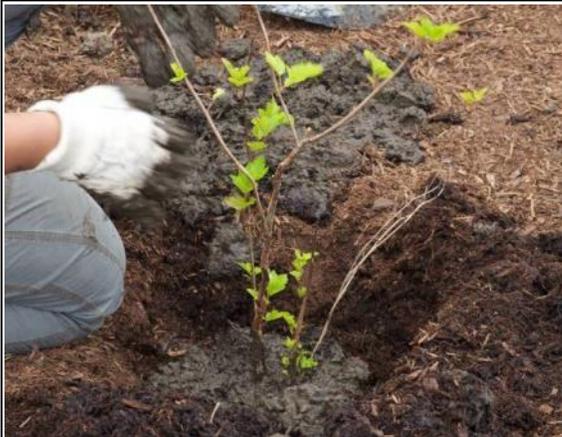
MODERATE

Soil is cohesive or sticking together when wet and there are signs that the practice is not draining quickly.

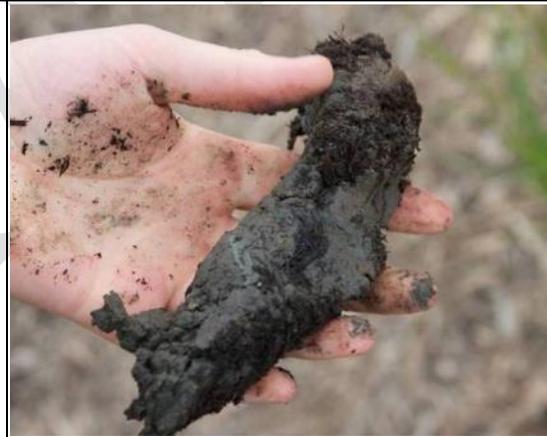
SEVERE

Soil has a high clay content which holds water and has a very slow infiltration rate.

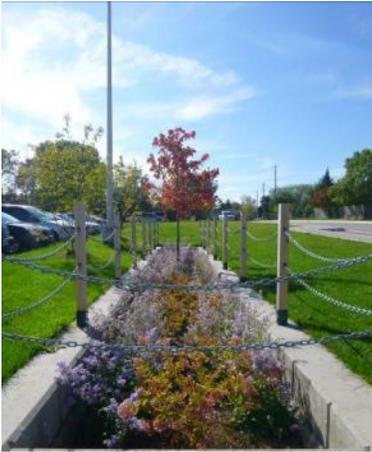
PASS

This bioretention has good vegetative cover.

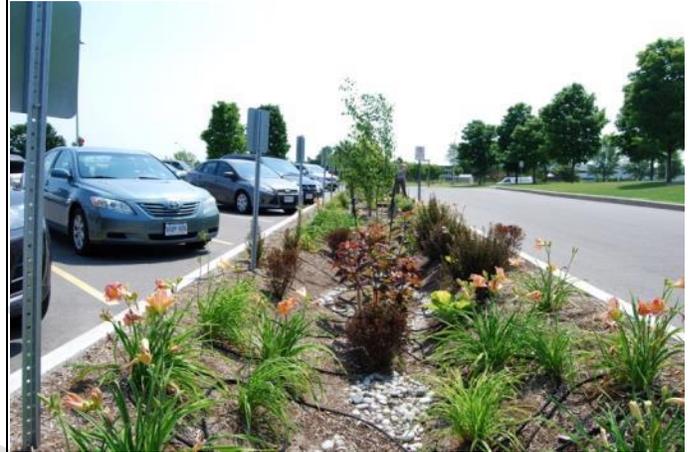
MINOR

This bioretention has a few bare spots and could use spot planting.

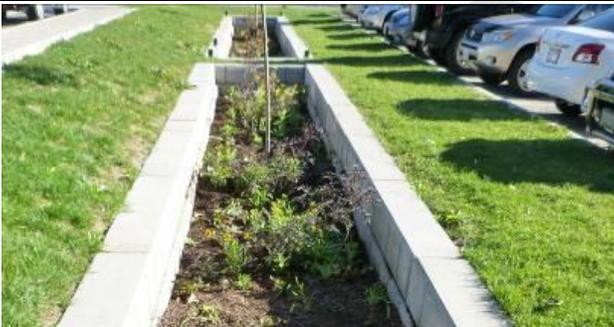
MODERATE

This bioretention has less than 75% vegetative coverage and is probably not functioning to its full potential.

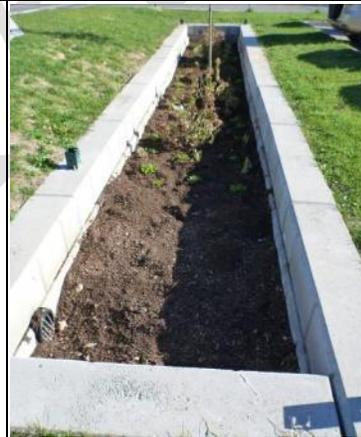
SEVERE

Vegetation is not growing in this bioretention as a result of it not being an environment conducive to vegetation or poor maintenance is occurring.

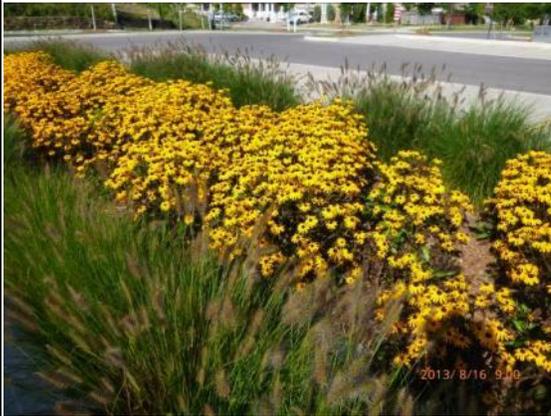
PASS

>80% of plants are thriving, and <5% are dead or diseased.
