LOW IMPACT DEVELOPMENT CERTIFICATION PROTOCOLS:
BIORETENTION PRACTICES

Version 1.0
2015

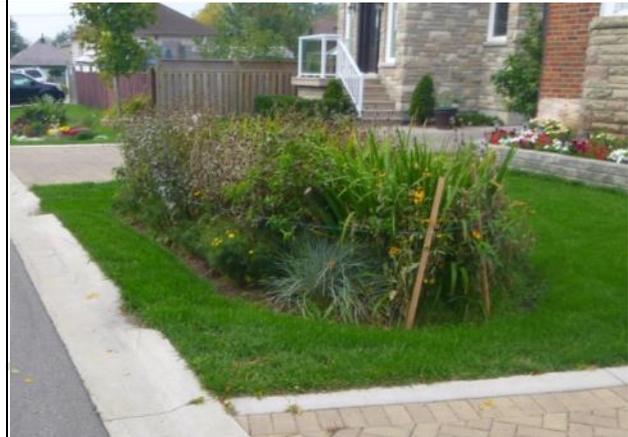
MINOR

5-20% of plants are dead or diseased.

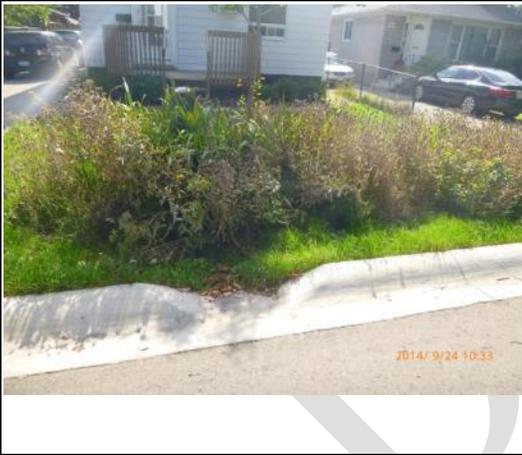
MODERATE

20-60 % of plants are dead or diseased.

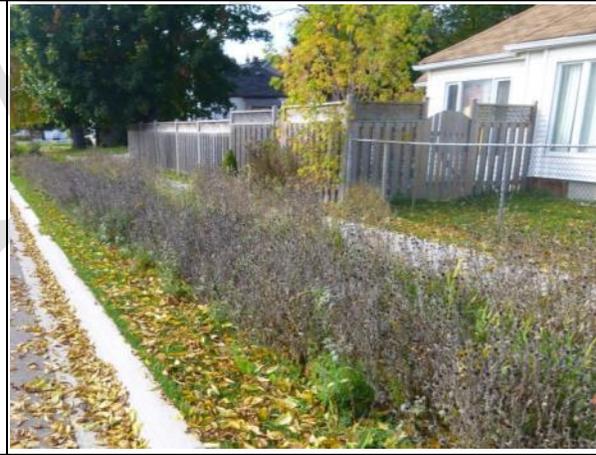
SEVERE

Over 60% of the plants are dead or diseased.

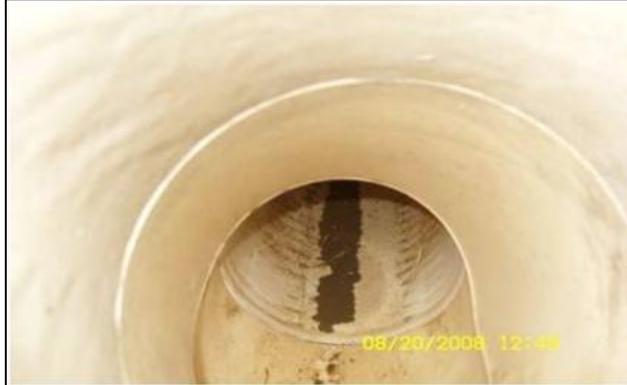
PASS

This underdrain is mainly free of sediment and debris.

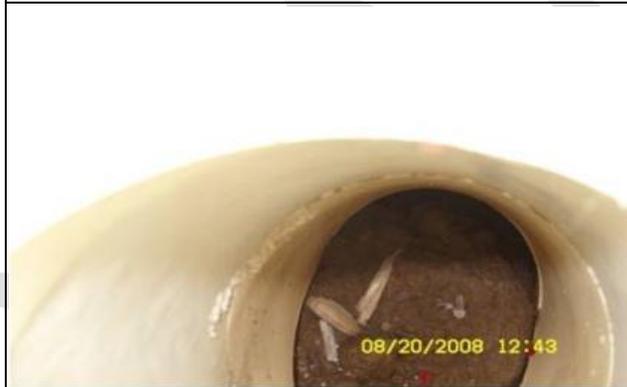
MODERATE

This underdrain is clogged with sediment. Further investigation is needed to determine the cause of the problem.

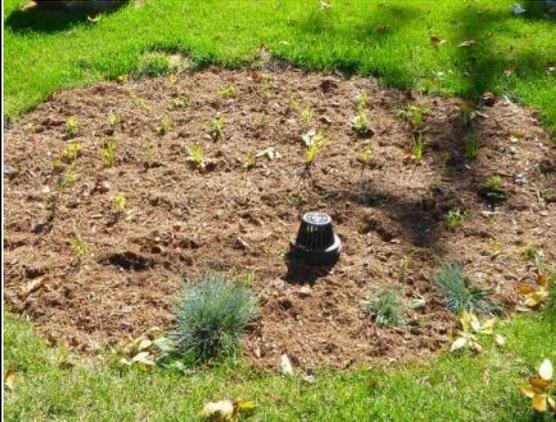
PASS

Outlet is clear and able to accept overflow.

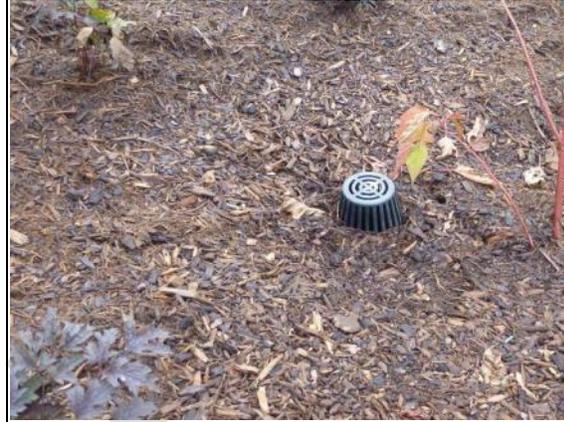
MINOR

Outlet is partially blocked, but still able to accept overflow.

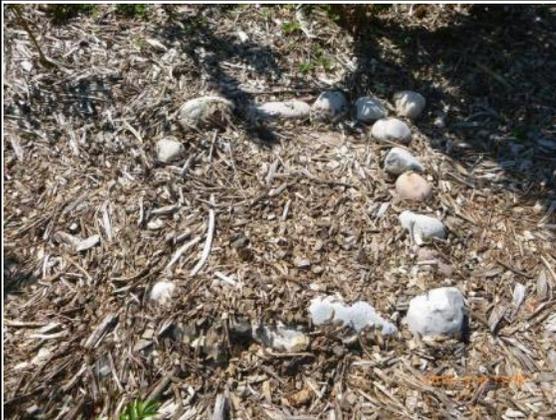
MODERATE

Outlet is covered but location is still visible.

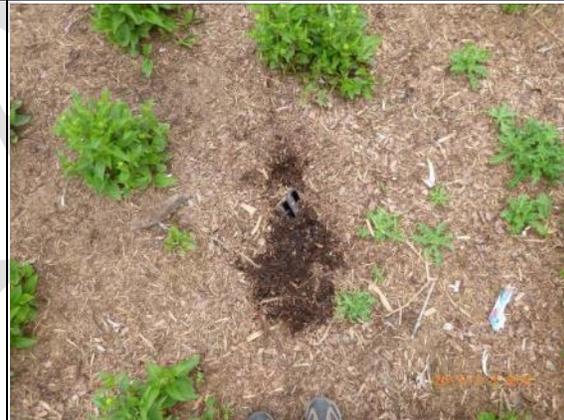
SEVERE

Outlet is completely covered and could not be located under debris. Overflow could not enter.

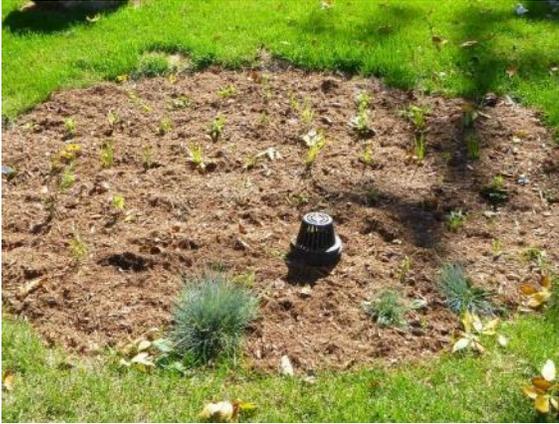
PASS

Outlet is present and in good working condition

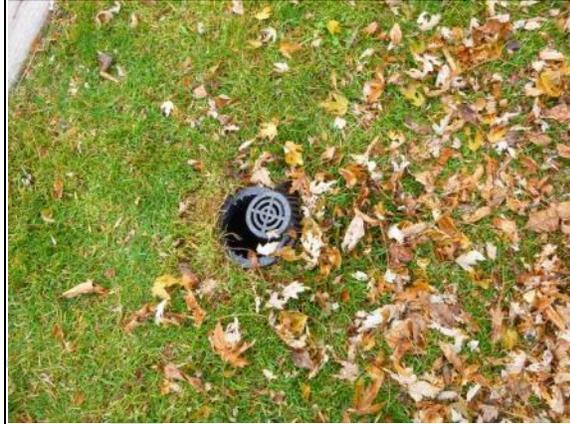
MINOR

Outlet is partially damaged, but still able to prevent debris from entering.

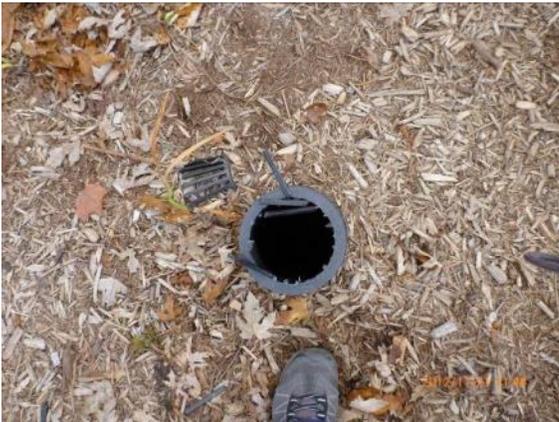
MODERATE

Outlet is damaged and should be replaced to prevent debris from entering.

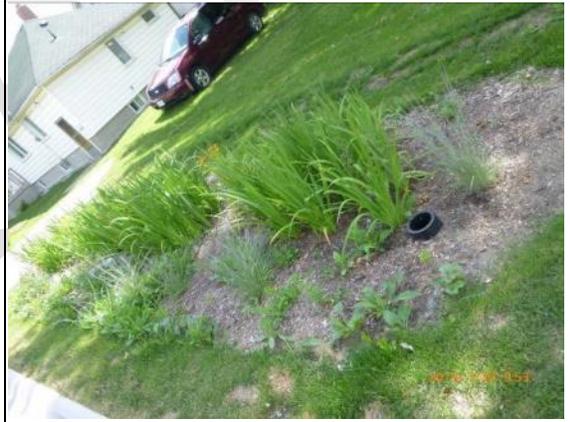
SEVERE

Outlet is completely missing, should be replaced immediately.

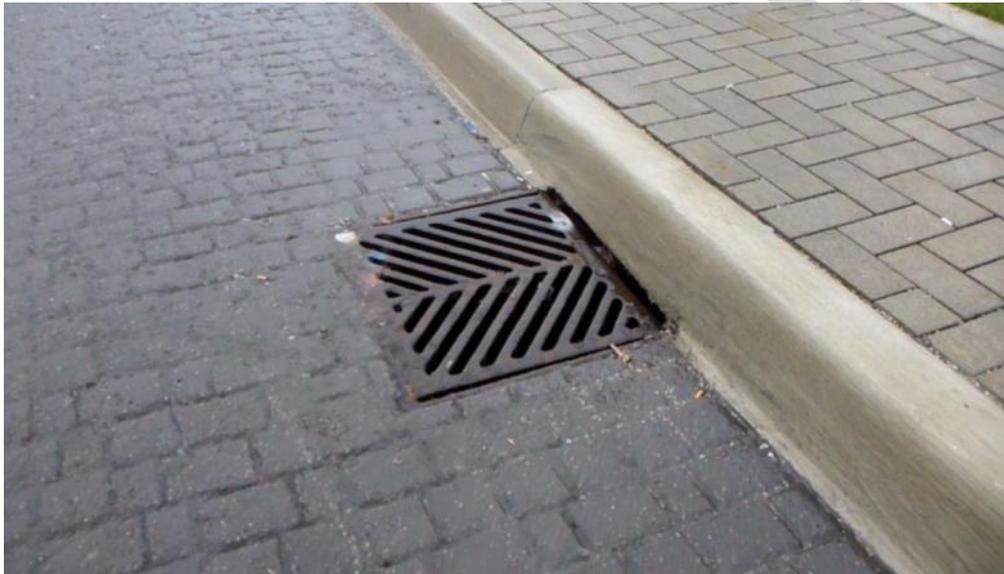
Still image from a video of water flowing into an inlet catchbasin during a rain event

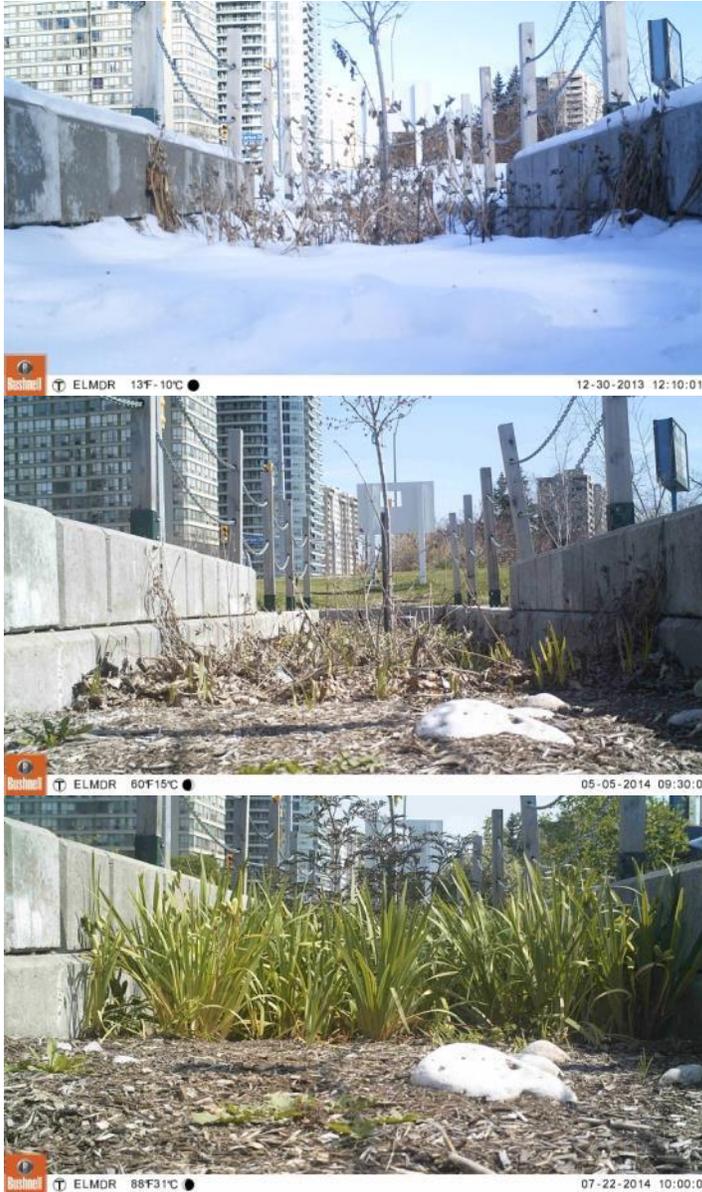
Photos from a trail camera installed in a bioretention showing seasonal variations

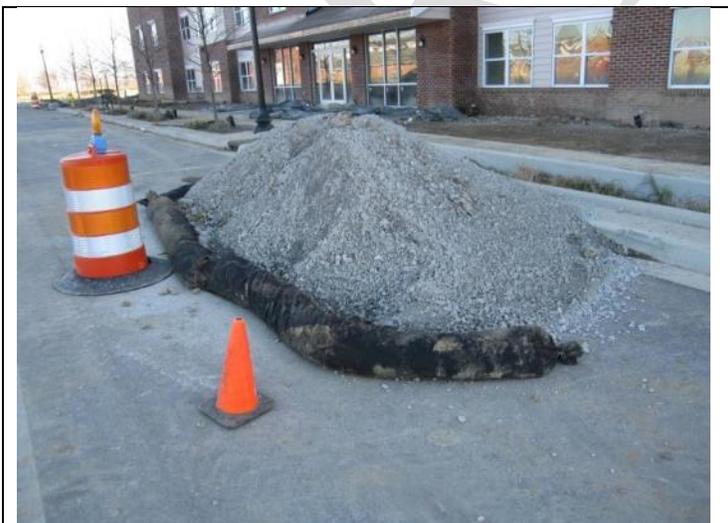
Proper material stockpiling practice in a bioretention planter drainage area.

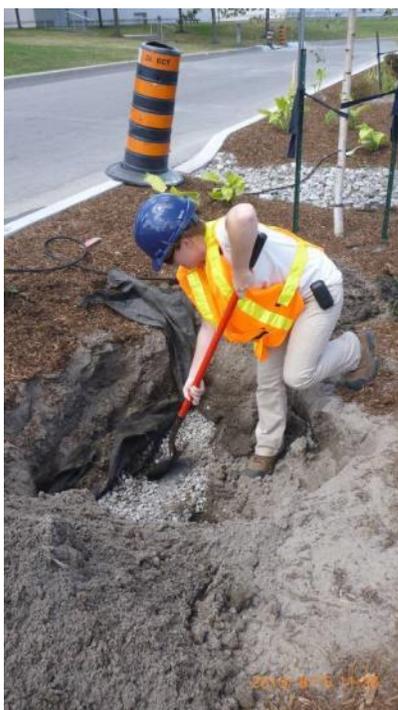
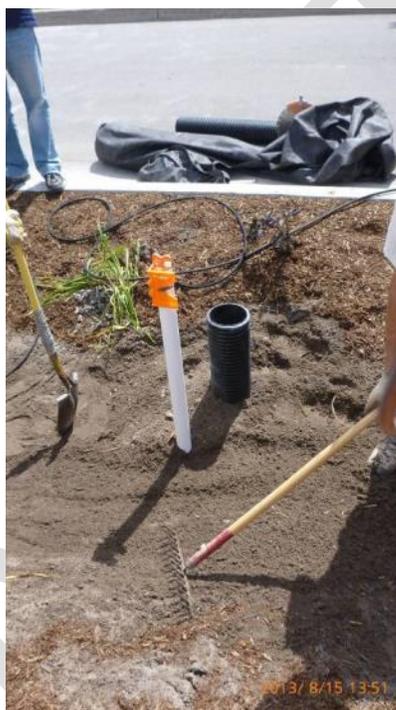
The photo on the left shows a CVC staff member digging to install the deep well. The photo on the right shows the deep well after installation and before it was cut with the casing in place

It is recommended that two loggers are used as that will give the most accurate data. A shallow and deep well are required to monitor the infiltration and surface ponding rates, which can be easily installed. The deep well, which is the one that measures infiltration rates, is either installed during the construction phase of the rain garden, or after construction is complete. It is easier to install your well during construction if possible as it is less intrusive and can be placed deeper. A standard piezometer pipe is used, with a metal well casing on the outside to prevent theft and vandalism. The piezometer pipe is buried so that the well is less visible and obtrusive. The well casing should be level with the ground surface. This will allow more accurate manual measurements to be taken to both calibrate the loggers and confirm their accuracy.

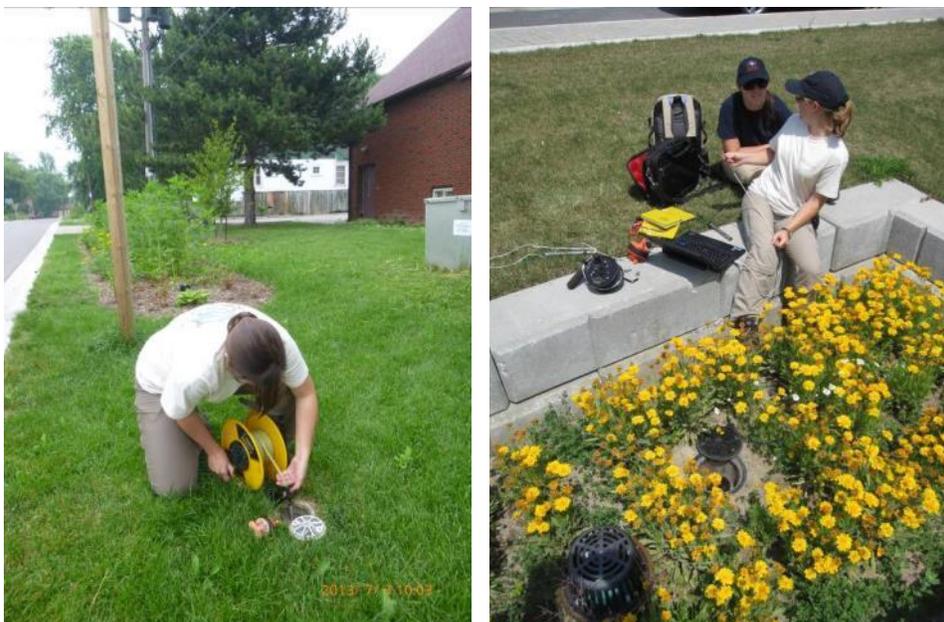
The photo on the left shows a CVC staff member taking a manual water level measurement with a level tape. The photo on the right shows CVC staff downloading the loggers at one of the LID sites.

- Taking photos and documenting any changes that might have occurred since the last visit
- Opening the well and taking a water level measurement
- Removing the logger from the well to download the data
- Replacing the logger in the well and securing the well casing
- Taking detailed notes of measurements, downloads, logger information, and site information

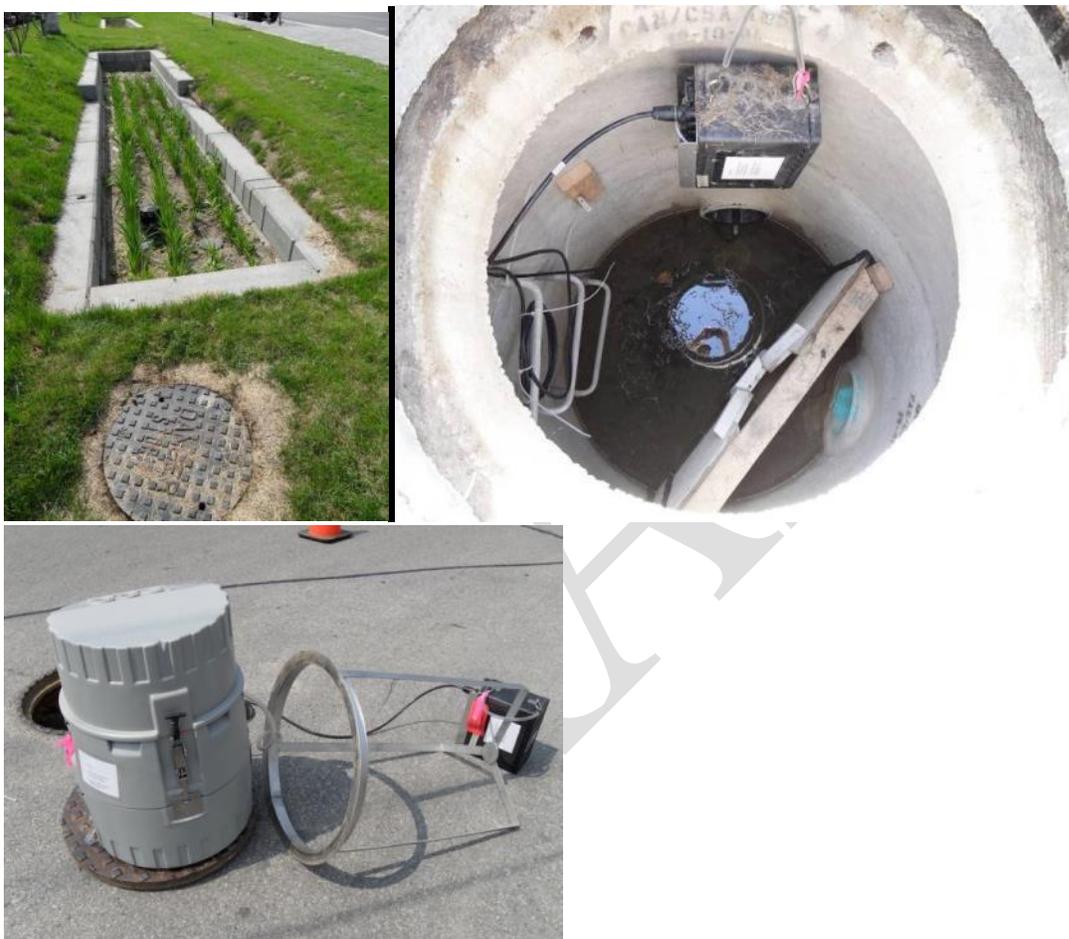
Monitoring station. An external and internal view of the manhole of the monitoring location at Elm Drive.

Finding the best water flow monitoring location(s) is the first and most important step in establishing a continuous monitoring site as flow variation will largely determine loading and related uncertainties. Flows must be laminar and not subject to back-watering. Ideally, a pipe weir or pre-manufactured flume weir can be installed for tracking pre-determined height/flow relationships. If not, then pipe flow equations or gauging will have to be accomplished. Existing site plans should be reviewed following a site walk to gain an understanding of the existing drainage system for the study area. For example, CVC uses flow loggers and autosamplers to conduct high-intensity monitoring.

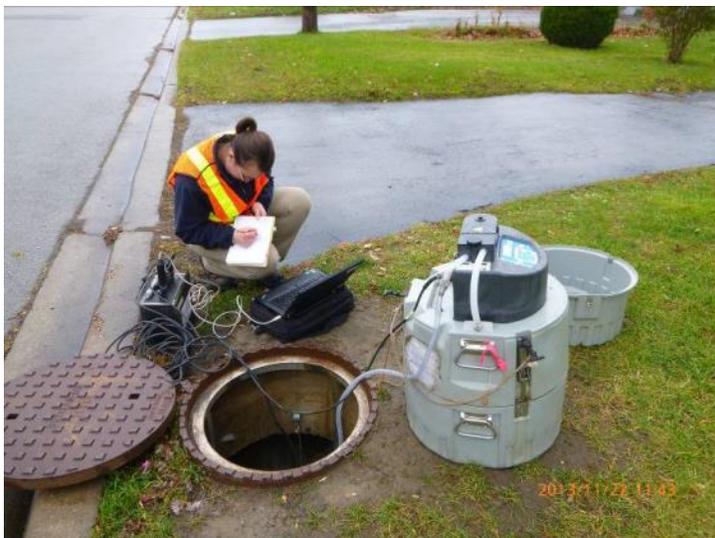
CVC staff member downloading flow data from the logger, along with the autosampler. Autosamplers provide the convenience and ease of sample collection.

When sampling for water quality at LID sites and control sites ('business as usual' stormwater management) it is important to capture the first flush (the beginning of outflow) and peak flow. Autosamplers are recommended in order to capture the first flush and the peak flow. Autosamplers should be programmed to begin sampling at the beginning of flow and should last for the entire flow event. In cases where sampling with an autosampler is not feasible, grab samples of the outflow can be collected directly. When sampling this way it is important to time the sampling appropriately to get a representative sample of the outflow.

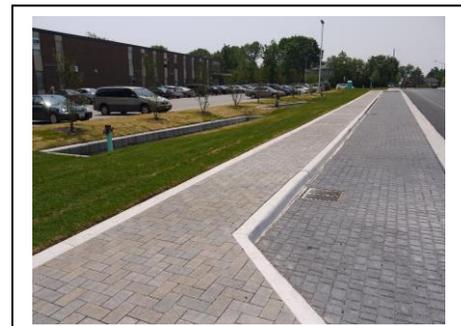
Elm Drive Permeable Pavement Lay-bys, sidewalk and bioretention cells

The Elm Drive low impact development (LID) road retrofit is located on Elm Drive West, just south of the Square One Shopping Centre in Mississauga, Ontario. Green infrastructure implemented includes both permeable paver lay-bys within the road right of way (on City of Mississauga property) and bioretention planters on the adjoining property owned by the Peel District School Board (PDSB). Runoff flows from Elm Drive West onto the permeable paver lay-by and into the bioretention planters via an open pipe. The bioretention cells have a sub-drain also known as a perforated pipe which collects the infiltrated water which then flows to the existing storm sewer. The bioretention soil mix is loamy sand whereas the native soils are clay/weathered shale. Native ornamental herbaceous plants are planted in the bioretention cells topped with mulch.

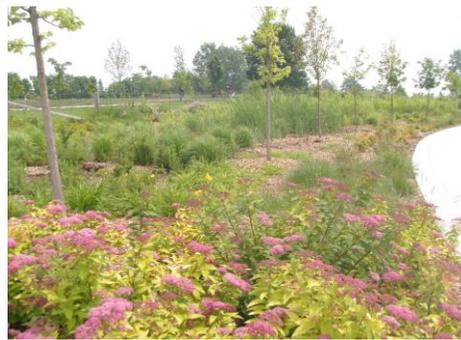
Lakeside Park is one of the City of Mississauga's newest parks located on Lakeshore Road West, east of Winston Churchill Blvd in Mississauga, ON. Green infrastructure at Lakeside Park includes a pervious concrete overflow parking area, bioswale, green roof, and a reclaimed water irrigation system that recycles water from the bioswale and splash pad. The bioswale (i.e.: bioretention) is designed as such that it accepts sheet flow runoff generated from the adjacent parking lot that enters the bioswale through a series of curb cuts and discharge to a main sub-drain also known as a perforated pipe. The bioswale media is loamy sand where as the native soils are of mixed clay fill over sand and gravel. The bioswale is planted with native sedge grasses topped with shredded pine mulch.

Lakeside Park bioretention swale takes runoff from the surrounding parking lot.

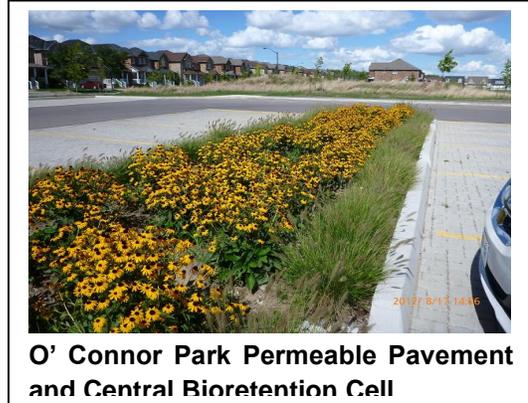
O'Connor Park is located on Bala Drive in the west end of Mississauga, Ontario in the Sawmill Creek sub-watershed. The practices of the park include: two soccer fields, wetland with a habitat island, naturalized areas, playground, walkway adjacent to the wetland and parking lot with innovative LID practices including permeable pavement and a central bioretention cell. Typical rainfall events are managed via the permeable pavement parking spots but larger rainfall events creating sheet flow are directed to the bioretention cell through the curb cut-outs. Runoff that infiltrates into the bioretention cell gets collected into a sub-drain or so called a perforated pipe.

O' Connor Park Permeable Pavement and Central Bioretention Cell

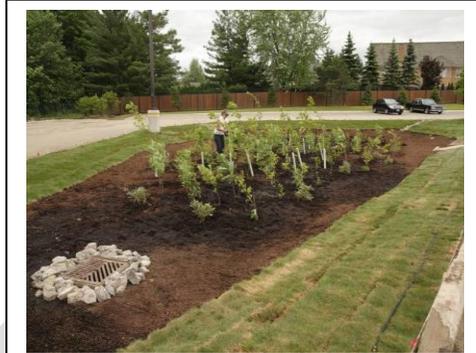
Portico Community Church is located just off of Queen Street South in Mississauga Ontario. In 2009, Portico demonstrated their dedication to environmental stewardship by constructing one of the first green parking lots in the Credit River watershed. Green infrastructure implemented at Portico Church includes permeable pavement, bioswale and a central bioretention cell. The central bioretention cell is designed as such that it accepts concentrated flow runoff generated from the adjacent parking lot and enters the bioretention through a series of curb cuts and discharges to a sub-drain or a perforated pipe. The bioswale media is clayey sand where as the native soils are clay. The bioswale is planted with native woodland and ornamental shrubs topped with shredded hardwood mulch.

Planted Bioretention Cell at Portico Church in 2011

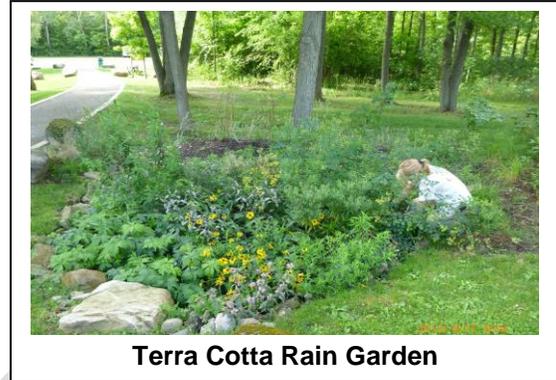
Terra Cotta Conservation Area (TCCA) is a 485 naturalized area located within the village of Terra Cotta. A rain garden was constructed next to the Visitors Welcome Centre similar to what would typically be constructed on a residential property. The rain garden accepts concentrate runoff from the Welcome Center’s rooftop through a roof leader. The bioretention soil mix is composed of silt and organic matter where the native soils were clayey loamy silt with an infiltration rate of 14 mm/hr for the native soils. The plant community is native woodland topped with shredded hardwood mulch.

Terra Cotta Rain Garden

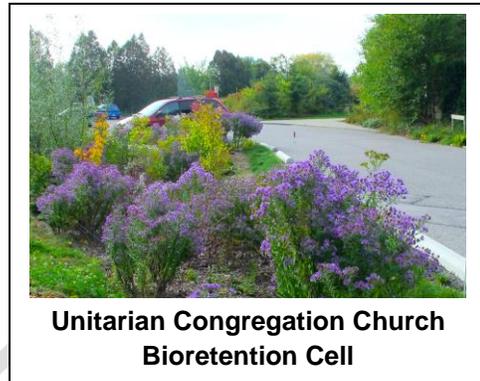
The Unitarian Congregation in Mississauga (UCM) is located on South Service Road between Mary Fix and Wolfedale Creeks, two urban and degraded creeks within the Credit River Watershed that drain into Lake Ontario. Green infrastructure at Unitarian Congregation Church includes a bioretention which is designed as such that it accepts sheet flow runoff generated from the adjacent parking lot that enters the bioretention cell through a series of curb cuts. The bioretention facility does not have a sub-drain/perforated pipe; however there is an overflow catchbasin that goes directly into the existing storm sewer.

**Unitarian Congregation Church
Bioretention Cell**
