FINAL REPORT

Lake Ontario Shoreline Hazards

Credit Valley Conservation

**Shoreplan
Engineering Limited**

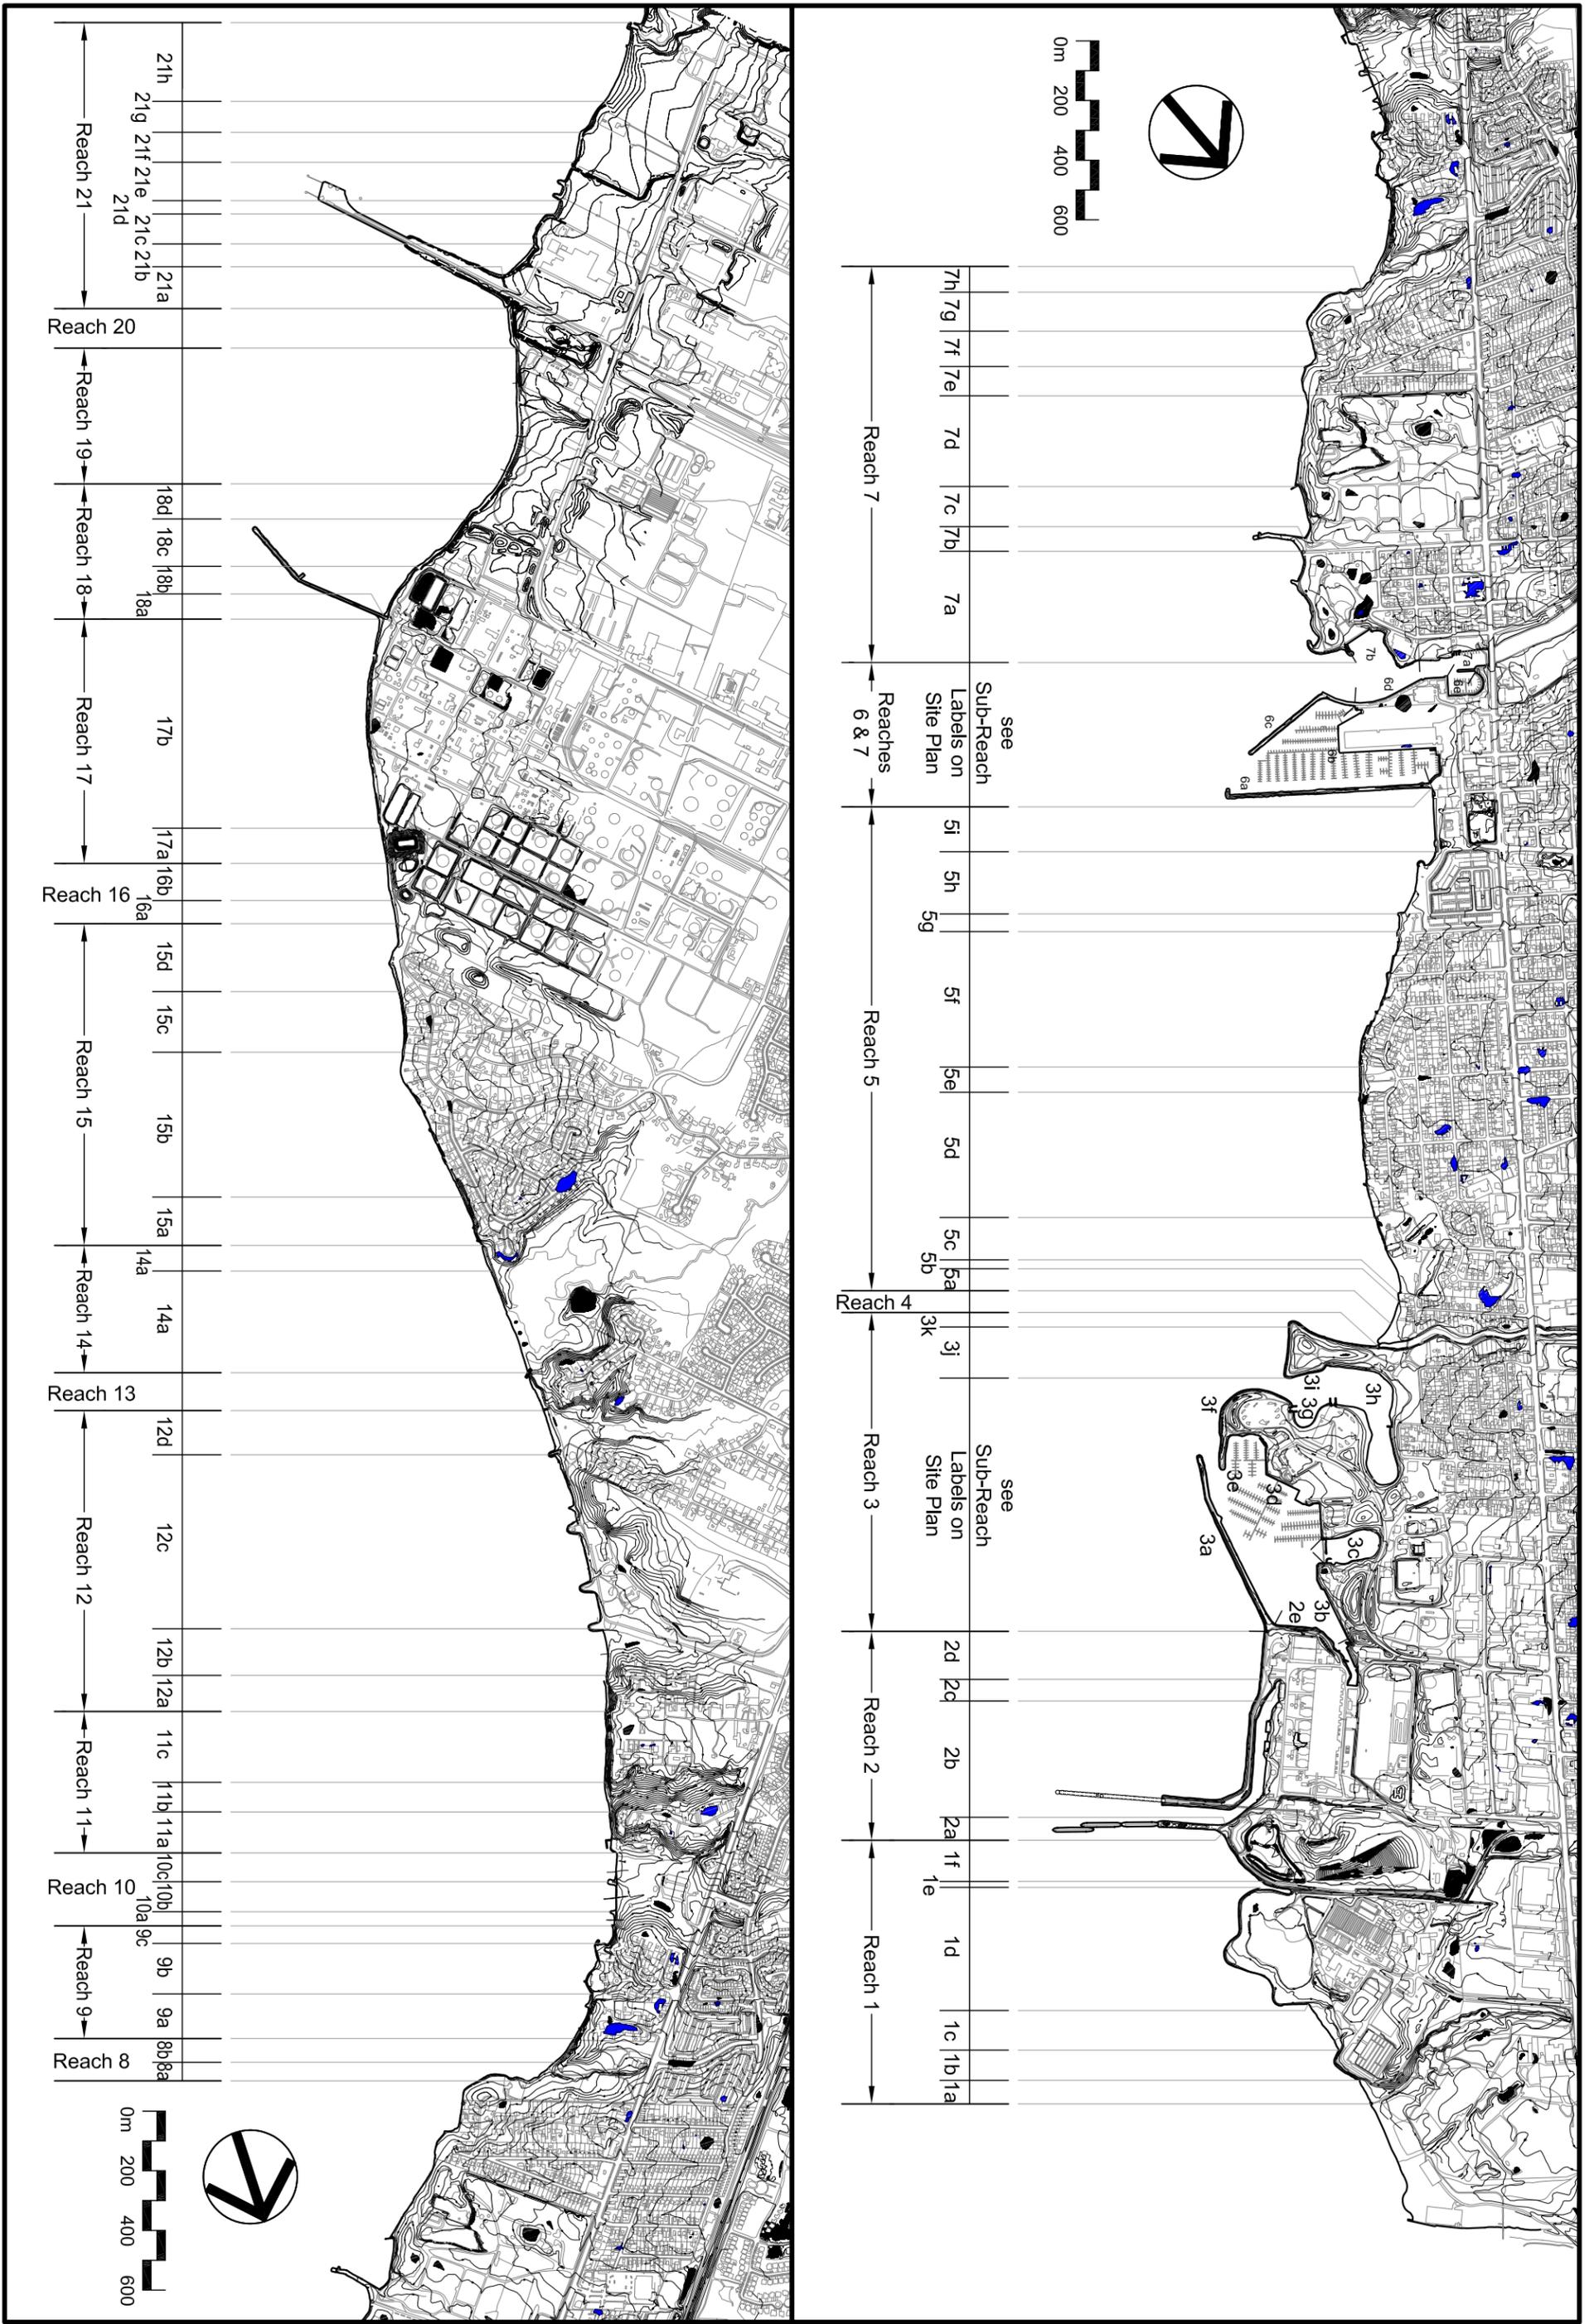
Figure 2.1
Reach Location Plan

Reach 7 was defined as a new reach starting on the south side of the Credit River. Reach 6e stops at the north side of the Credit River and the river mouth was left as a discontinuity along the shoreline. The remaining reaches (5, 9, 11, 13, 15, 17 and 20) were defined because they were the next section of shoreline adjacent to the dynamic beach reaches. Reach 1 is the north-eastern most primary reach and reach 22 is the south-western most primary reach.

The Lake Ontario shoreline within the CVC watershed is located mainly in the City of Mississauga and has a total length in the order of 13 kilometers. For this study the shoreline was divided into a total of 22 primary reaches based on coastal processes. Each primary reach was further sub-divided into secondary reaches where required to ensure that relatively consistent hazard conditions existed within each secondary reach and to consider public ownership. There were a total of 87 secondary reaches. Figure 2.1 shows the Lake Ontario shoreline within the CVC jurisdiction and the limits of the primary and secondary reaches.

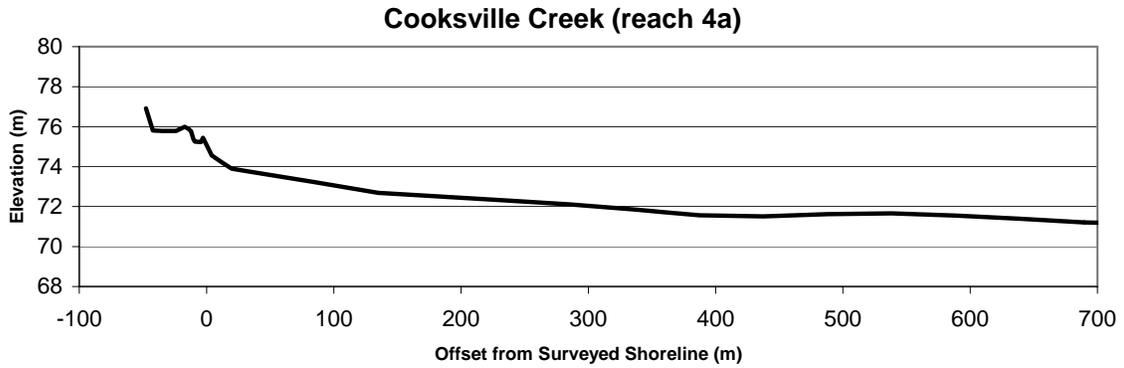
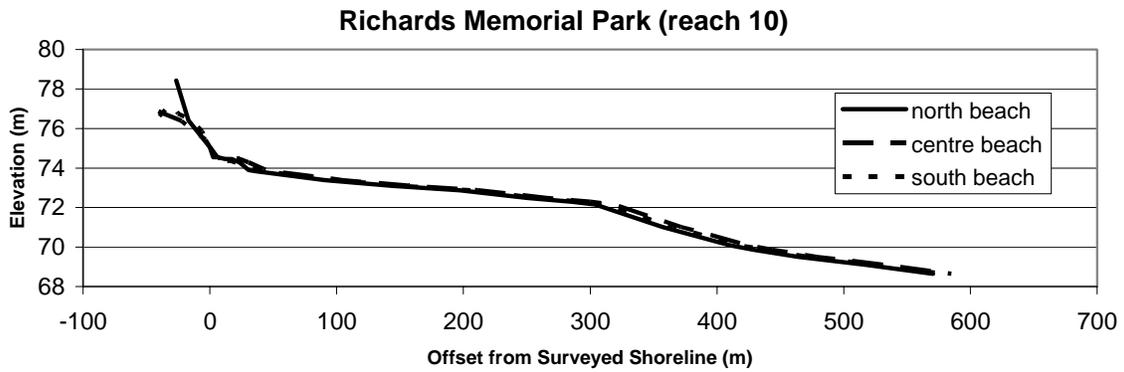
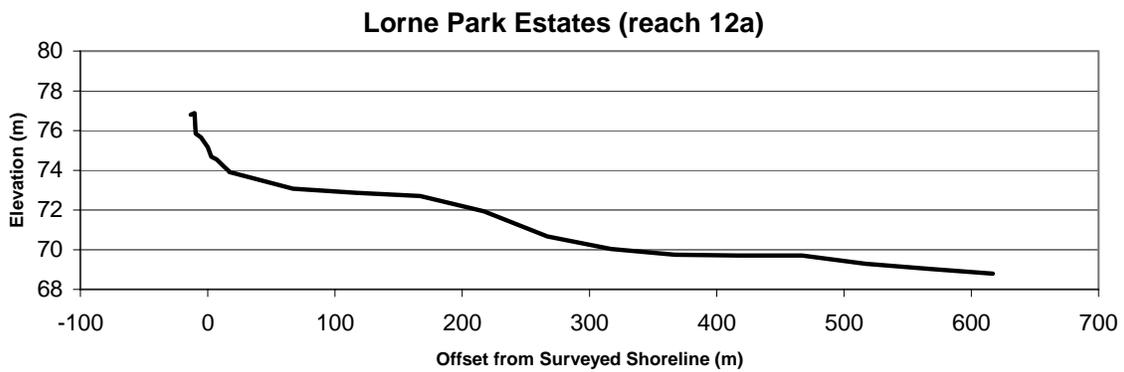
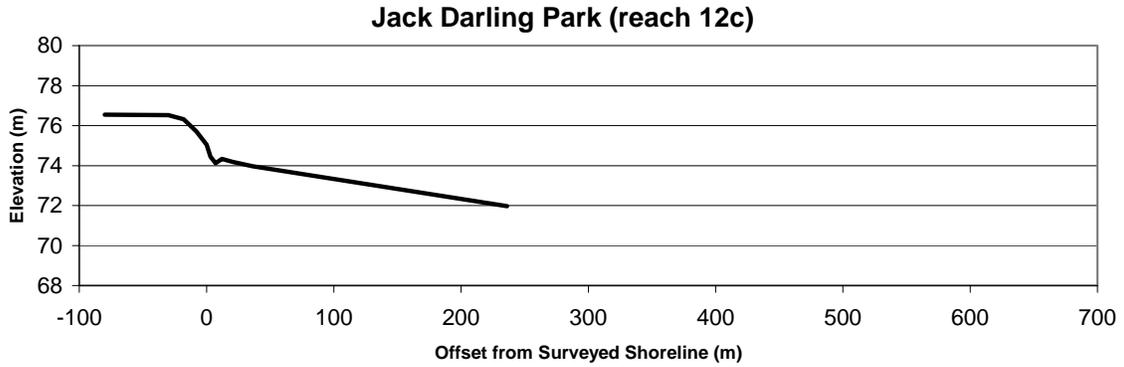
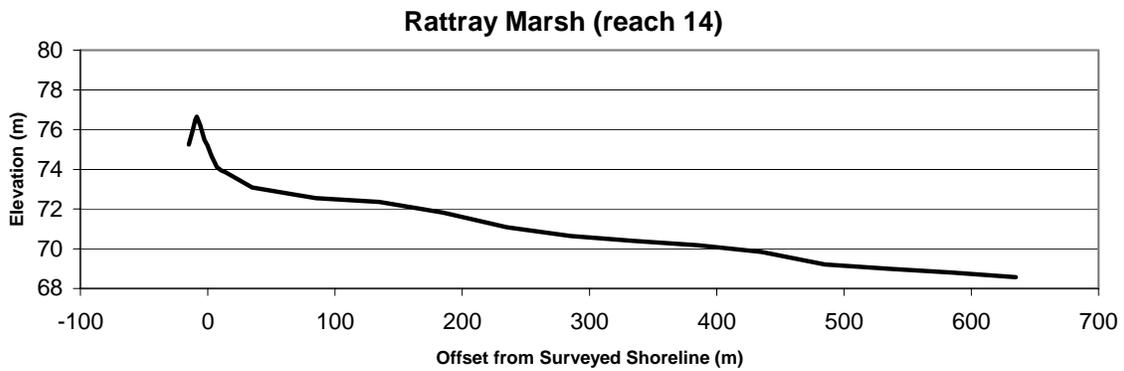
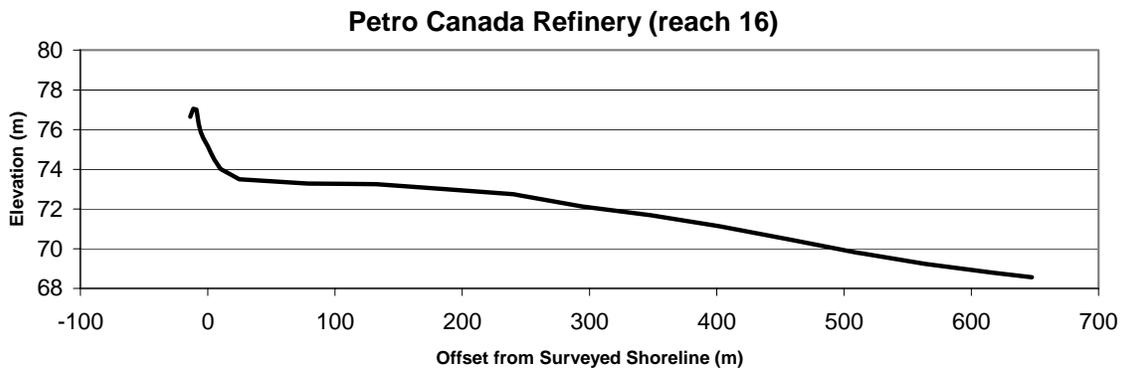
Beach Profiles

A series of wave uprush calculations were carried out for typical revetment and wall structures as well as a number of surveyed profiles. Nearshore profiles were surveyed within each reach where it was thought that dynamic beach hazards might apply. The surveyed profiles were extended into deeper water using data surveyed by the Canadian Hydrographic Service. Cross sections of the combined profiles from the Shoreplan surveys and the CHS data are presented in Appendix A.

Flood hazard limits for each dynamic beach reach were calculated from surveyed typical profiles within those reaches. Cross-sections of the profiles used in those calculations are presented in Appendix A. Due to the nature of the beaches within the study area the flood limits tended to extend beyond the actual limits of the beaches. This is due to the lack of dune or berm formation associated with a general lack of supply of beach material.

Reaches originally considered as dynamic beaches included reaches 4, 8, 10a-c, 12a-d, 14a-b, 16a-b, 19 and 22. The Guidelines specify that the dynamic beach hazard only be applied where the beach deposit is at least 30 metres wide and 100 metres long. Reach 4 is a small sand fillet beach that has formed against the outlet of Cooksville Creek because of the adjacent headland from Lakefront Promenade Park. This was determined to not be a dynamic beach because the portion of the fillet beach that was more than 30 metres wide was less than 100 metres long. A beach profile was still surveyed, however, so that the wave uprush limits could be accurately determined. The surveyed cross-section is included in Appendix A.
