## **Appendix 'L'**

### **Alternative Cost Estimates & Visualizations**

**Belfountain Dam and Headpond Class EA**  
**Alternative D2H2: Rehabilitate the Dam and Headpond**  
**Conceptual Cost Estimate**

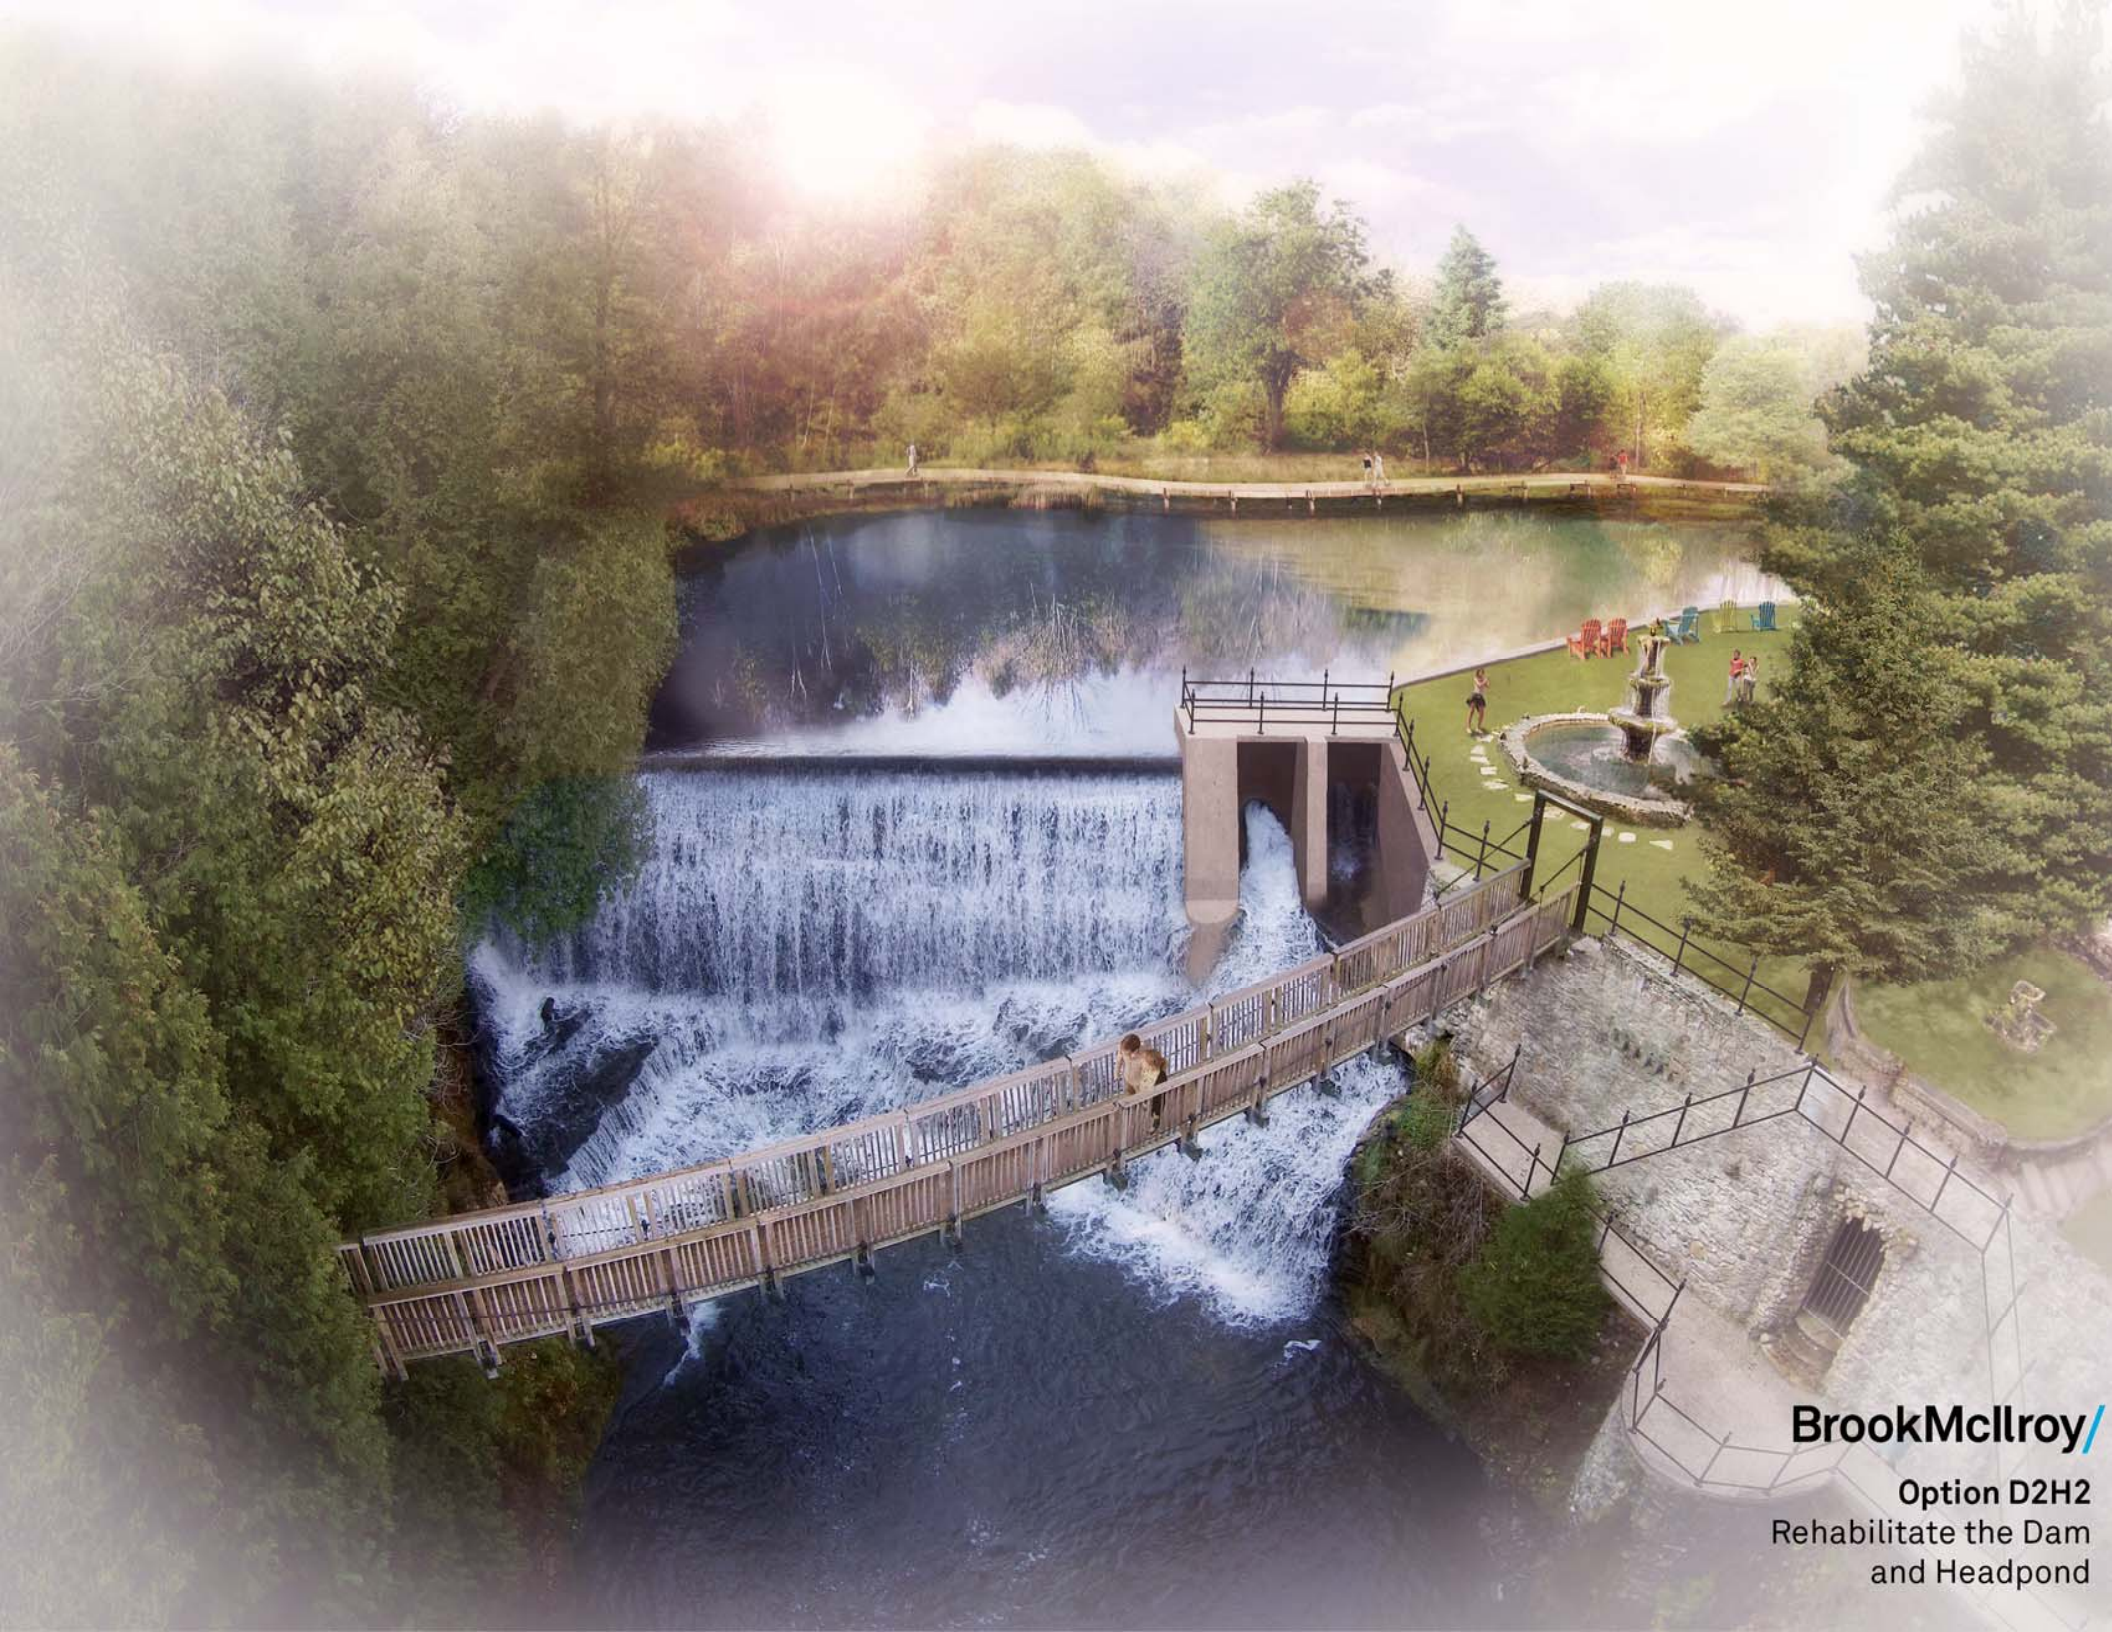
**Option D2H2**  
Rehabilitate the Dam  
and Headpond

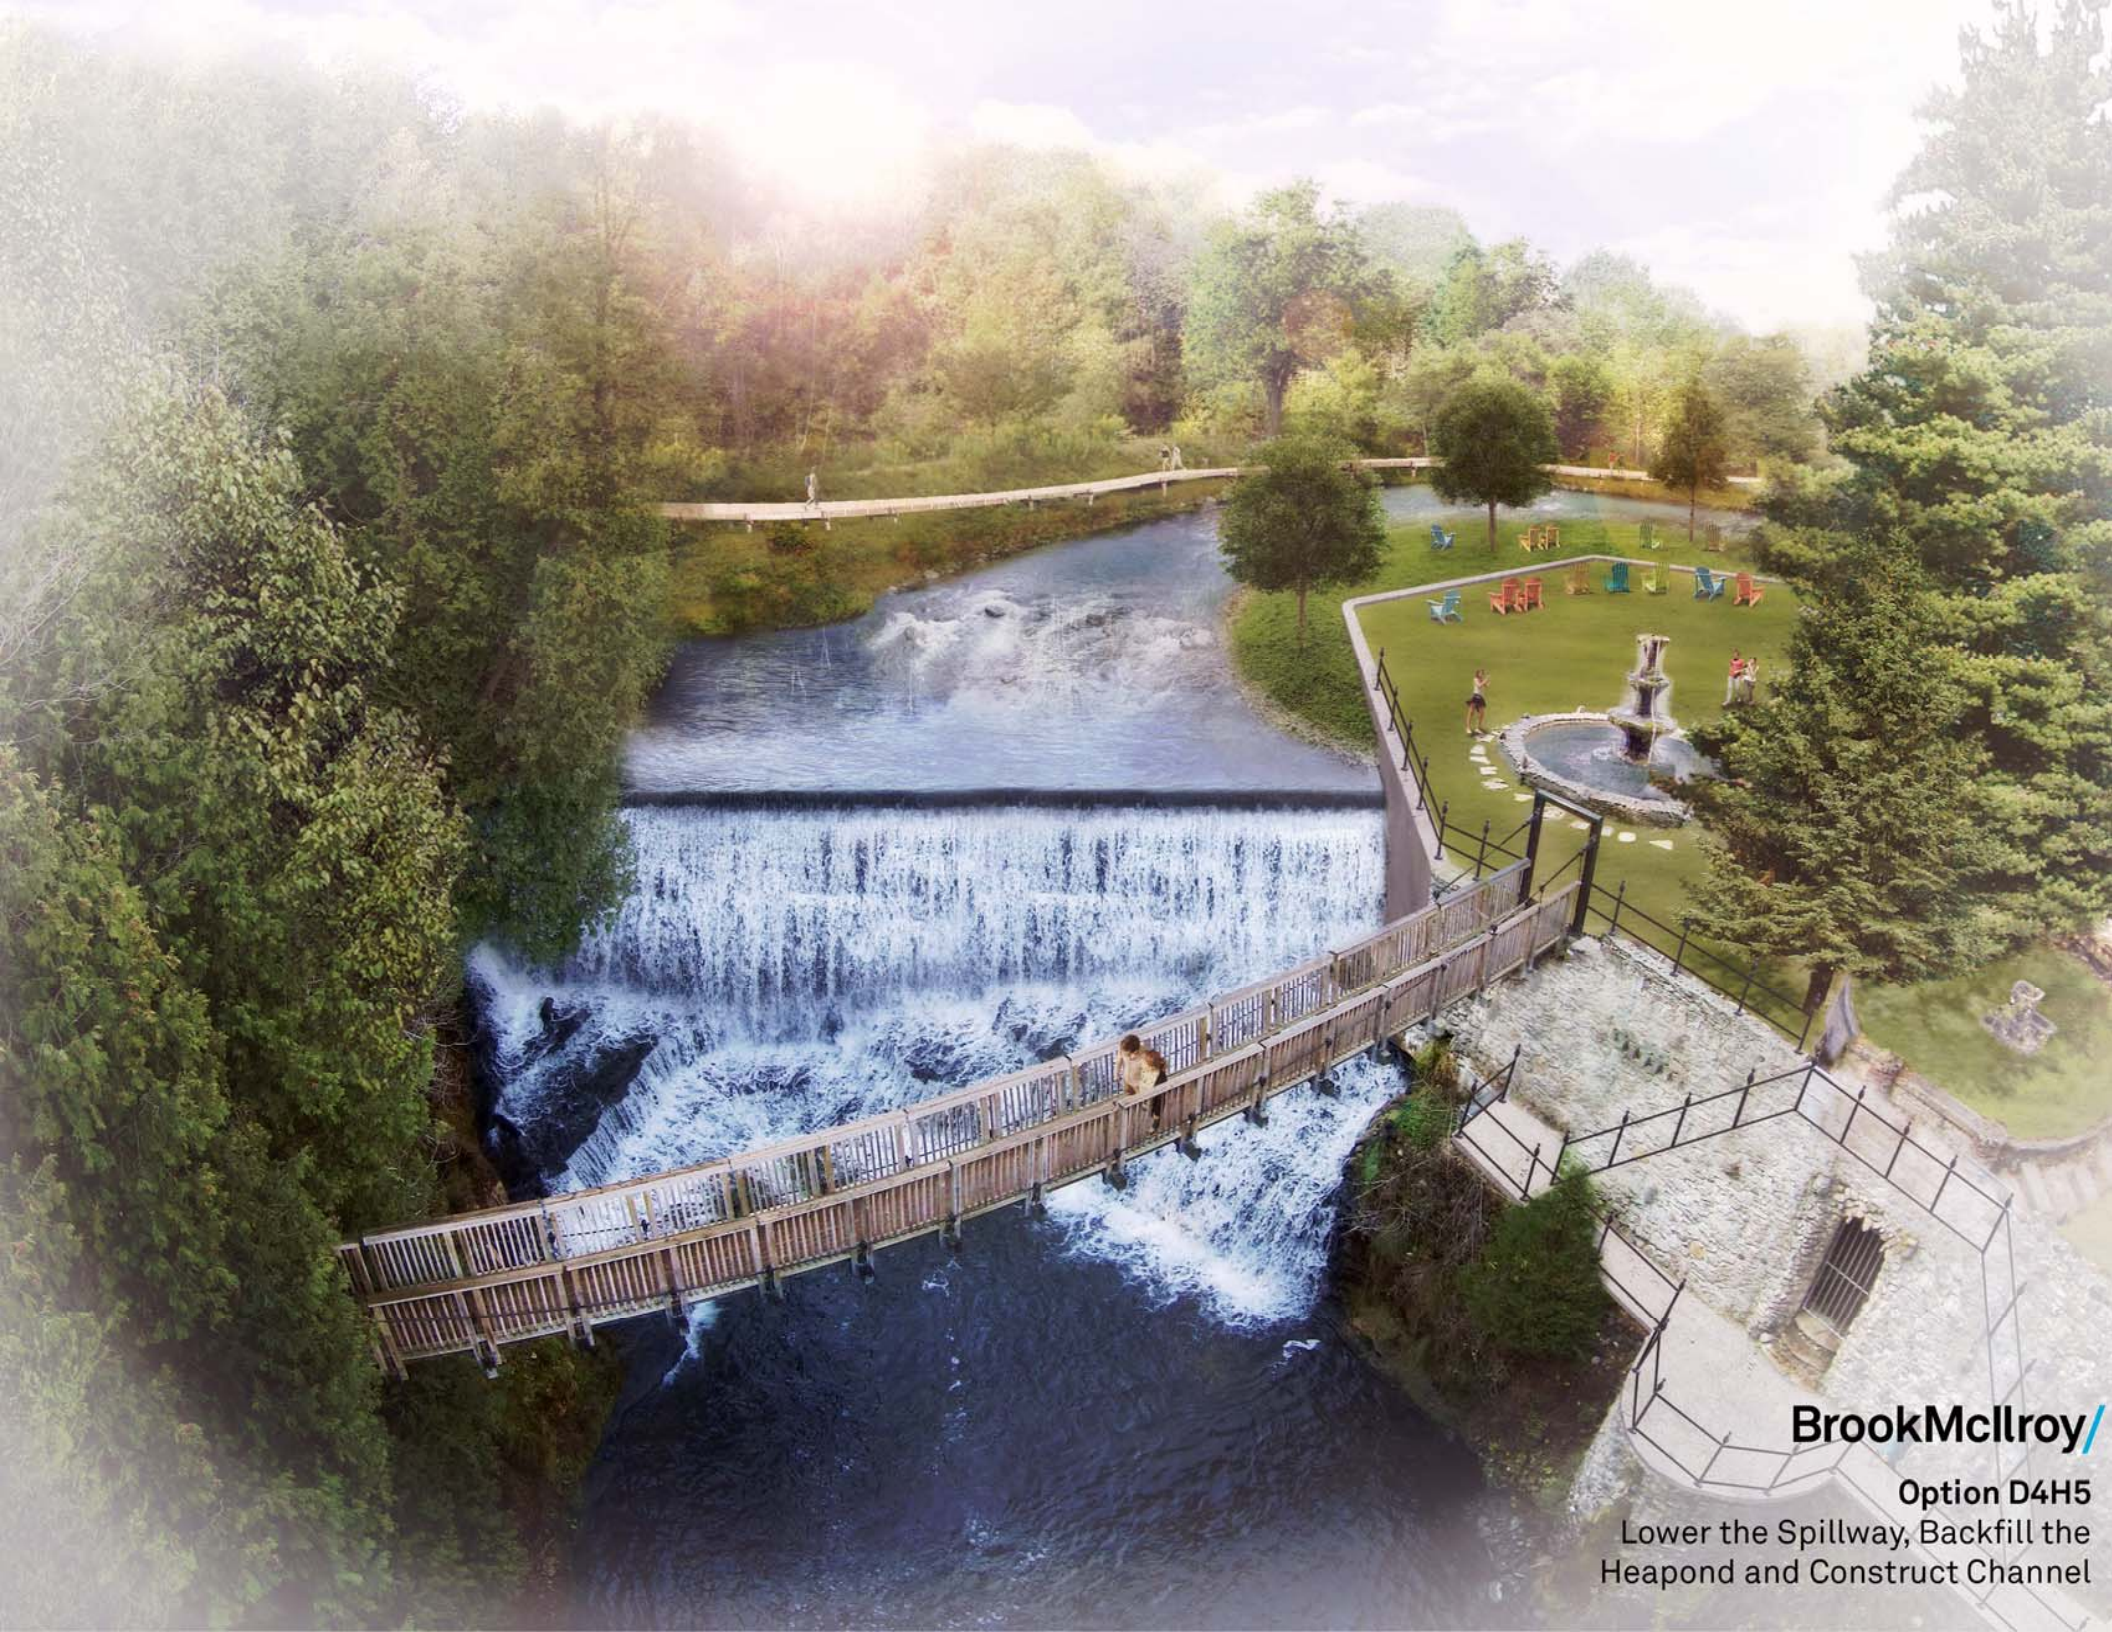
**Option D4H5**

Lower the Spillway, Backfill the  
Heapond and Construct Channel

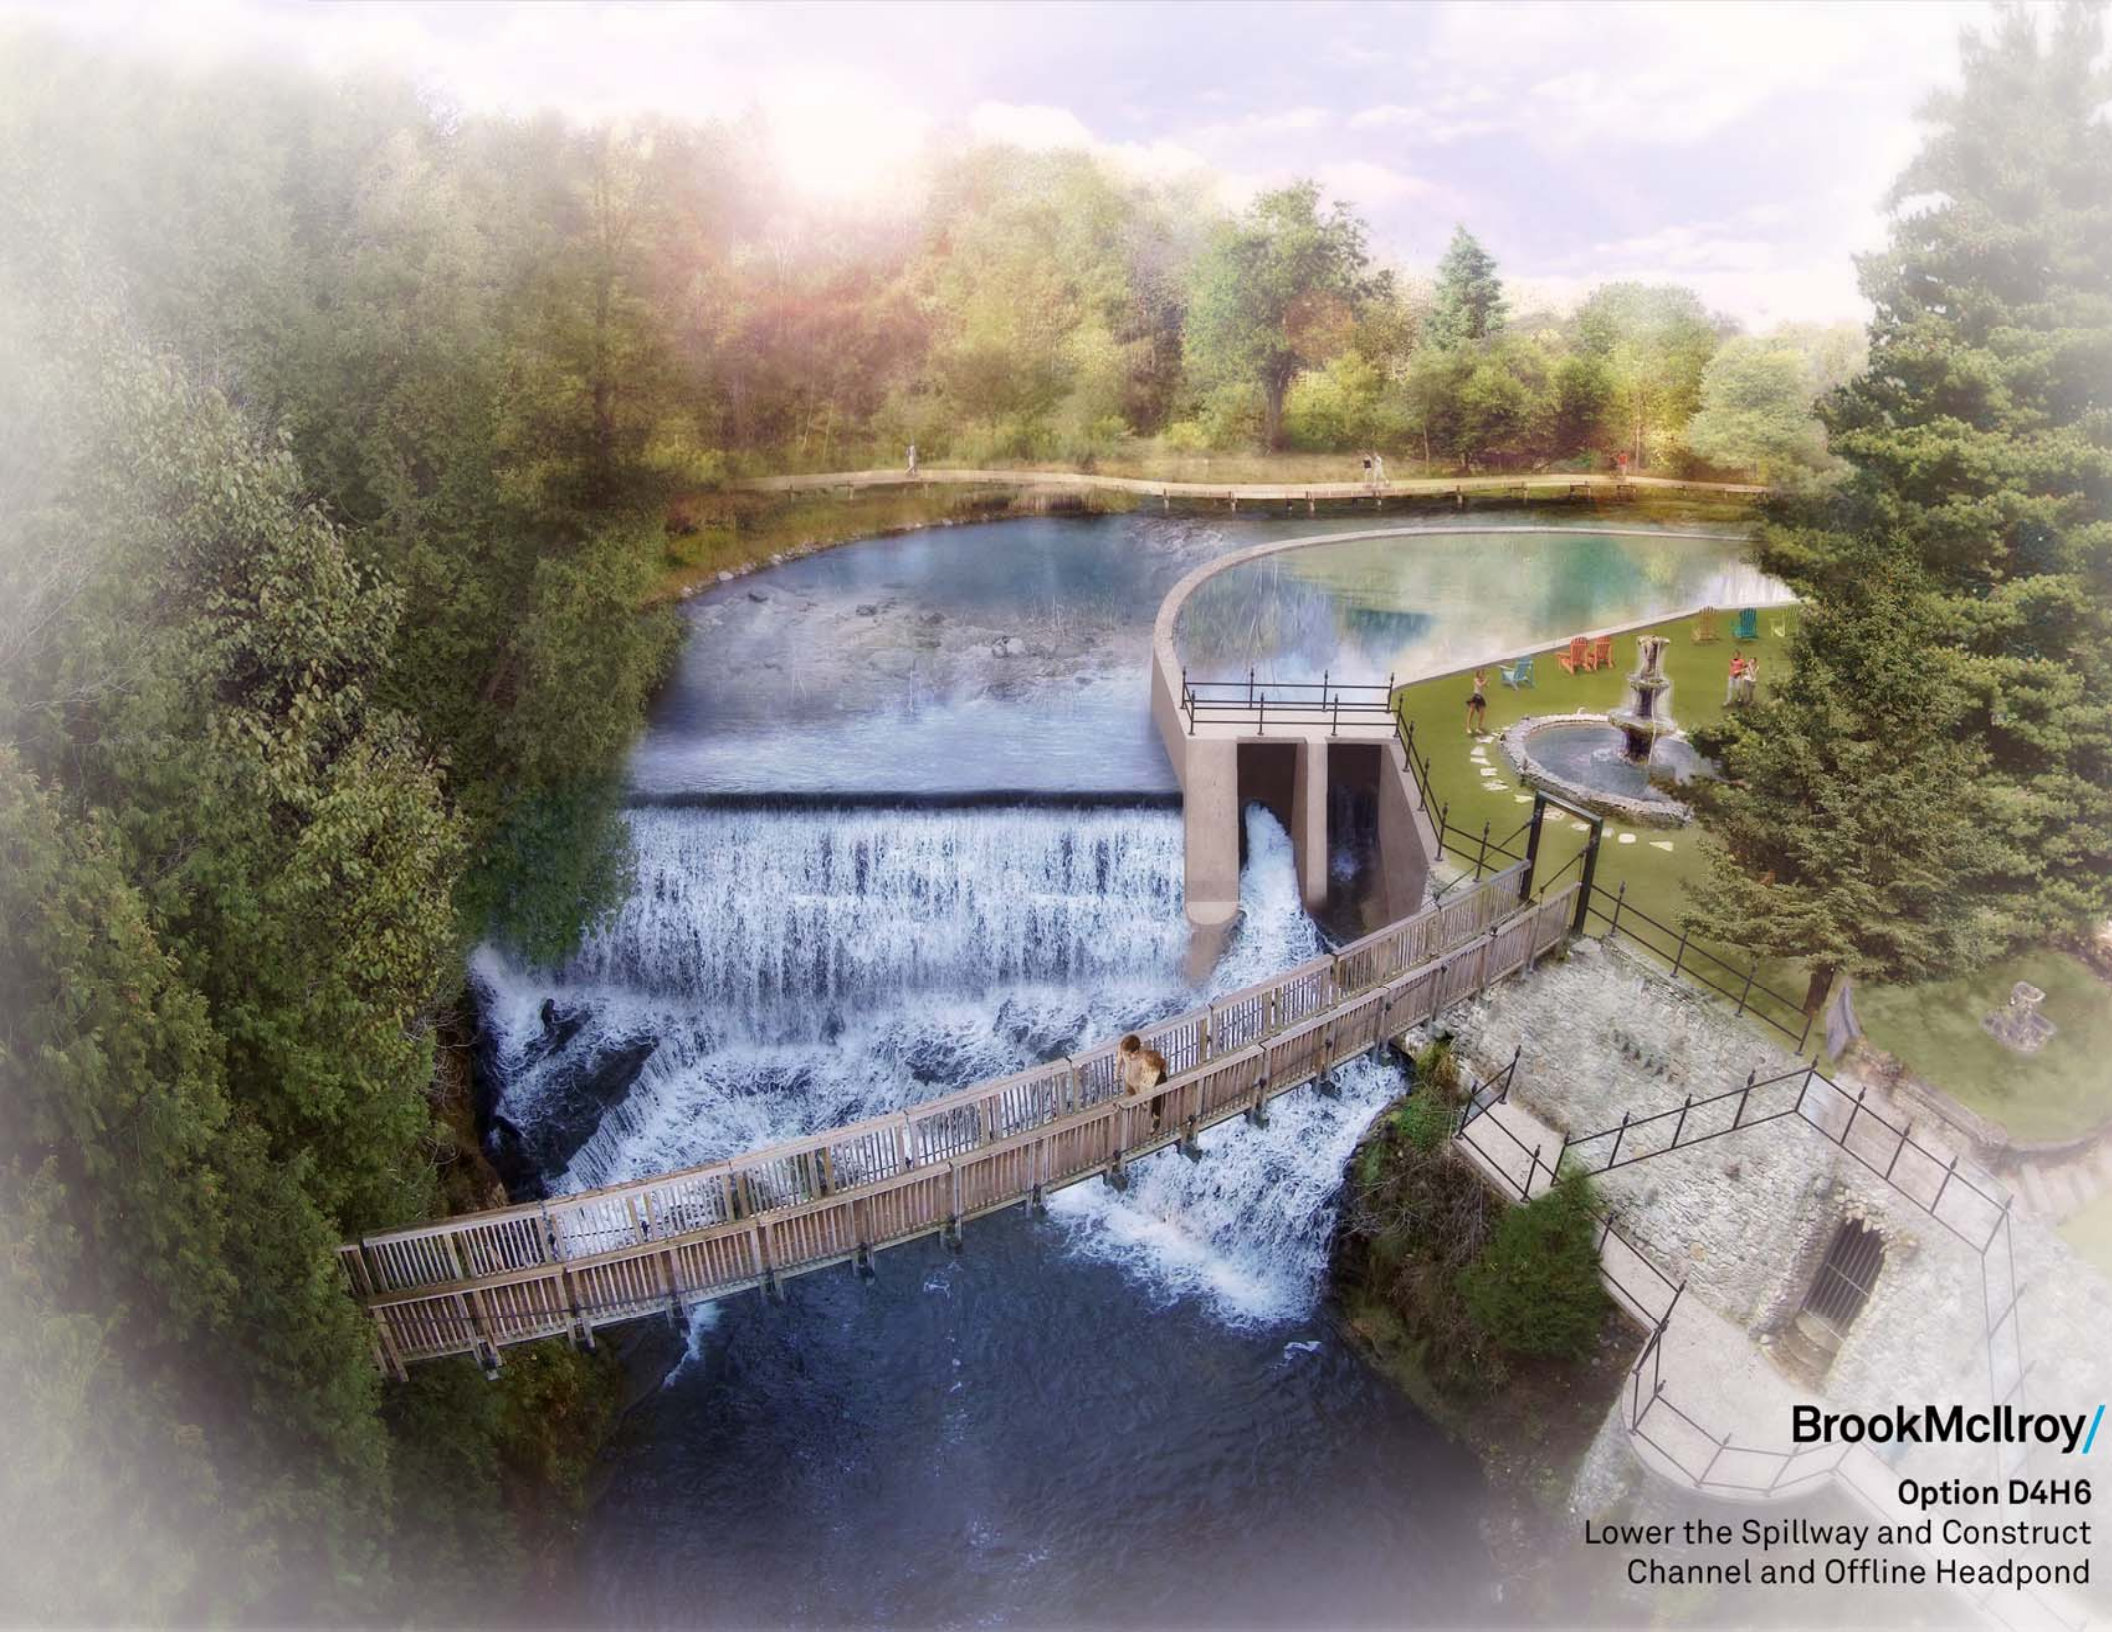
**Option D4H6**

Lower the Spillway and Construct  
Channel and Offline Headpond
